# Paul Cornell and Associates

**Inspection Report  
prepared for:**

**Property Address:  
61 Pearl Street  
Newton, MA 02458**

<b>Date of Inspection :</b> 10/14/2010 <b>Time Started</b> 08:25 AM		<b>Time Finished</b> 02:35 PM
<b>Property Address :</b> 61 Pearl Street Newton, MA 02458	<b>Report Prepared For :</b> Joesphine McNeil	<b>Report ID :</b> OCT10_61 Pearl St_Newton

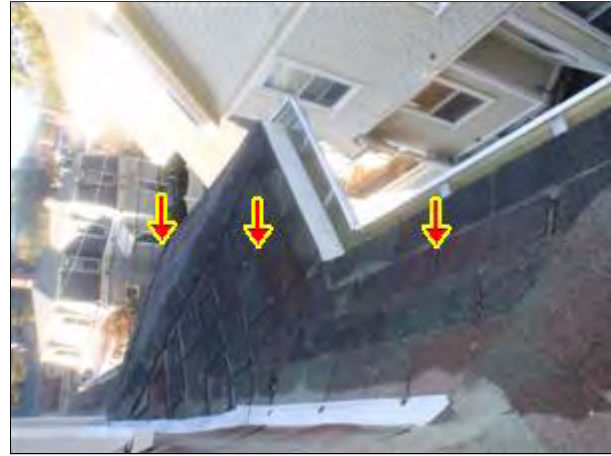
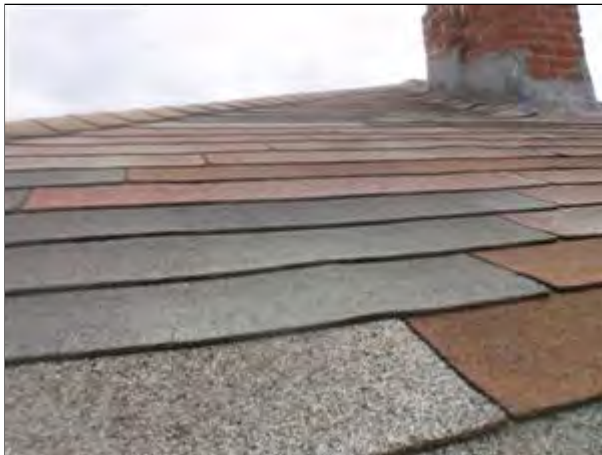
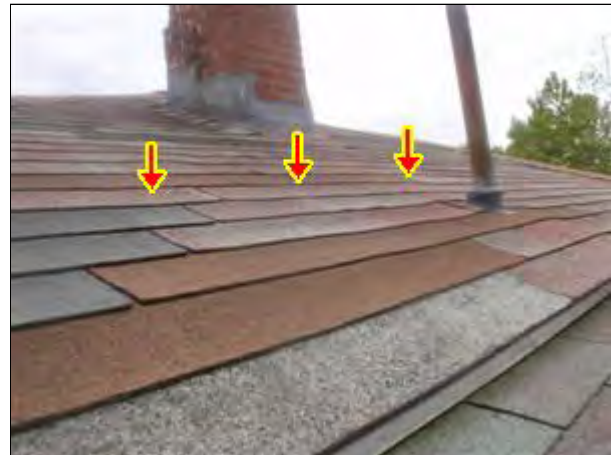
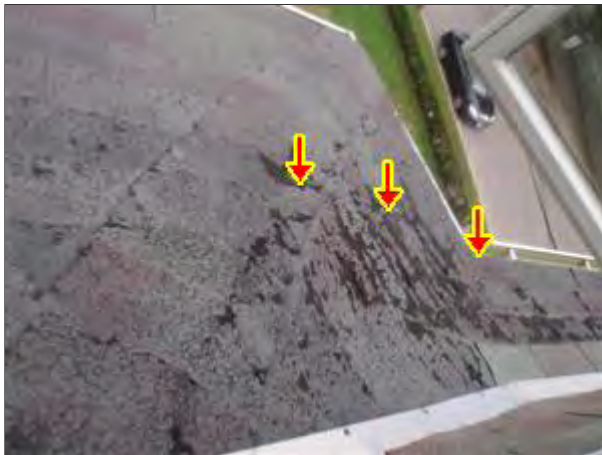
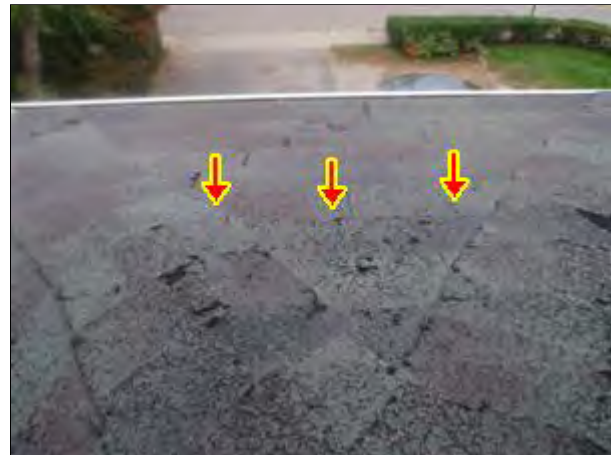
(5) Asphalt shingles on the right and left side of the lower mansard roofs are worn out, dried out and need to be replaced. Asphalt shingles on a lower pitch roof will be problematic. Replacement with metal or rubber roofing is recommended.

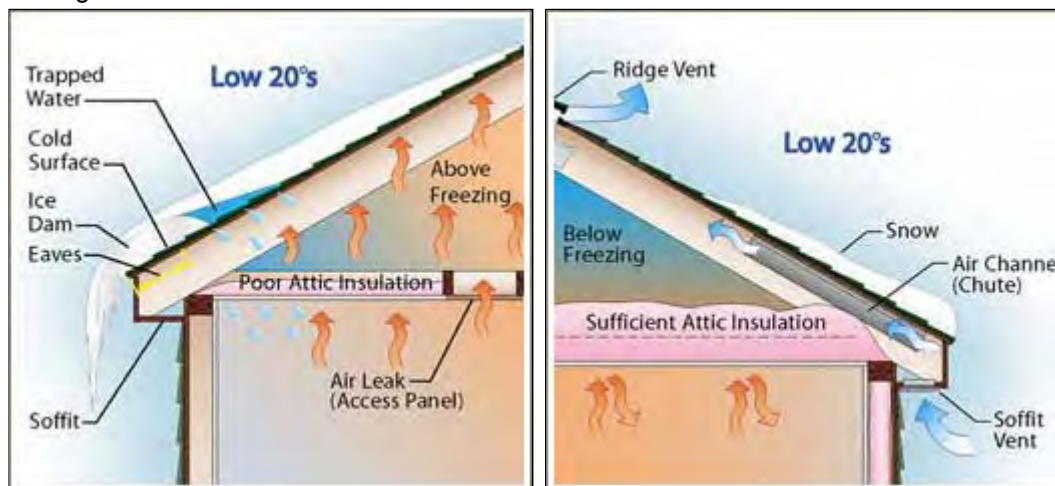
1.5 Picture 1

**1.5 VENTILATION** : There is limited means of roof ventilation. Limited roof ventilation combined with heat loss into the attic during the winter months can contribute to ice damming and condensation problems when snow is present on the roof. Limited ventilation can also contribute to excessive heat build up in the attic during the summer months and can

shorten the serviceable life of the roof cover. Proper and effective ventilation of the roof may prove to be impossible due to the design and framing.

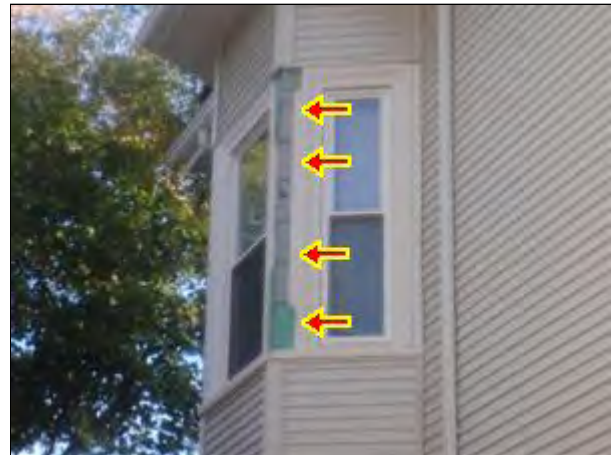
3.0 Picture 2

**3.0 (1) SIDING :** Vinyl siding installation on the left side 2nd floor bay is incomplete(Pictures 1&2). Repair is needed.

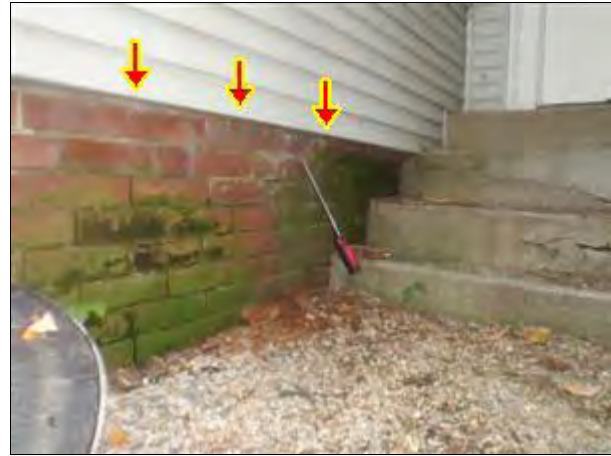
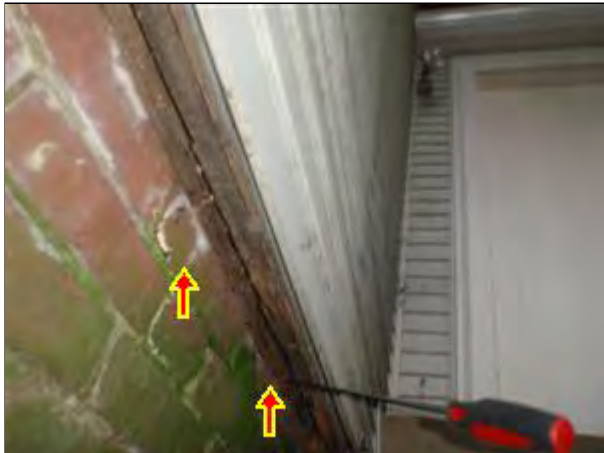
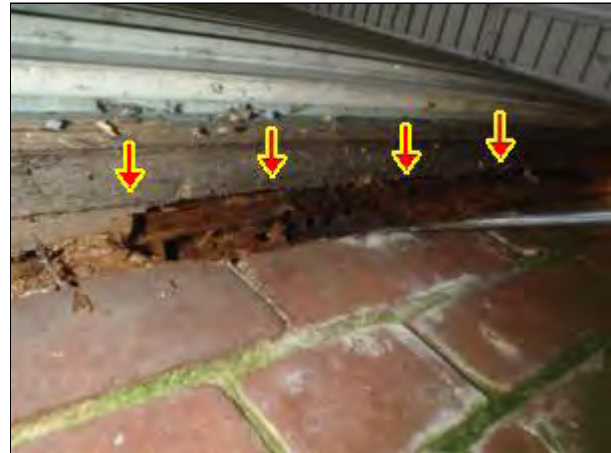
(3) Evidence of significant water damaged and decay was found behind the lower course of siding on the left side wall of the rear addition. The sill, sheathing and wall framing behind siding is rotted. Repairs are needed. The extent of damage is unknown. Further investigation is needed as concealed damage to framing behind is suspected. The lower 2 to 3 feet of siding on this wall will need to be removed to allow for evaluation. Damage may extend higher up the wall.

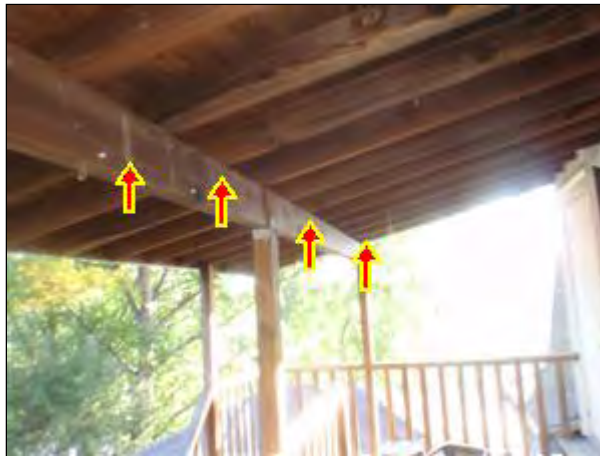
4.8 Picture 3

(7) Rafters supporting the roof over the 3rd floor of the deck are only toe nailed into the beam. This can allow for wind lift. Hurricane ties need to be installed to resist uplift during high winds.

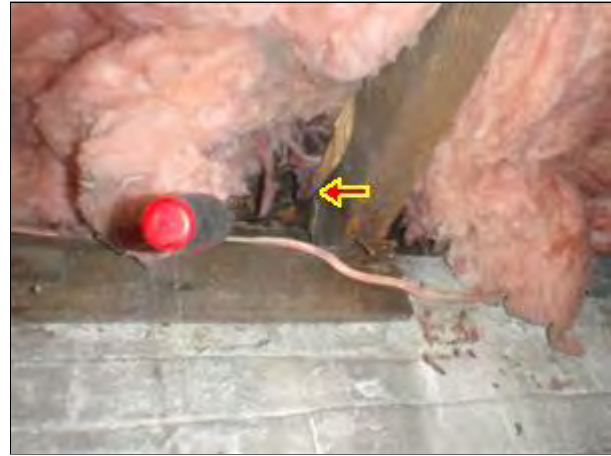
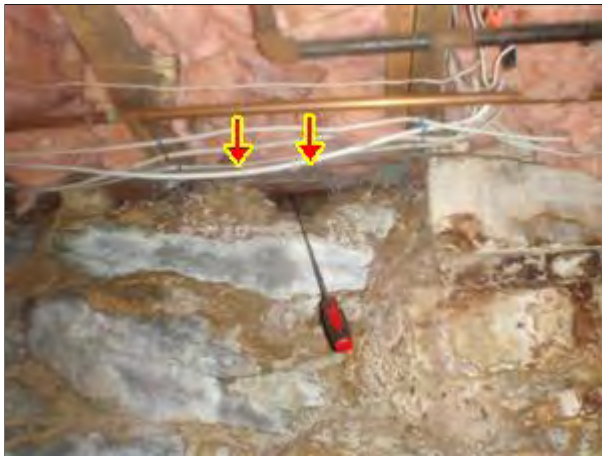
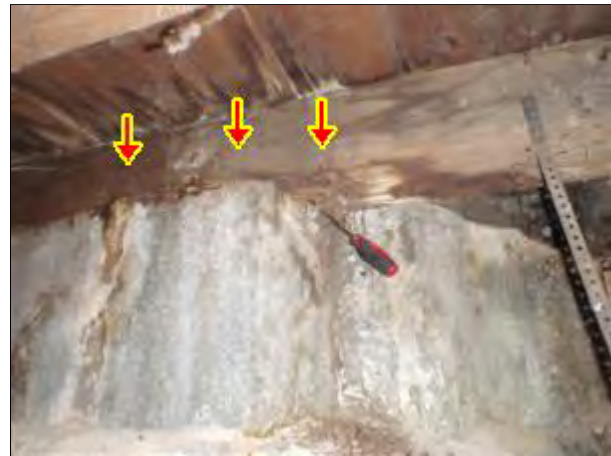
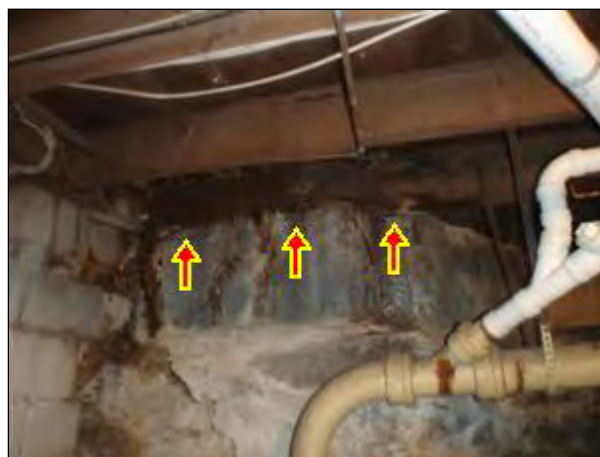
(3) Many of the floor joists at the main beam mortise and tenon connections are cracked and failing. Joist hangers need to be installed to arrest cracking and failure.

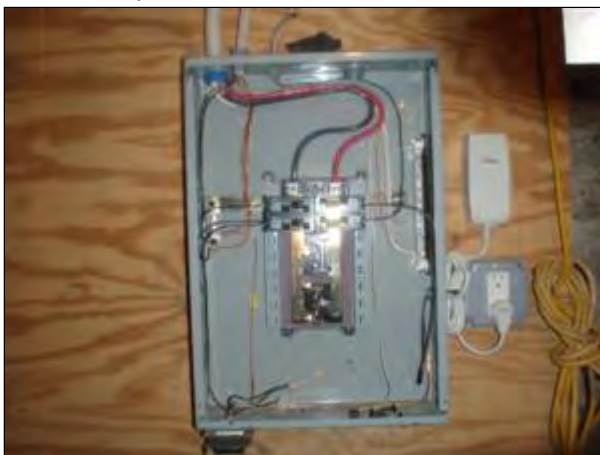
13.3.A Picture 1

**13.3.A CIRCUIT BREAKERS** : One breaker in the panel is double tapped which is typically not permitted. This is typically overlooked with the door bell transformer. The panel is rated for 24 circuit breakers, it has 4.

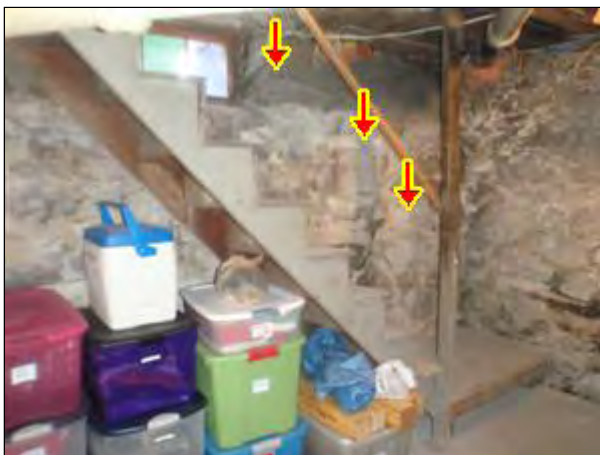
14.6 Picture 1

(3) The cellar stairway needs intermediate guard rails for safety. Headroom in this stairway is low and poses a risk for personal injury.
