# Paul Cornell and Associates

**Inspection Report  
prepared for:**

**Property Address:  
54 Taft Avenue  
Newton MA**

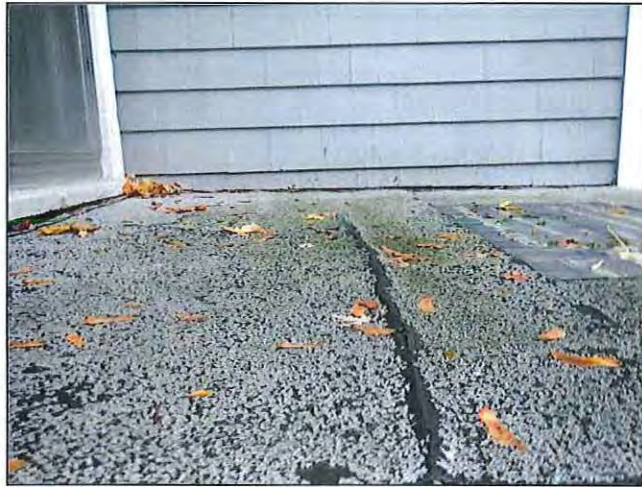
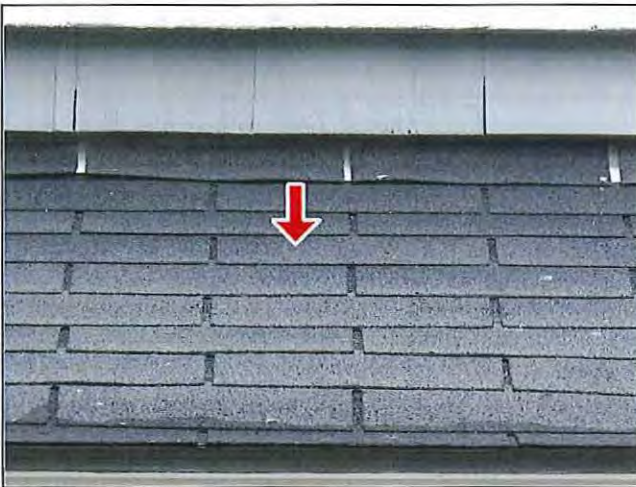
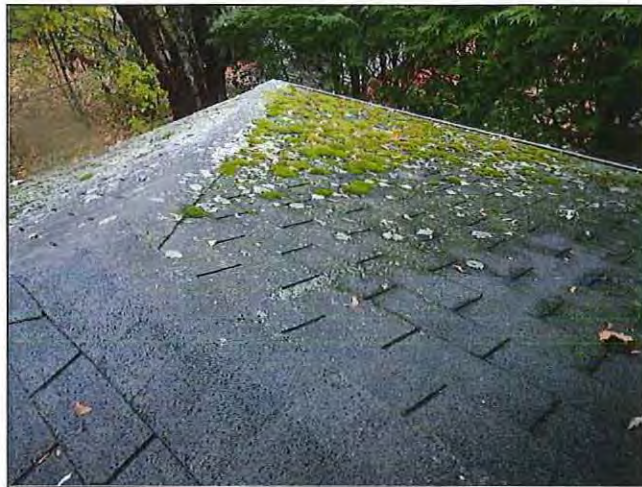
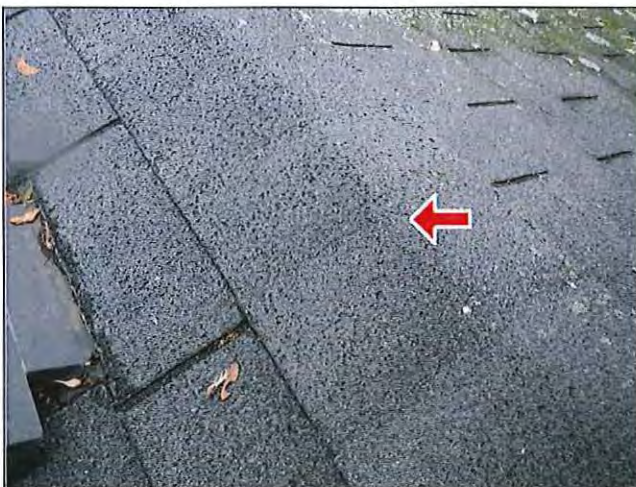
1.1 The roof cover has outlived its useful service life and should be replaced.

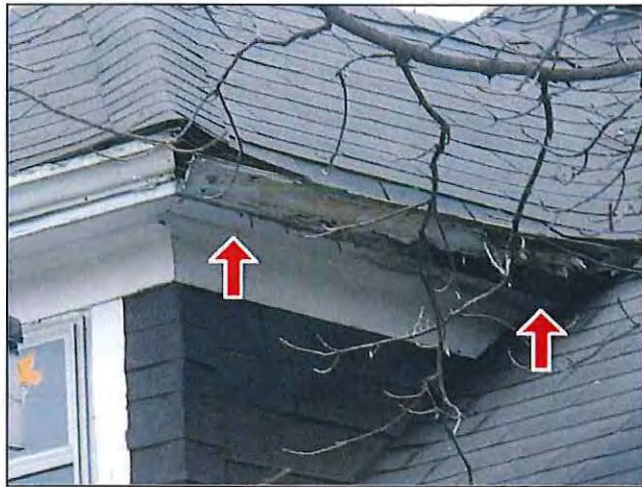
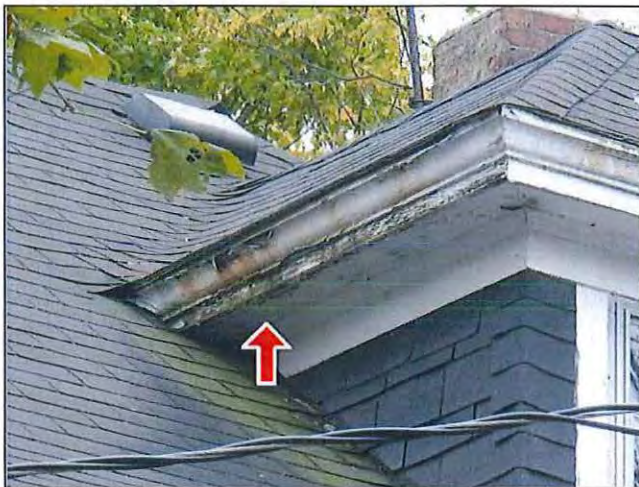
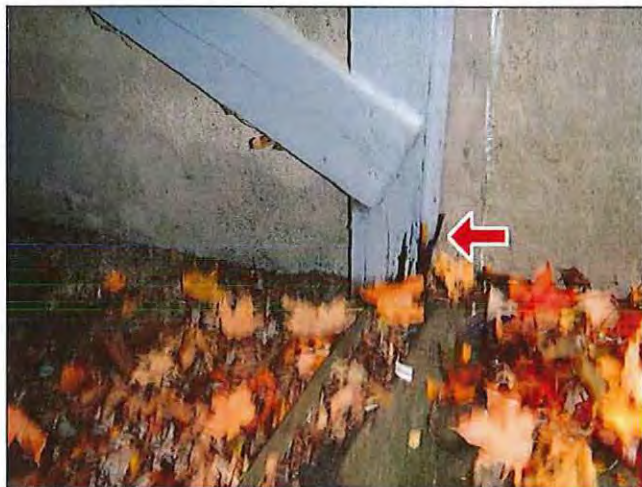
3.2 (1) Some of the exterior trim, soffits and fascias show signs of water intrusion and decay. They should be repaired as needed. A qualified contractor should be consulted for cost estimates now.

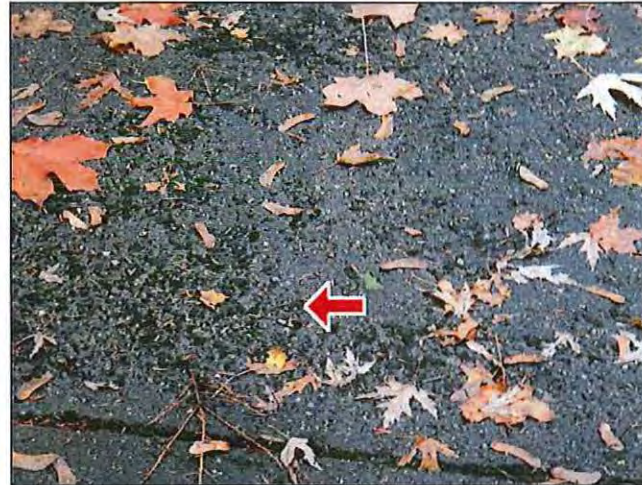
4.5 Item 2(Picture)

**4.5** Uneven settlement and deterioration of walks has created safety hazards. Correction is needed.

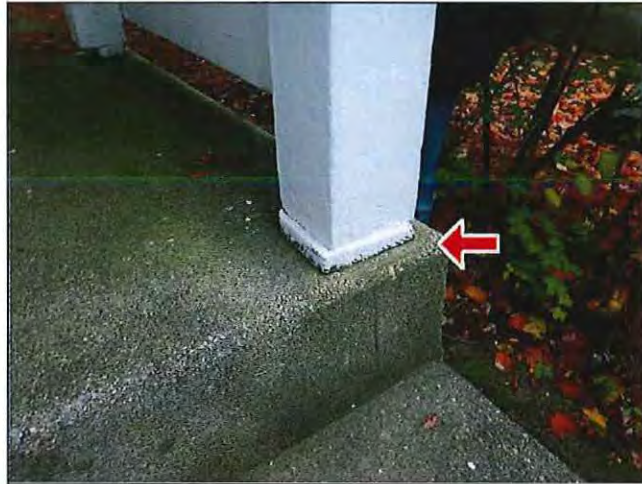
4.7 Item 3(Picture)

4.7 (2) The right side entry guard rail is deteriorated and should be replaced. The base of the right side entry roof support posts are also deteriorated. Replacement is needed.

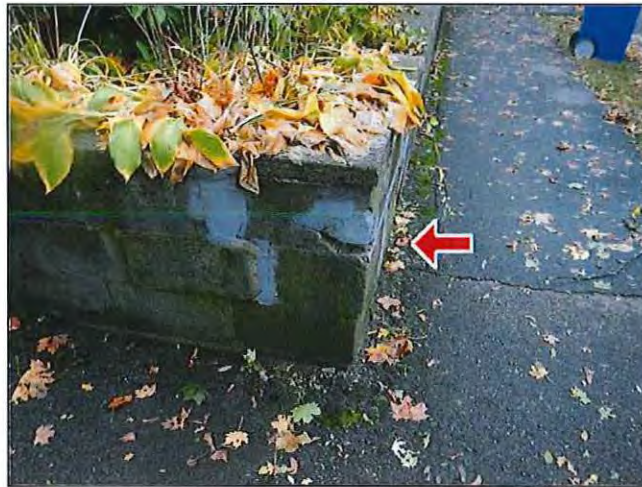
4.10 Item 2(Picture)

**4.10** Block retaining walls have failed and need to be replaced.

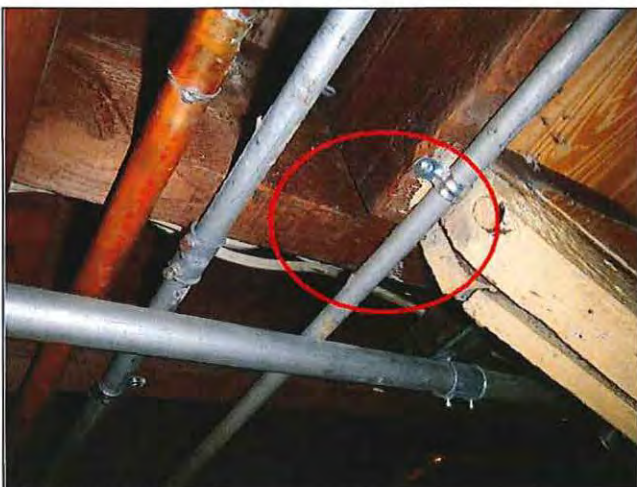
6.3 Item 5(Picture)

**6.3 (2)** The basement stairway framing header junctures should be post supported to better resist sag and settlement typical of this area.

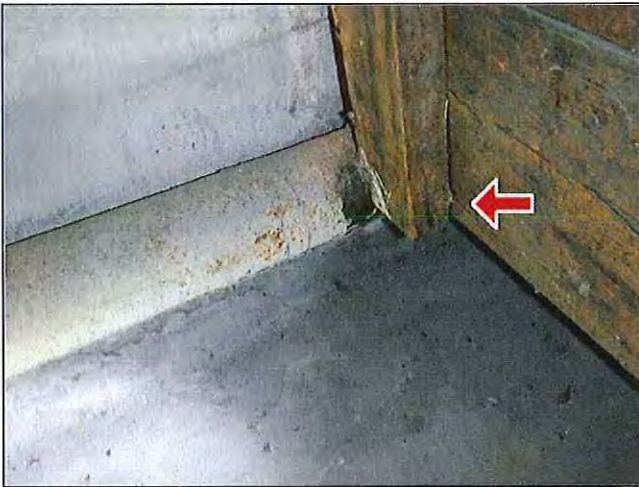
6.13 Item 3(Picture)

6.13 (3) The cellar stairs need to be properly re-supported. Consideration should be given to re-building the stairs.

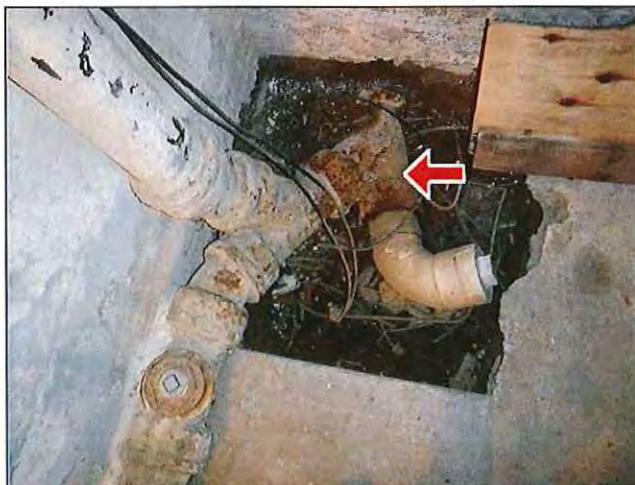
9.1 Item 1(Picture)

9.1 Visible waste plumbing appears functional as intended at this time. Pipes below the floor should be scoped to know there integrity.

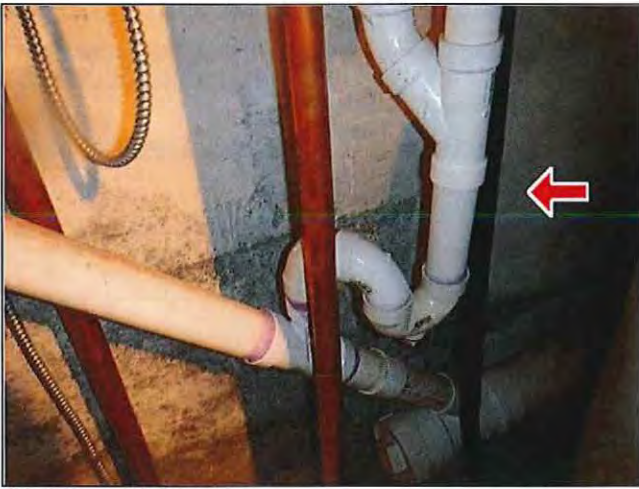
11.4 Item 1(Picture)

11.4 The washer trap is not vented and may be subject to siphoning.

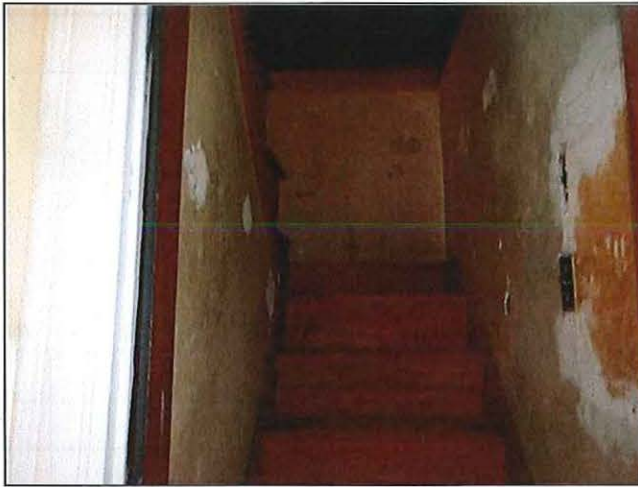
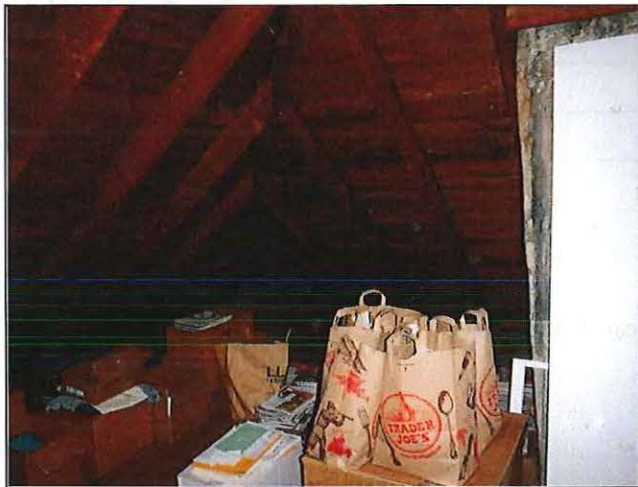
17.0 (1) The attic stairway, needs a handrail for safety.

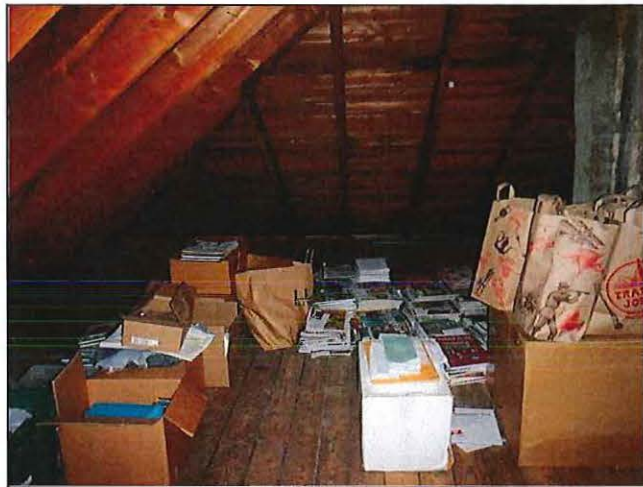
17.0 Item 4(Picture)

17.0 (2) Guard rails are needed around the attic stairway opening for safety.
