PHASE I - Before

Construction- Phase I: Additional Deterioration Conditions and Treatment Approaches

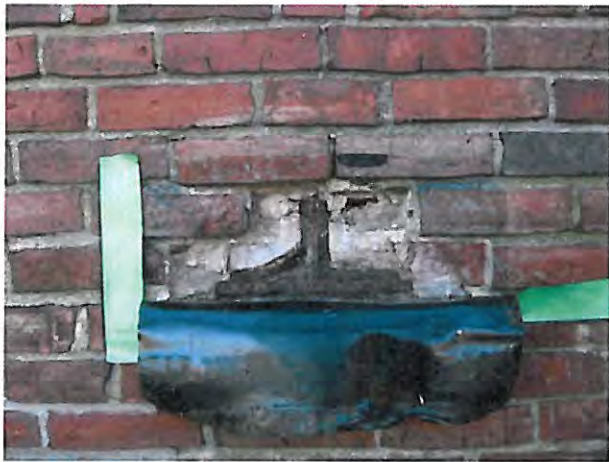
North Wall:

Upper Photo: Modified bitumen protection was applied over a section of removed loose masonry, as part of the temporary stabilization work in 2009. Prior to rebuilding the masonry, rusted steel beams pocketed within the masonry wall were prepared, primed and painted to minimize the potential of additional rusting leading to rust jacking and spalling of the brick masonry.
