## EXISTING CONDITIONS AND RECOMMENDATIONS

## NEWTON CENTRE PLAYGROUND

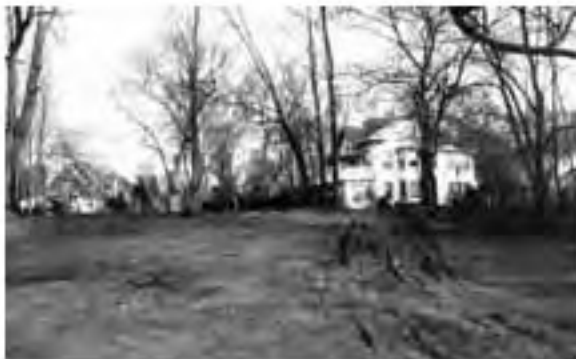
*Homer Street entrance, 2006*

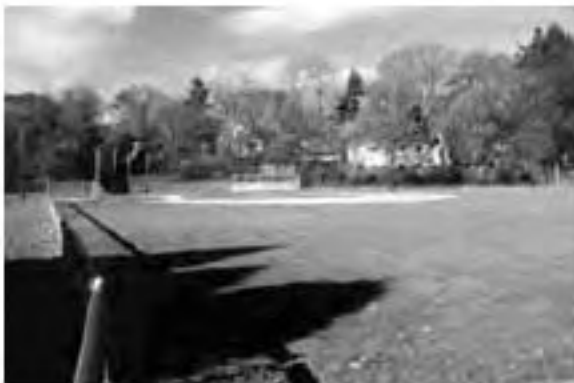
*Little League field, 2005*

The Little League field has a chain link fenced enclosure and backstop. The field and enclosure are in excellent condition. The field is undersized with the outfield fence 180' from home plate. The current standard is 200'. In March of this year the home of the Little League World Series began the process of expanding that distance to 225'. The Little League field barely fits into its current site and makes access to other facilities from Homer Street difficult. It has been reported that balls have been found in the backyards of residential neighbors.

These facilities are well used and in excellent condition. No immediate recommendations are offered. Little League officials are currently satisfied with their field even though it is undersized.

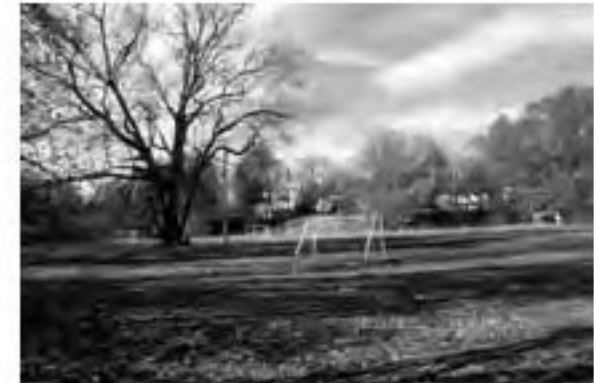
In fair condition, this area is used as an informal practice field as well for volleyball. Dog owners also use the area.

*Soccer field, 2005*

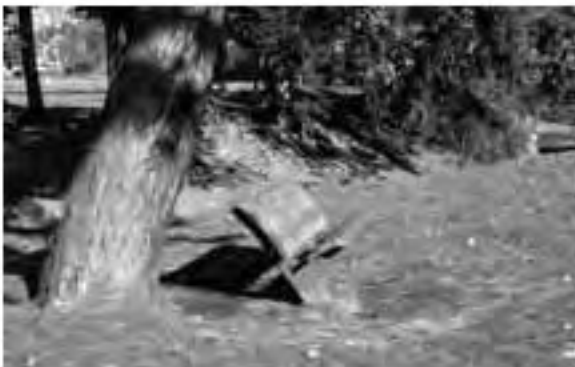
There are 5 styles of benches in the playground in the park today: 3 of wood with backs and concrete supports; 6 of wood with backs and steel supports [tennis courts]; 4 of recycled material with backs and steel supports [play structure area]; 1 of wood without a back [play structure area]; and 4 of aluminum without backs [team benches]. Most are related to activities, with very few sited in passive areas. All are in good to fair condition. Benches at the tennis courts are set too low.

*Bench near Hammond Brook, 2005*

In general, more benches should be provided throughout the playground, particularly in relation to passive recreation areas. Where possible, benches should be placed in relation to tree plantings such that shade is provided. Ideally, benches should be placed with a hard surface beneath them to prevent the eroded appearance that lawn will give.

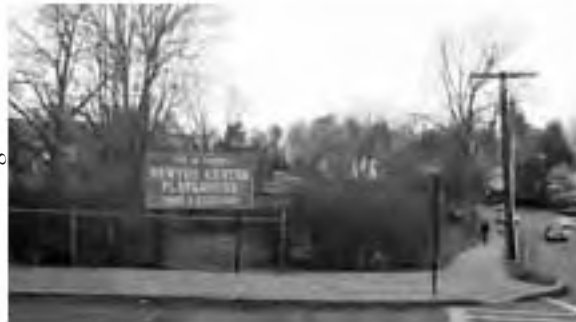
*Identification Sign, 2005*

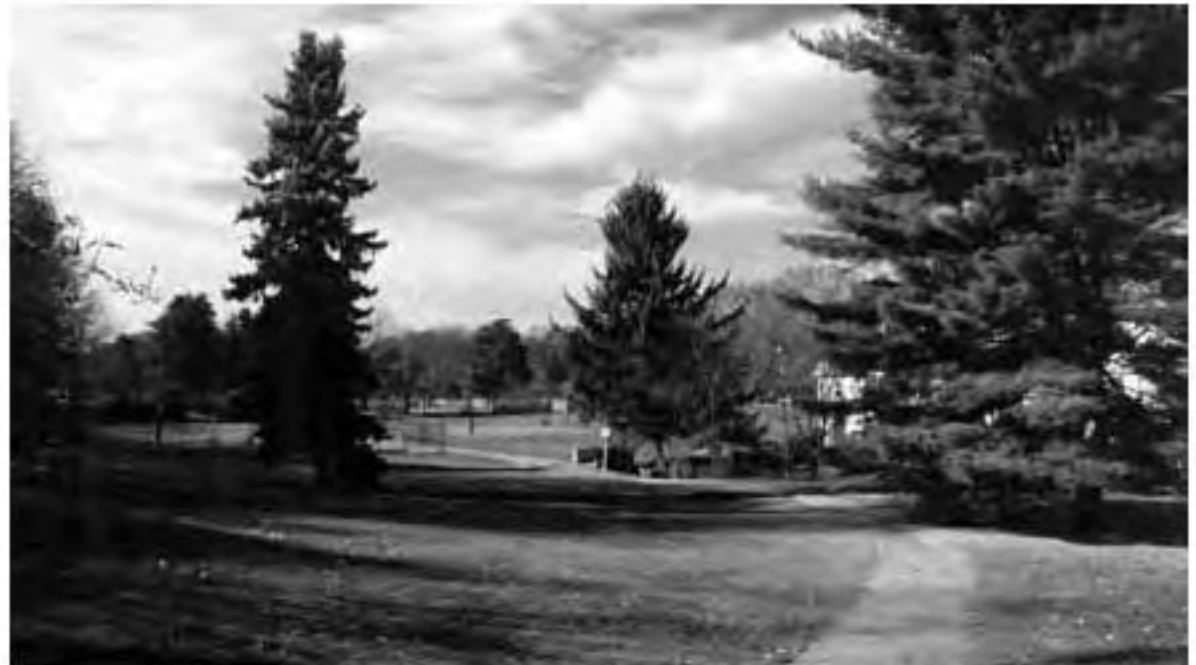
While general recommendations were made by Kellaway, there is little record of specific plantings that were installed. The oldest and largest trees, mostly Oaks and Maples that existed in 1908, are in poor condition having received little maintenance over the years. Shade trees historically seen in the childrens corner have also diminished in quantity. Overgrown shrubs near the Centre Street entrances may be remnants of original plantings. Willows along the brooks have disappeared and have largely been replaced with several large groves of evergreen trees, changing the character of the playground.

*View into playground from Tyler Terrace/Centre Street entrance, 2005*

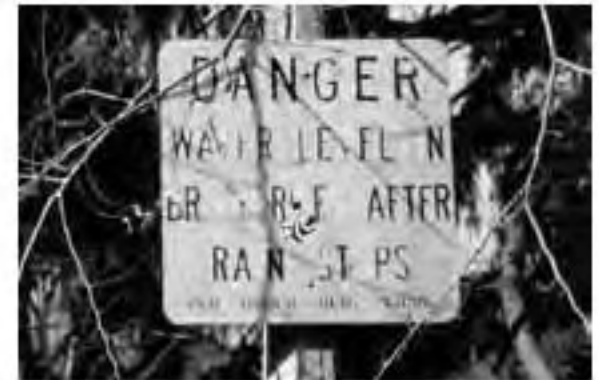
*Sign at Hammond Brook, 2005*

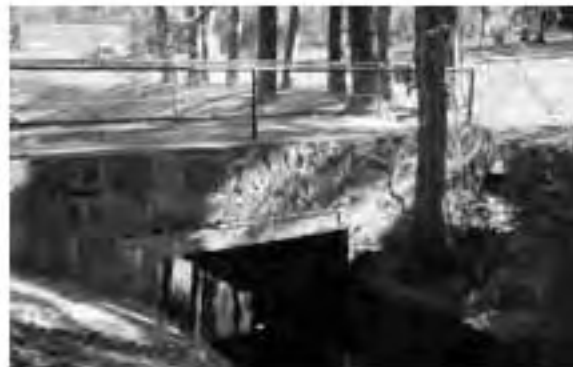
*Bridge over Hammond Brook, 2005*

Provide new bridges over Hammond Brook near the Centre Street entrance and the Mason-Rice School parking area as well as near the new play structure area over the brook from Homer Street to improve accessibility to the playground. The first two should have a sufficient width for pedestrian use while the latter should be wide enough for vehicular access. The latter should also replace the existing adjacent bridge. All other bridges should remain in place.

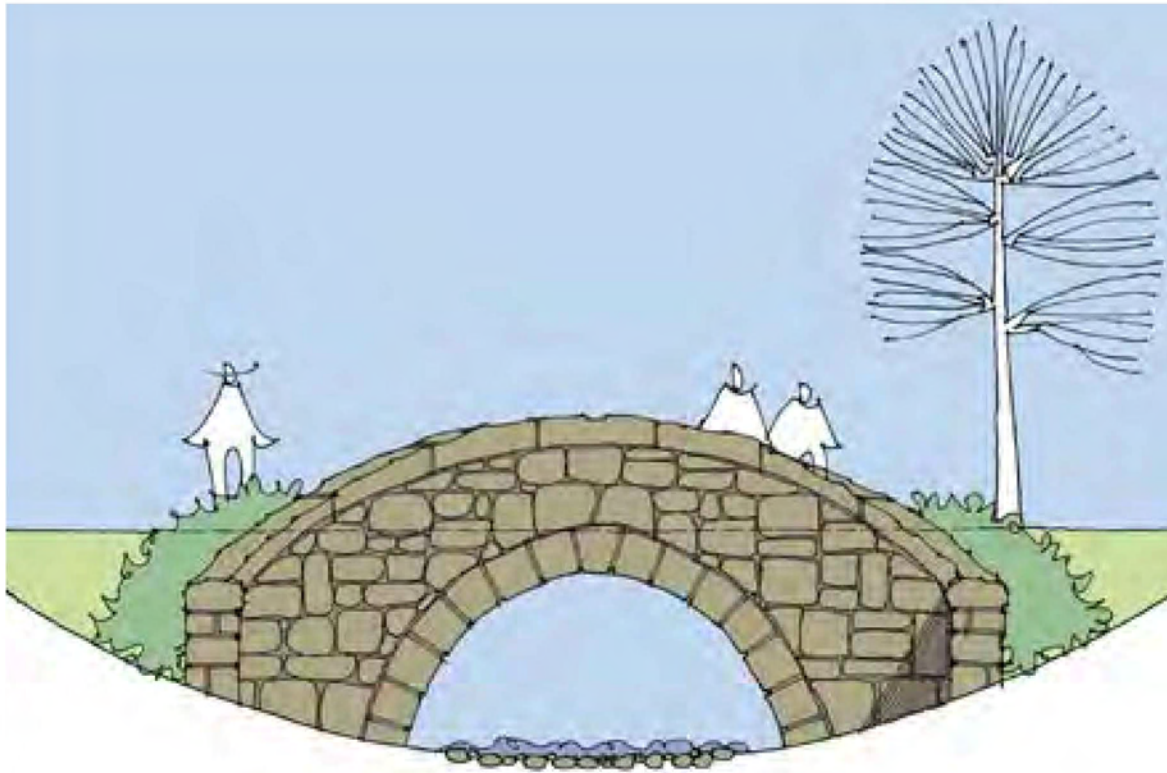
*Conceptual elevation of new stone bridge*

The style of the new bridges should be consistent with the intent of the Olmsted firm plan. That is they should have a style that is compatible with natural scenery, made of rustic stone masonry with curving walls. In the event that the cost of stone exceeds budget limitations at the time of construction, rustic wood bridges would be an acceptable alternative.

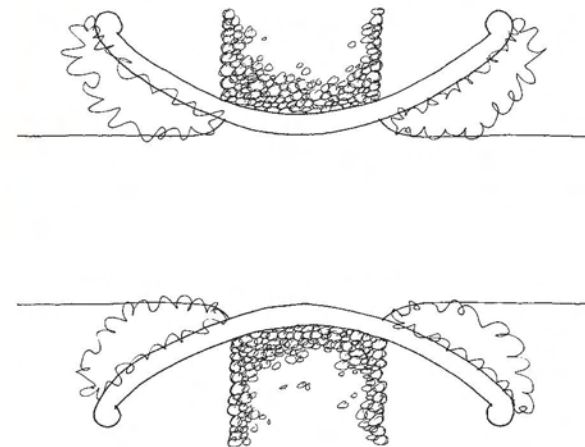
*Conceptual plan of new stone bridge*

The 4 bridges to remain over Hammond Brook should be reconstructed in a similar style as such time as they need structural repairs. Existing deteriorated sections of the remaining channels should be repaired as soon as possible.
