West Newton Armory

1137 Washington St, Newton, Massachusetts 02465

Report of Facility Condition Assessment

Project 100060875

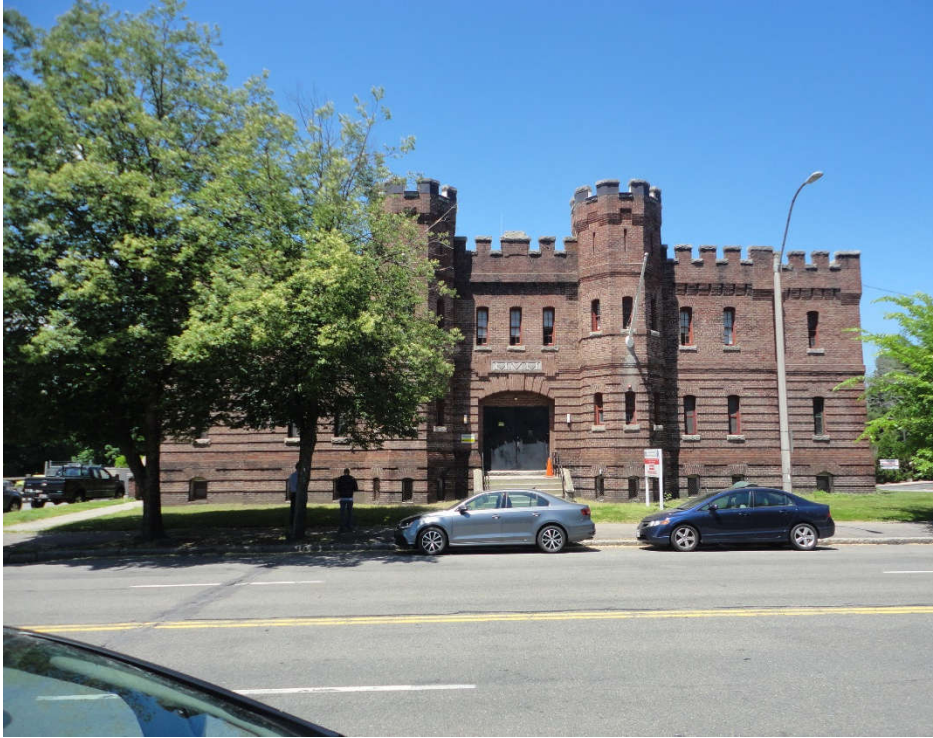
Photograph No. EXT-01
Building south entrance

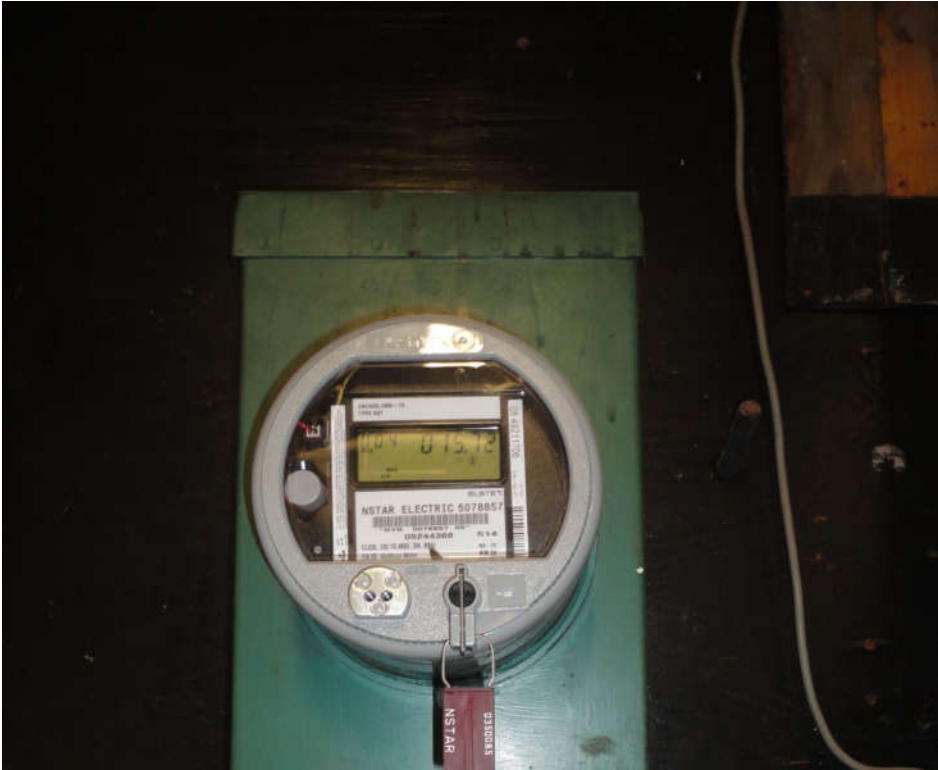
Photograph No. E-01

Nstar electric meter

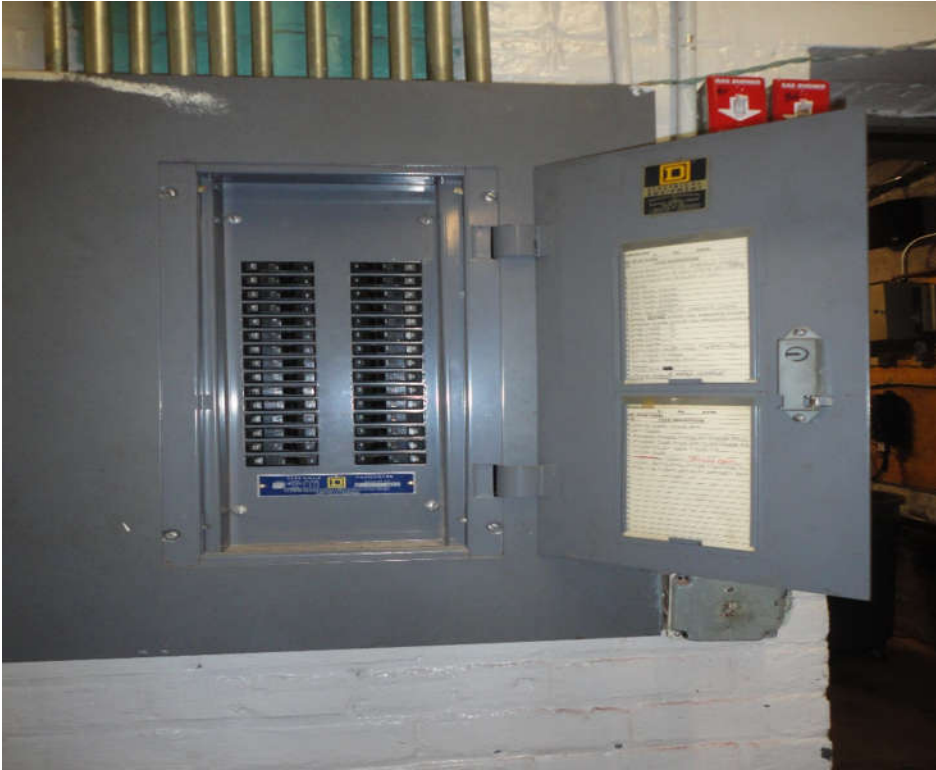
Photograph No. E-03
Upgraded Square D load center in basement

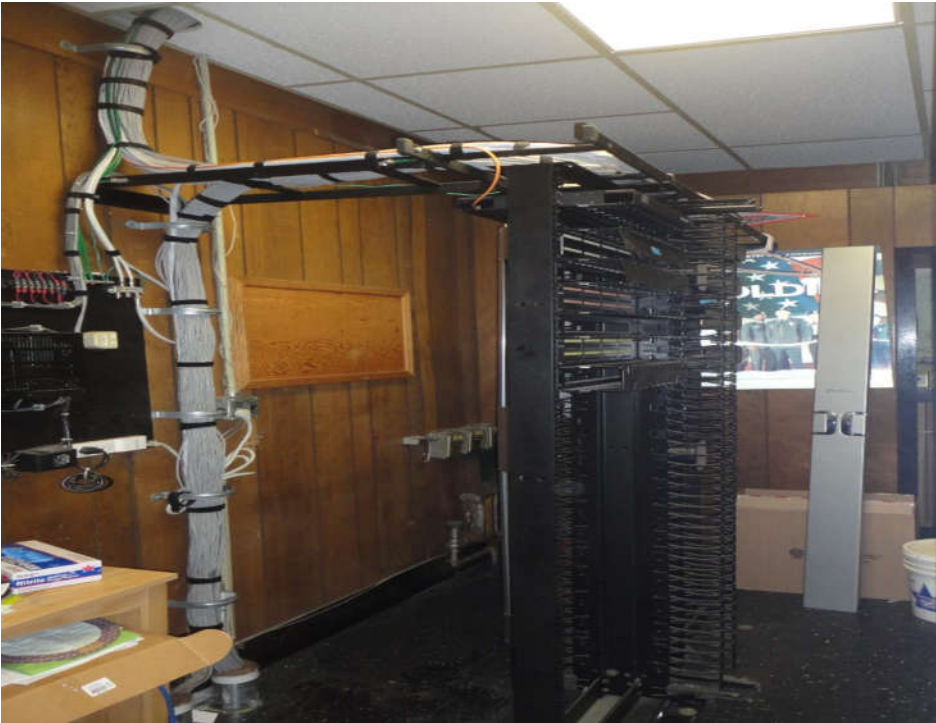
Photograph No. E-04
Main telephone-data service and server rack

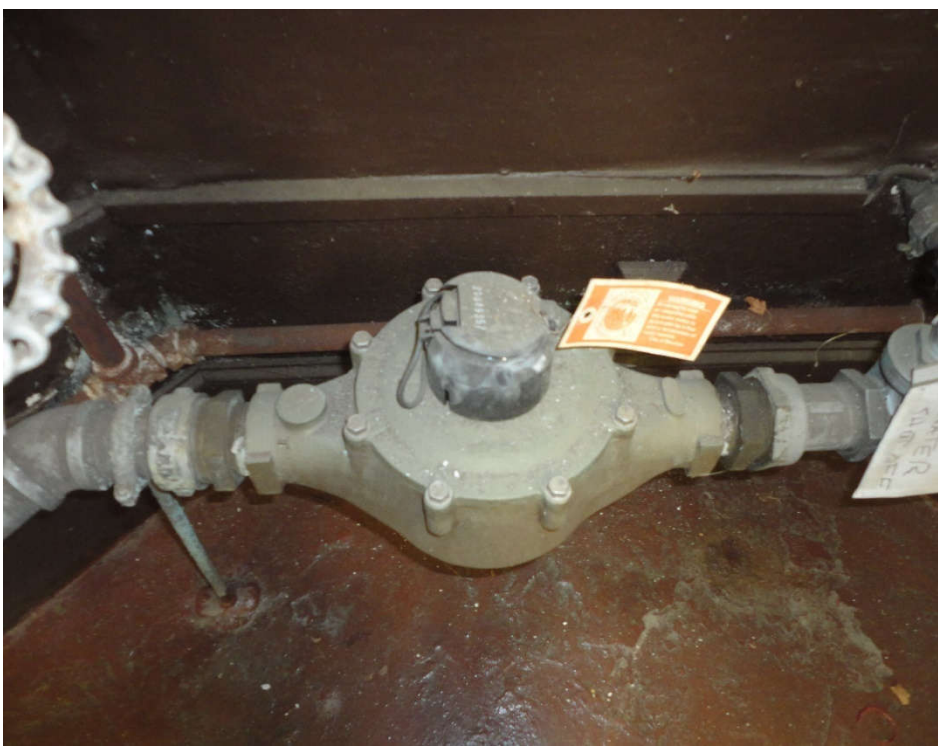
Photograph No. P-01
Incoming 2.5-inch water service and meter

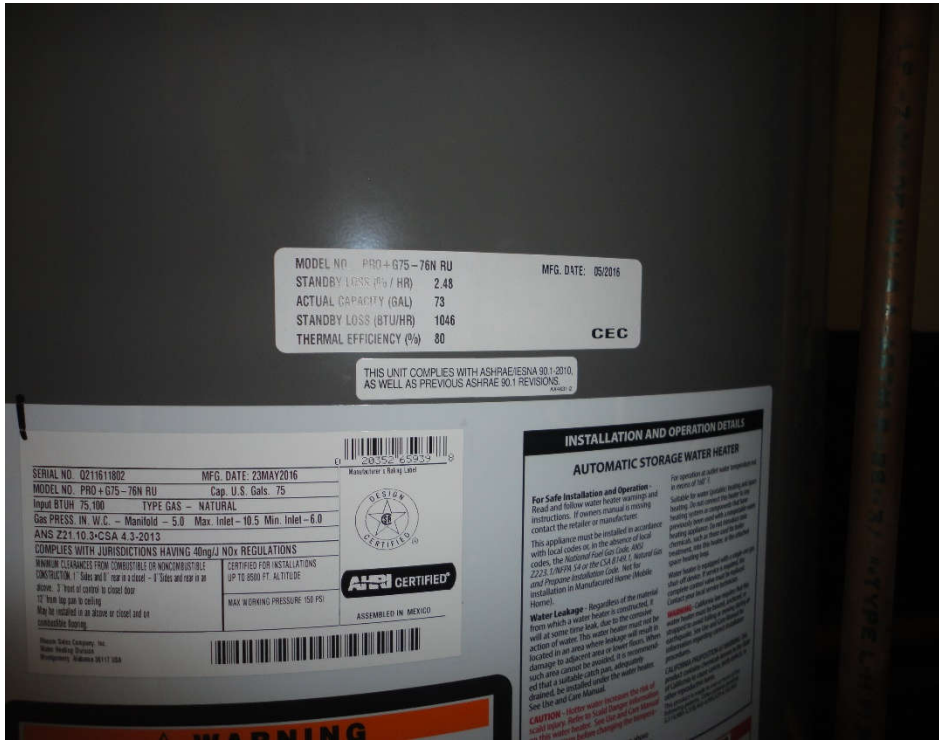
Photograph No. P-02
RUUD domestic hot water heater (2016 installation)

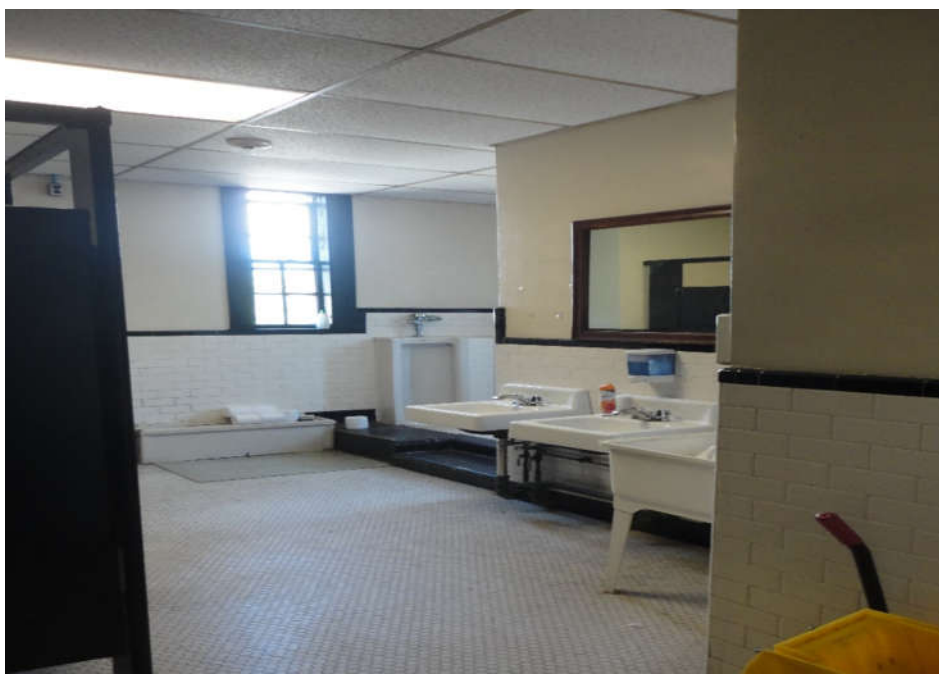
Photograph No. P-03
Representative plumbing fixtures largely original to the building

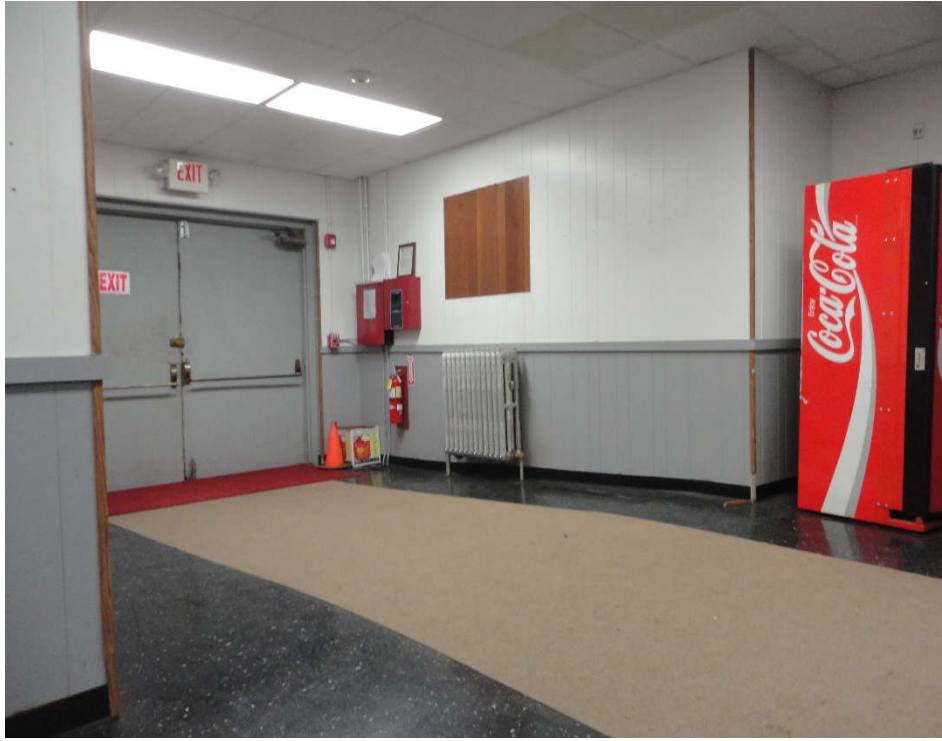
Photograph No. INT-01

First-floor lobby area

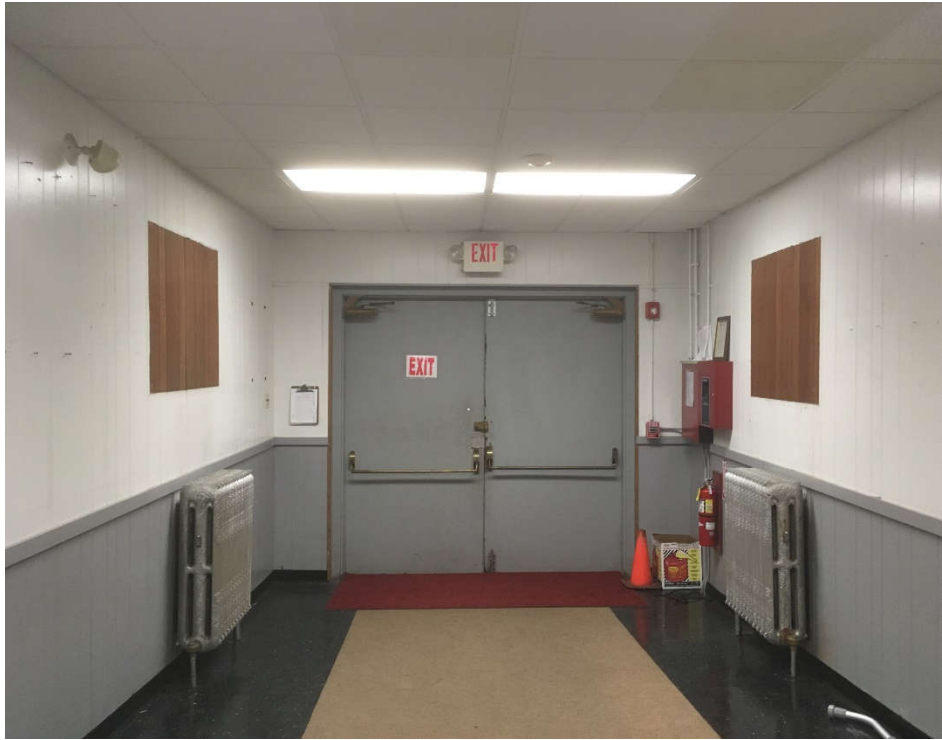
Photograph No. INT-02

First-floor lobby with representative original steam radiators

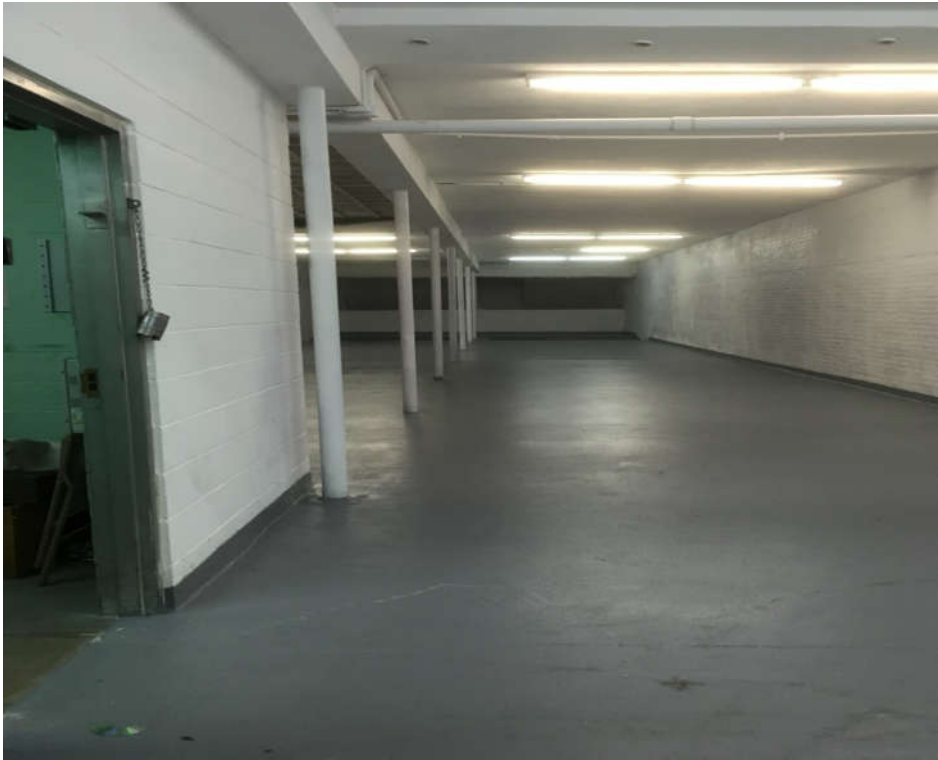
Photograph No. INT-05

Basement with CMU and interior partitions

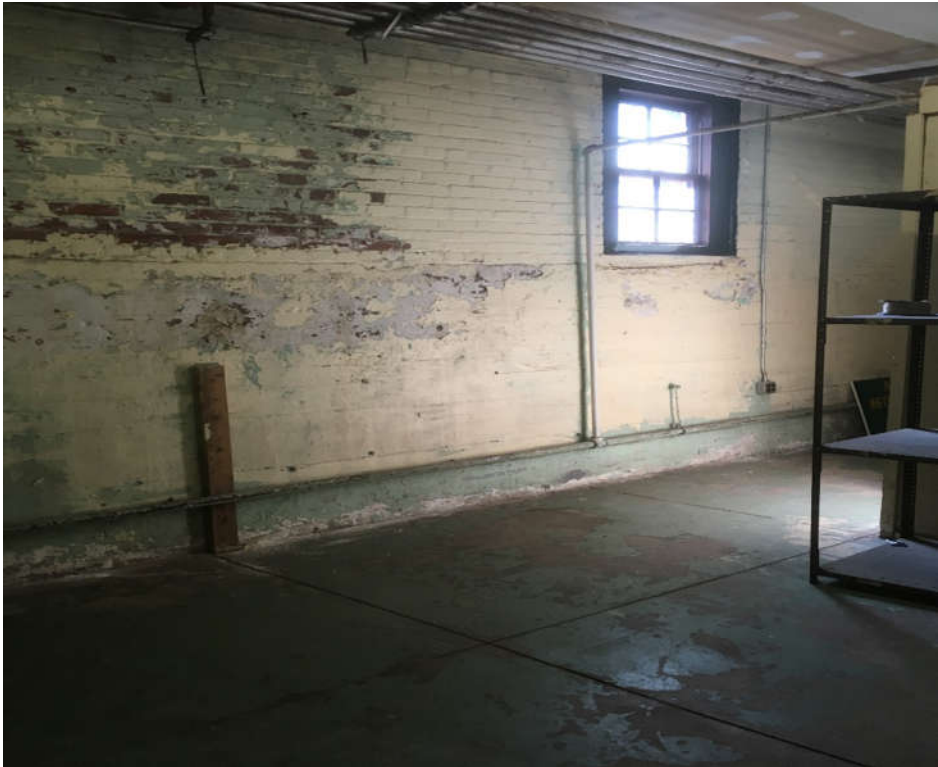
Photograph No. INT-06

Exterior brick and concrete foundation walls

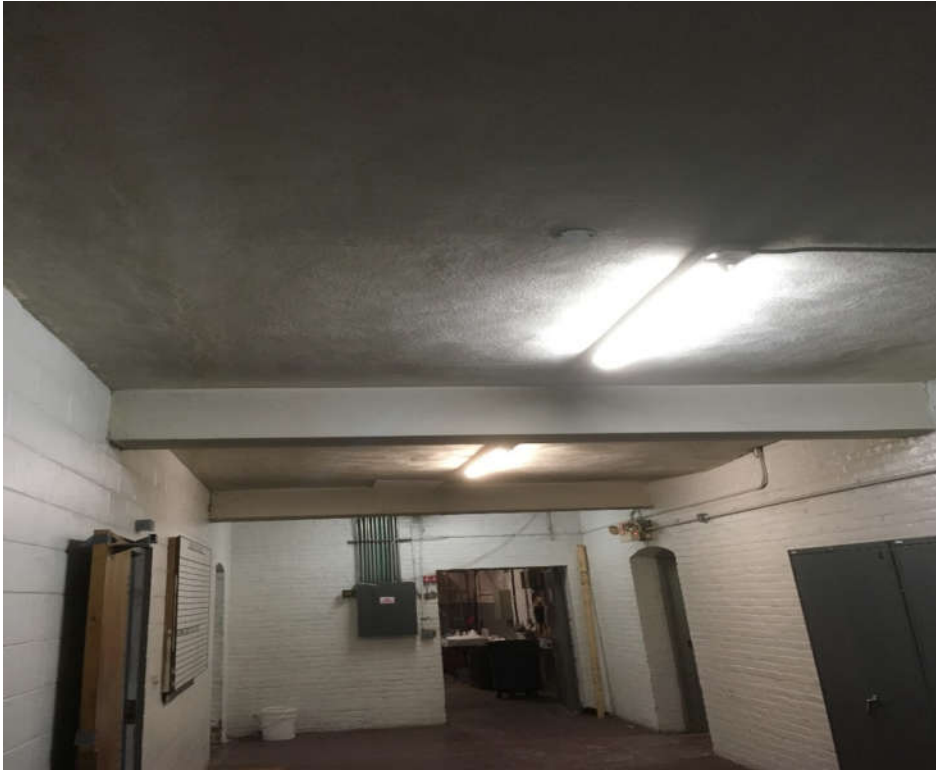
Photograph No. INT-07

Basement interior partitions of brick and CMU

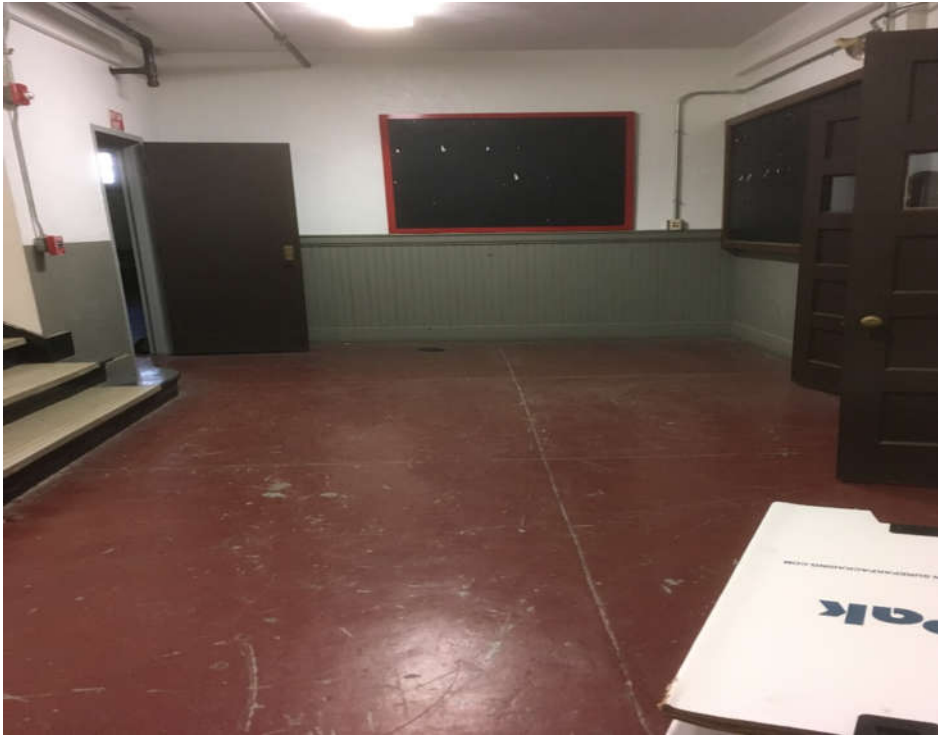
Photograph No. INT-09

Painted concrete basement slab on grade
