Re: **June 2018 Follow-Up Inspection  
MA03414 Bulloughs Pond Dam  
Newton, Massachusetts**  
(Pare Project No.:09124.56/152)

**Commonwealth of Massachusetts  
Department of Conservation and Recreation  
Office of Dam Safety Follow-up Dam Inspection Form**

**Dam Name:** Bulloughs Pond Dam  
**Dam Owner:** Unknown

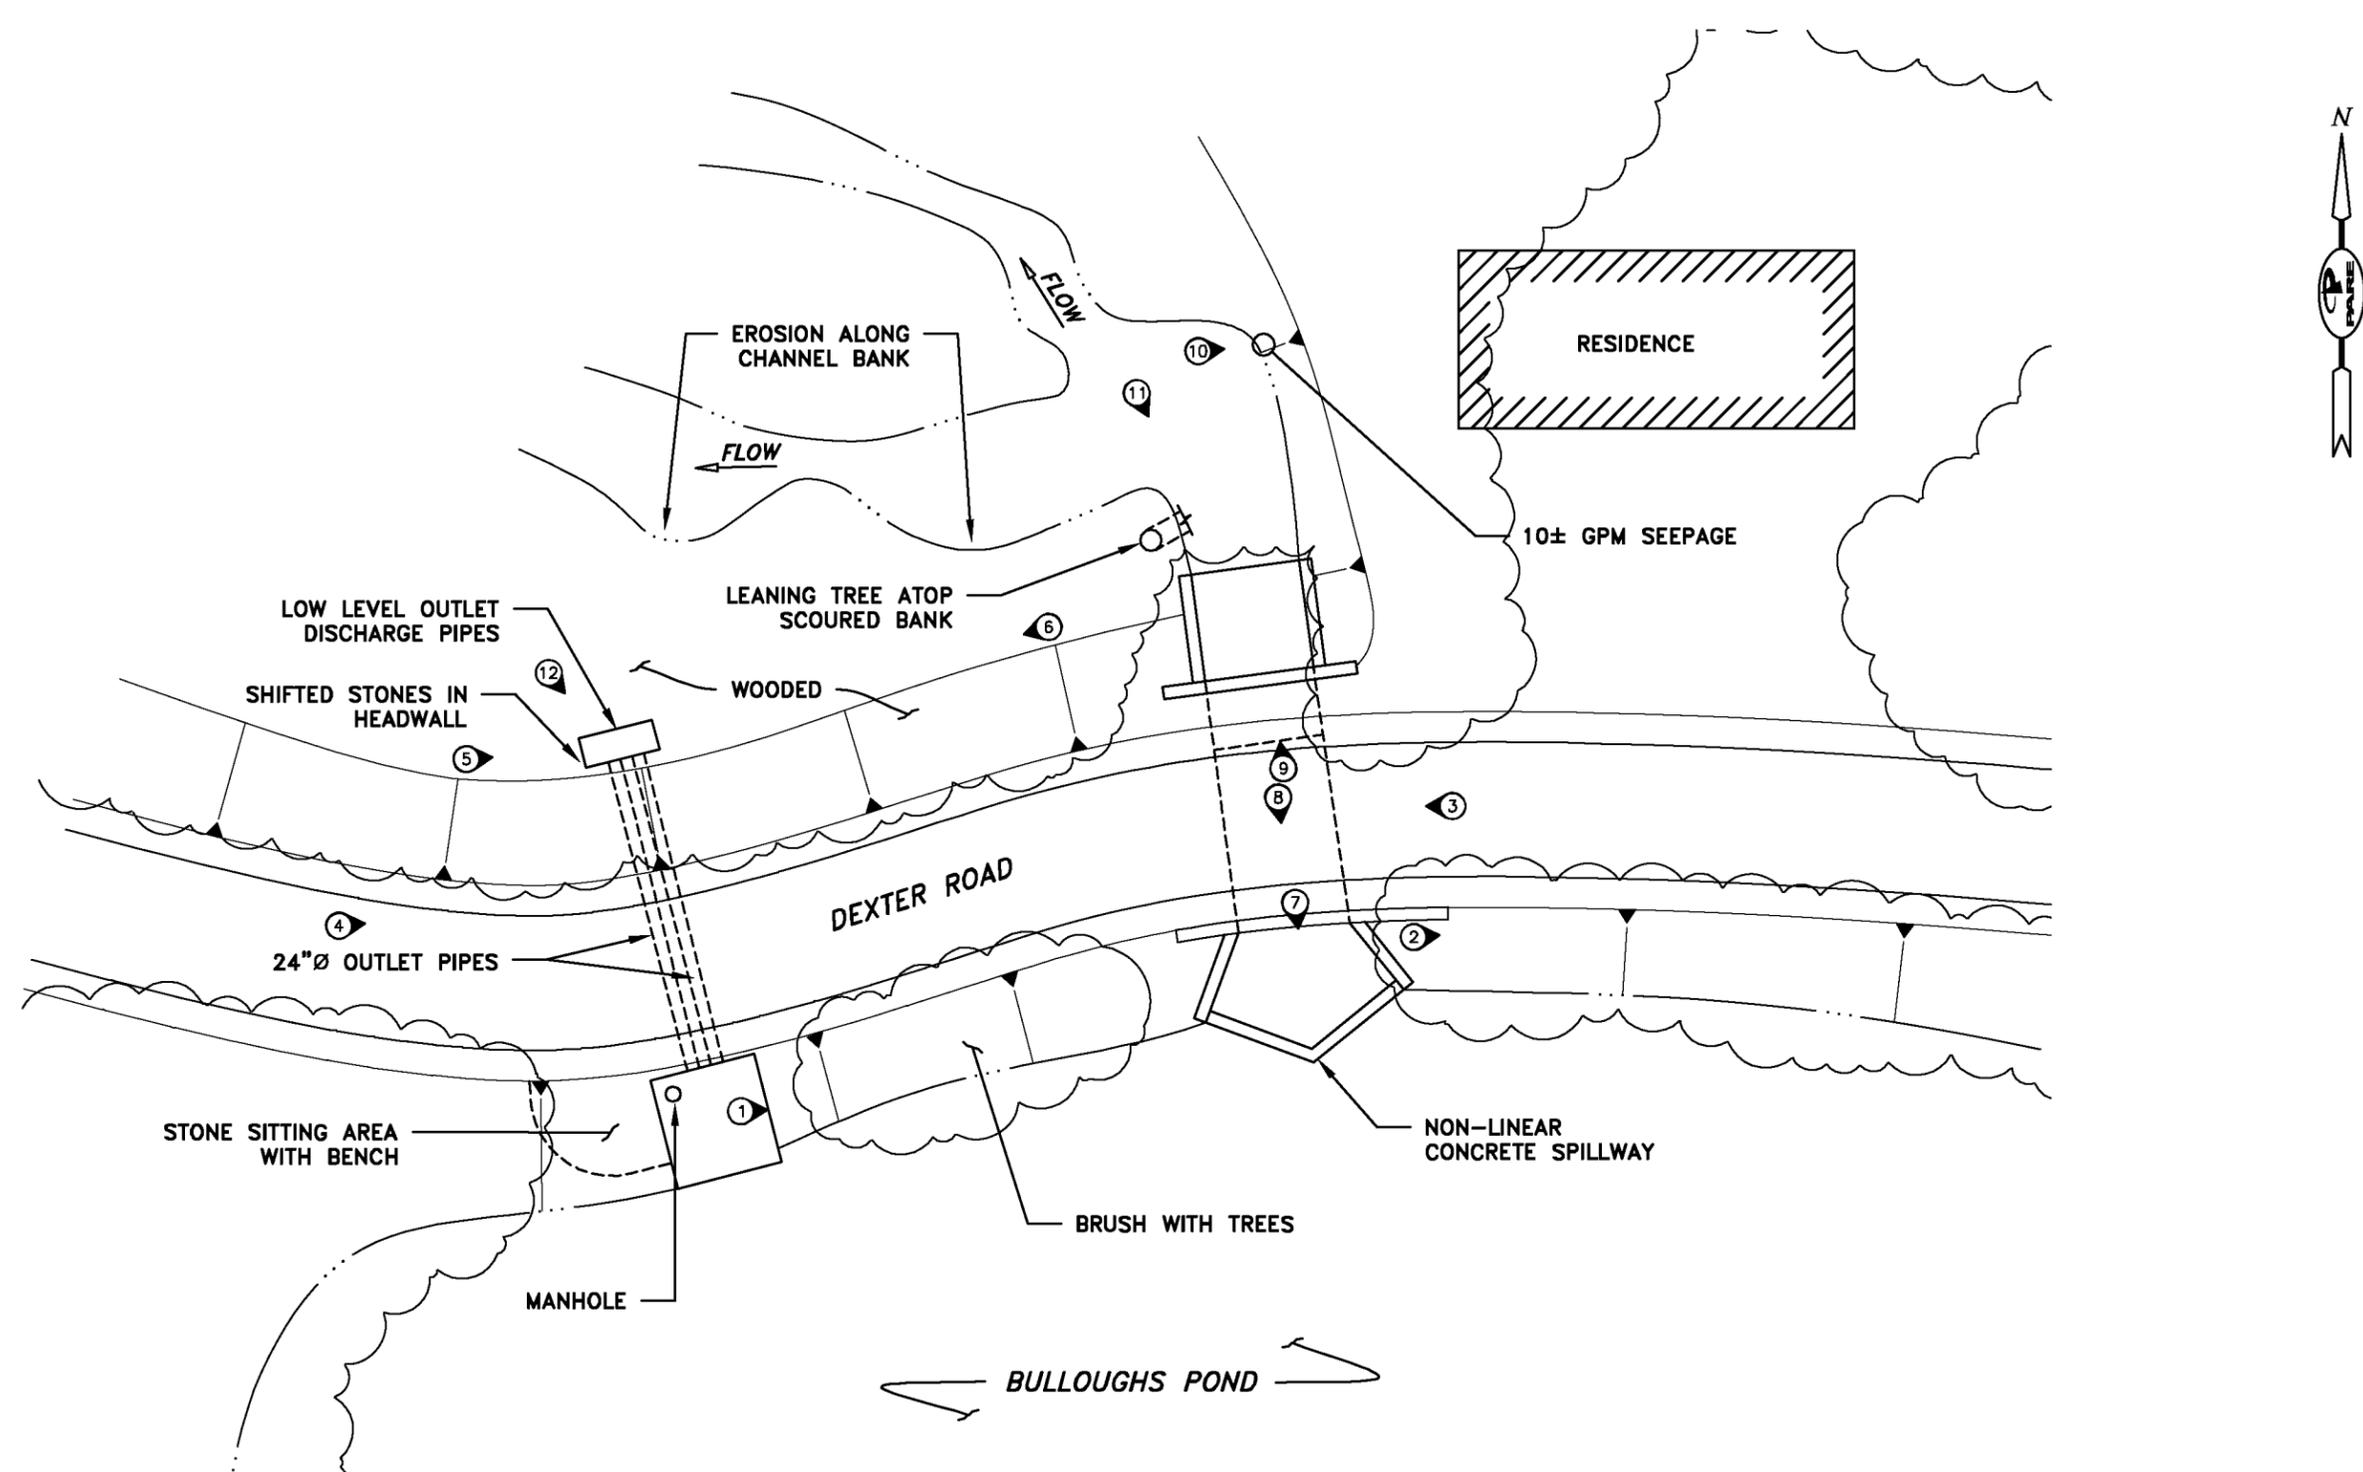
Bulloughs Pond Dam, as shown on Figure 3: Site Sketch, consists of an approximate 170-foot long earthen embankment dam with a 35-foot long concrete weir spillway and a low-level outlet consisting of gated twin 24-inch diameter conduits. At the time of the inspection, the level of the impoundment was near normal pool levels with approximately half an inch of flow over the spillway weir. During the current inspection, there was no apparent indication of significant additional deterioration beyond that previously observed.
