PHASE II REPORT FOR BULLOUGH'S POND DAM

Newton, MA

May 22, 2020

Phase II Engineering Evaluation and Alternatives Analysis

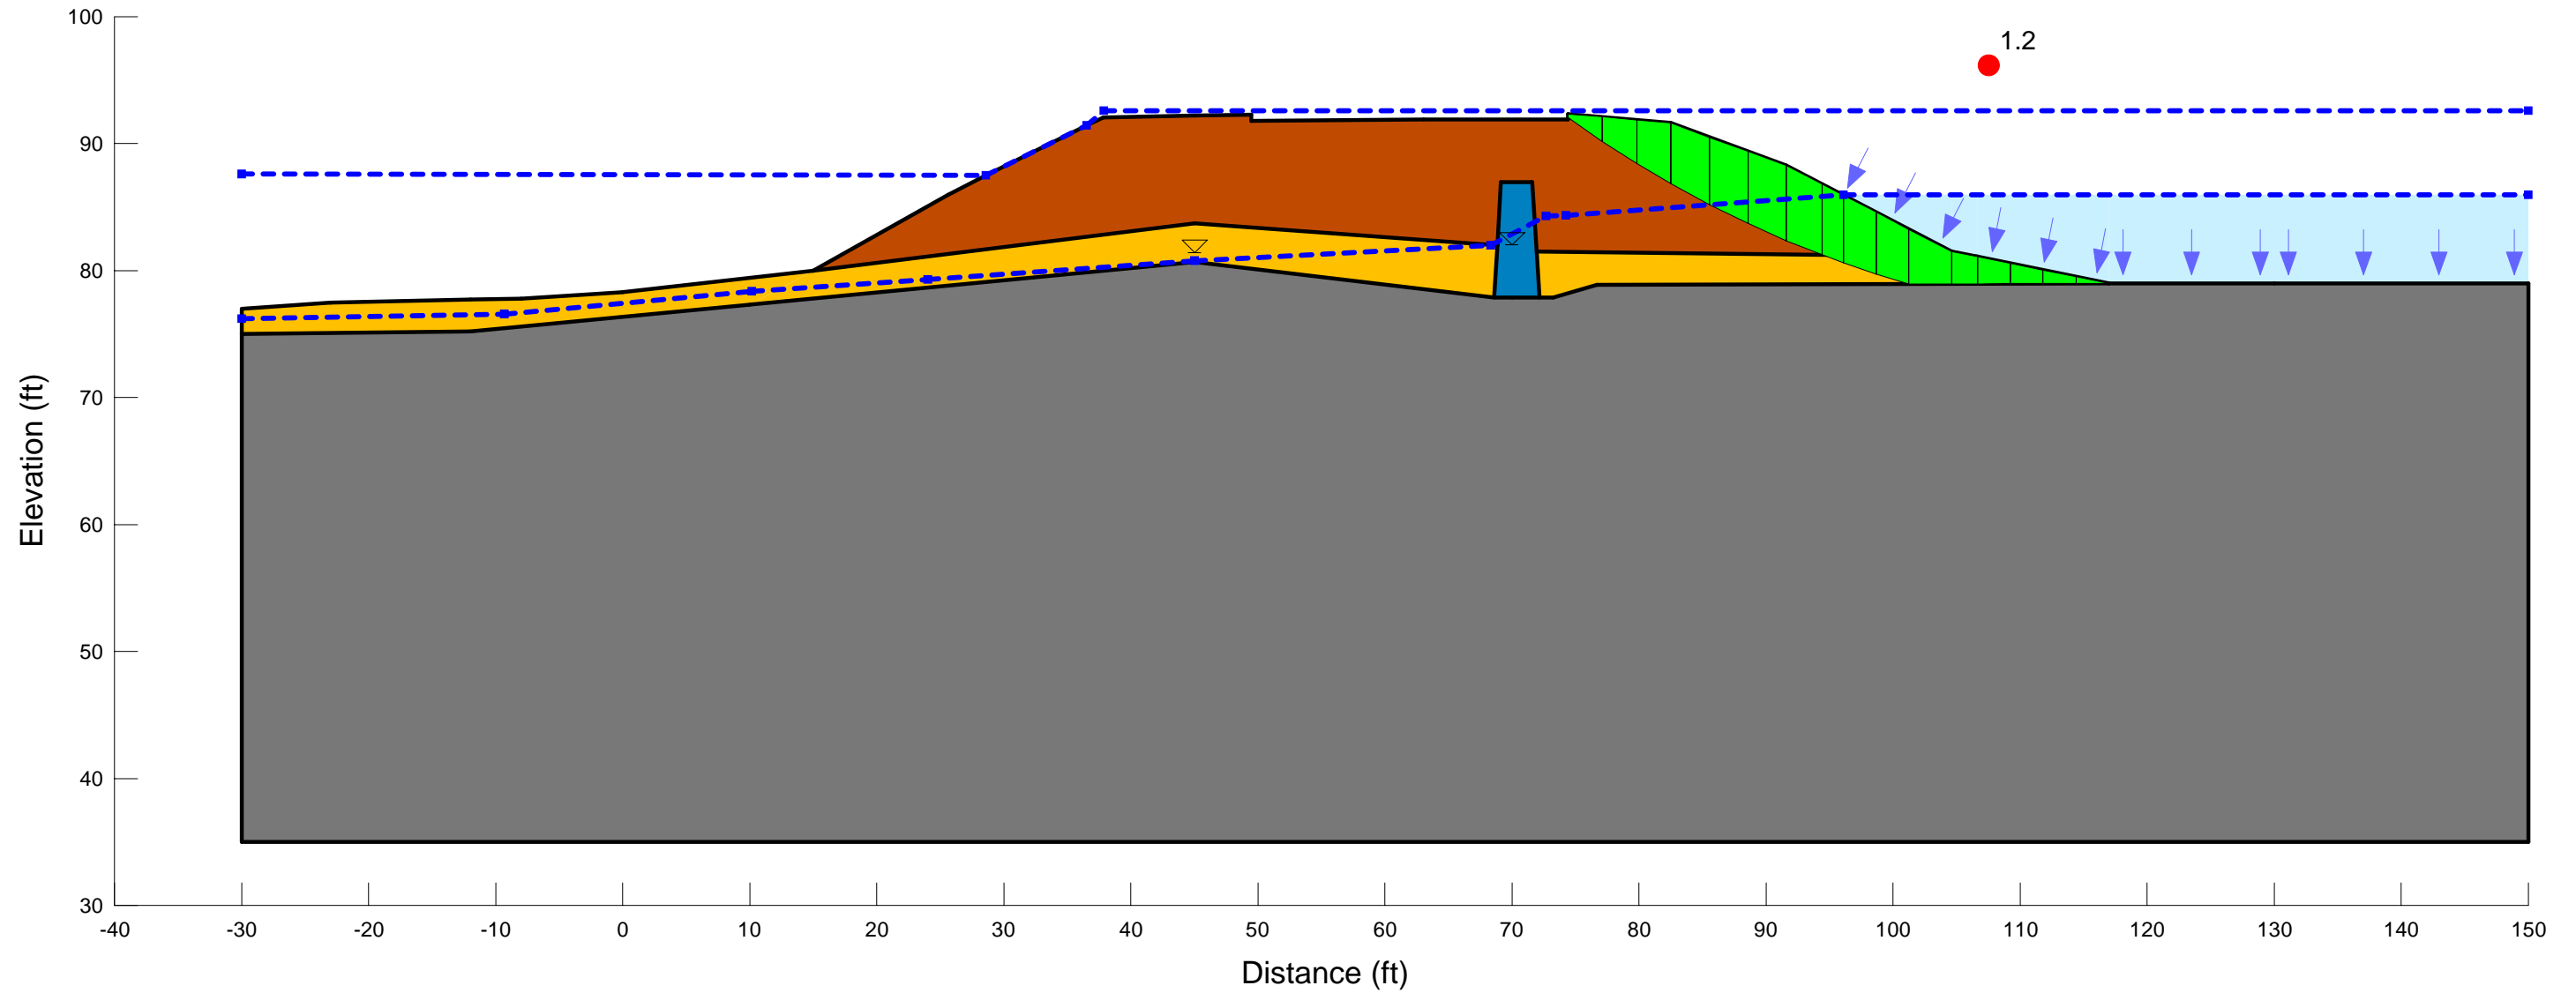
FIGURE G-1

Load Case	Loading Condition	Dam Face	Factor of Safety		Comments / Notes
			Minimum	Existing	
1	End of Construction	Upstream	1.3	Not Applicable	
		Downstream			
2	Sudden drawdown from maximum pool (Flood)	Upstream	1.1	1.2	Figure G-1
3	Sudden drawdown from spillway/top of gates (Normal)	Upstream	1.2	1.3	Figure G-2
4	Steady-state seepage at maximum storage pool (Normal)	Upstream	1.5	1.5	Figure G-3
		Downstream		1.5	Figure G-4
5	Steady-state seepage at surcharge pool (Flood)	Upstream	1.4	1.7	Figure G-5
		Downstream		1.0	Figure G-6
6	Earthquake ⁽²⁾ (Steady-state seepage at normal pool)	Upstream	1.0	0.9	Figure G-7
		Downstream		0.9	Figure G-8
