**NEWTON PUBLIC BUILDINGS SURVEY
PHASE II – ANALYSIS OF HISTORICAL SIGNIFICANCE**

Building Analysis

Ward Elementary School

Address: 10 Dolphin Road
Year of Construction: 1928

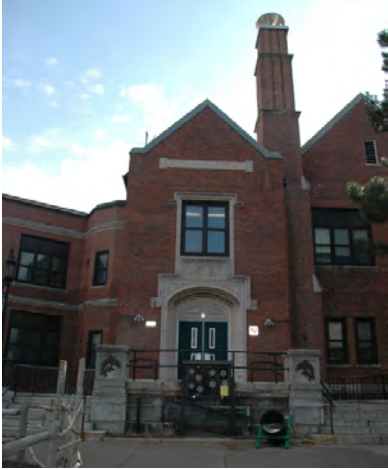
Figure 2: Main entrance bay and chimney. Figure 3: Close up view of main entrance door surround.

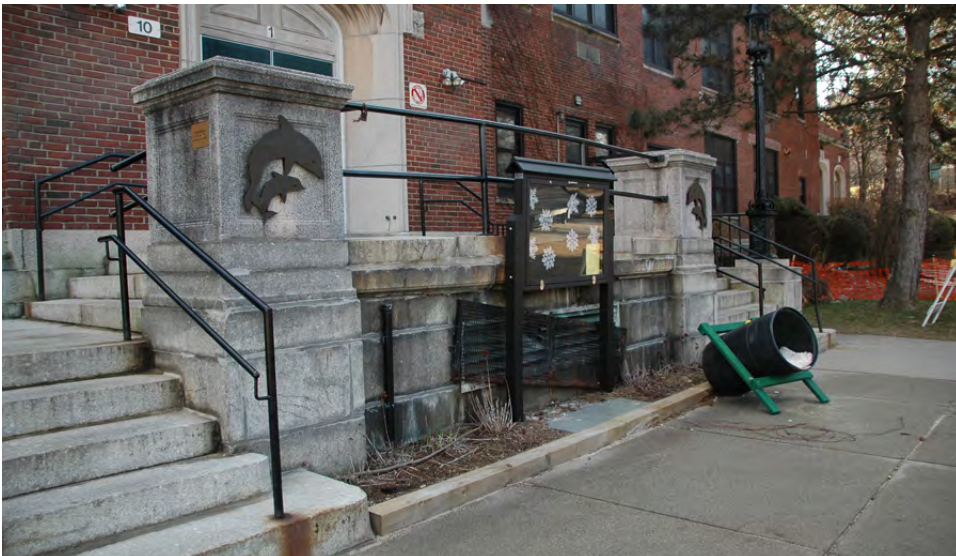
Figure 4: Main entrance staircase.

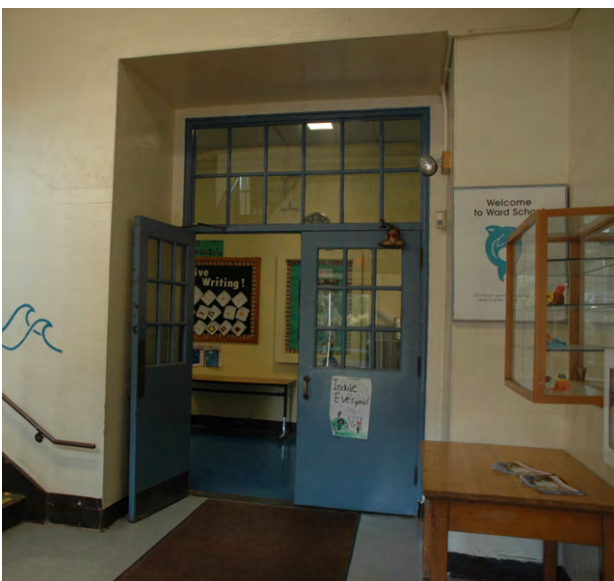
Figure 5: Interior wall partition.

- The walls are covered with a tall (~7'+) wainscot of painted, textured blocks mimicking travertine, above which are textured plaster walls and a plaster ceiling. There is adhered acoustic tile on the ceiling in the north wing. The original flooring has been typically been covered with vinyl tile.
- A wood picture rail runs along the wall of the second floor corridors.
- Built-in wood cubbies line the corridors.
- The extant wood classroom doors are in good condition. They feature 9 lights each, some with privacy glass, with tall 9-light transoms in wood frames.
- As is typical for the Newton schools of this time period, there are two metal framed glazed walls in the south wing corridor, consisting of a pair of doors with 9 lights each, flanked by 4-
