Public Facilities Committee Report

City of Newton In City Council

This Emergency Action Plan (EAP) was prepared for the Owner of the Bulloughs Pond Dam in accordance with the Commonwealth of Massachusetts General Laws, M.G.L. 253, Section 44, Chapter 302 C.M.R. 10.00, "Dam Safety, dated February 10, 2017". This EAP establishes a basic plan of action if conditions at the dam indicate the potential for dam failure or if any individual observes and reports that a dangerous condition is developing at the dam. This EAP follows a template developed by the Department of Conservation and Recreation (DCR) Office of Dam Safety (ODS). The development of the template has been primarily based on the Federal Emergency Management Agency (FEMA) "Federal Guidelines for Dam Safety: Emergency Action Planning for Dam Owners," dated October 1998, the Federal Energy Regulatory Commission (FERC) "Emergency Action Plan Guidelines," dated November 1998, 2006 Natural Resources Conservation Service (NRCS) recommendations for developing EAPs, and other publicly available EAP templates from state dam safety programs.

PHASE II REPORT FOR BULLOUGH'S POND DAM

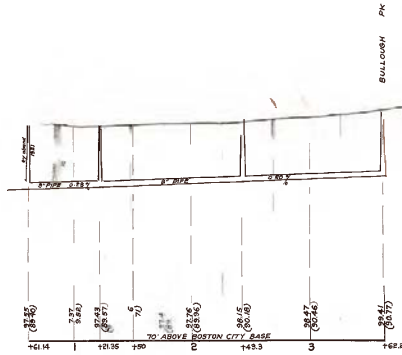
17407
S-49

CITY OF NEWTON
 MASSACHUSETTS
 DEXTER ROAD
 BULLOUGH PK. WESTERLY
 PLAN AND PROFILE SHOWING
 SEWER AND SEWER ASSESSMENT
 February 6, 1922.
 CITY ENGINEER
 17407

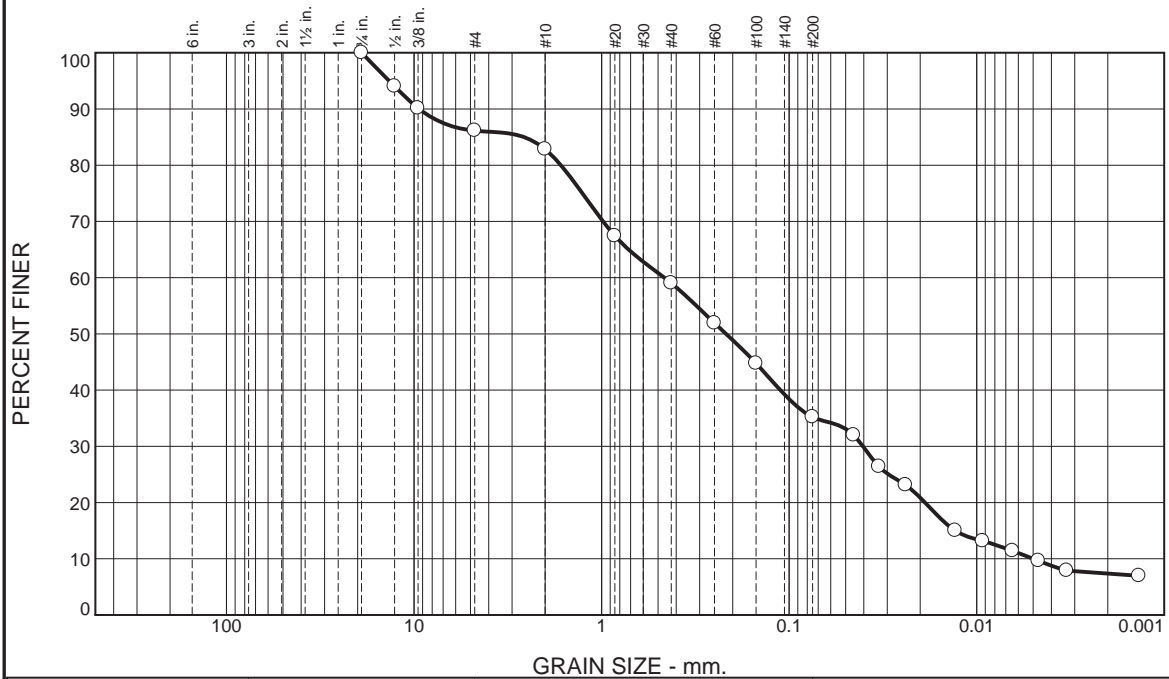
Figure S-1

Particle Size Distribution Report

% +3"	% Gravel		% Sand			% Fines	
	Coarse	Fine	Coarse	Medium	Fine	Silt	Clay
0.0	0.0	13.9	3.2	23.9	23.8	27.8	7.4

Test Results (D7928 & ASTM D 1140)			
Opening Size	Percent Finer	Spec.* (Percent)	Pass? (X=Fail)
0.75"	100.0		
0.5"	94.0		
0.375"	90.2		
#4	86.1		
#10	82.9		
#20	67.4		
#40	59.0		
#60	51.9		
#100	44.8		
#200	35.2		
0.0453 mm.	32.0		
0.0332 mm.	26.4		
0.0239 mm.	23.1		
0.0130 mm.	15.0		
0.0093 mm.	13.2		
0.0064 mm.	11.4		
0.0047 mm.	9.6		
0.0033 mm.	7.9		
0.0014 mm.	7.0

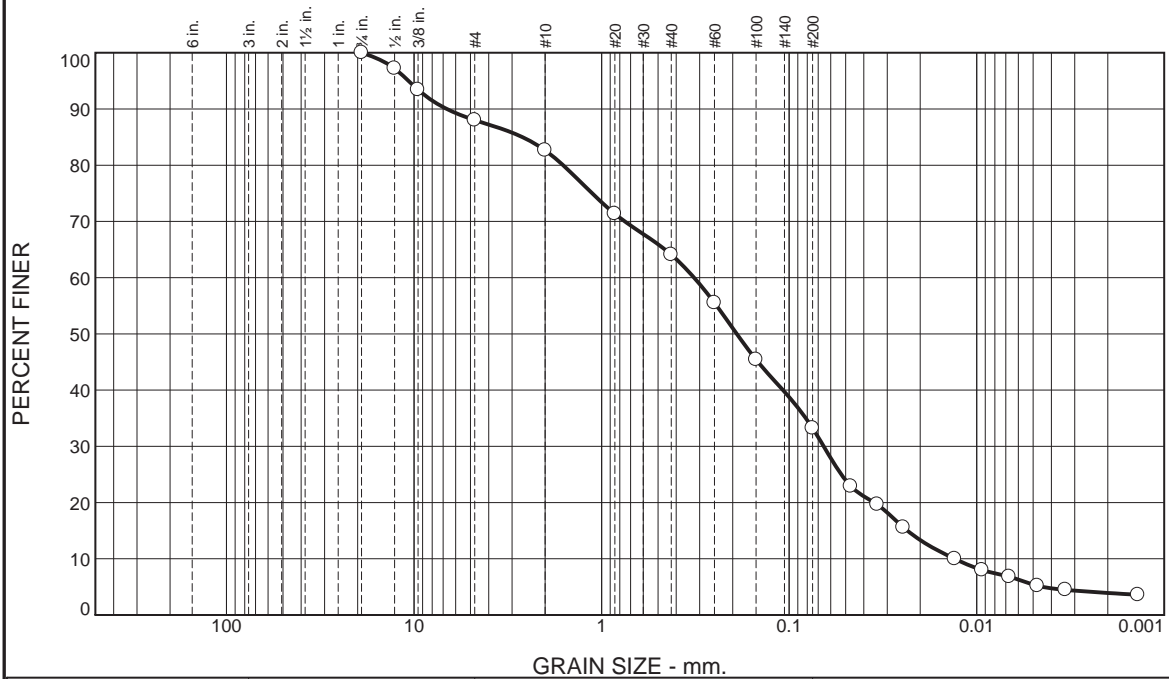
Thielsch Engineering Inc. Cranston, RI	<p>Client: GZA GeoEnvironmental</p> <p>Project: Bulloughs Pond Dam Phase II Newton, Massachusetts</p> <p>Project No: 01.0174021.00</p>
Figure S-2

Particle Size Distribution Report

% +3"	% Gravel		% Sand			% Fines	
	Coarse	Fine	Coarse	Medium	Fine	Silt	Clay
0.0	0.0	12.0	5.4	18.5	30.9	29.3	3.9

Test Results (D7928 & ASTM D 1140)			
Opening Size	Percent Finer	Spec.* (Percent)	Pass? (X=Fail)
0.75"	100.0		
0.5"	97.2		
0.375"	93.4		
#4	88.0		
#10	82.6		
#20	71.4		
#40	64.1		
#60	55.5		
#100	45.4		
#200	33.2		
0.0469 mm.	22.9		
0.0339 mm.	19.6		
0.0246 mm.	15.6		
0.0131 mm.	10.0		
0.0094 mm.	8.0		
0.0067 mm.	6.8		
0.0047 mm.	5.2		
0.0034 mm.	4.5		
0.0014 mm.	3.6

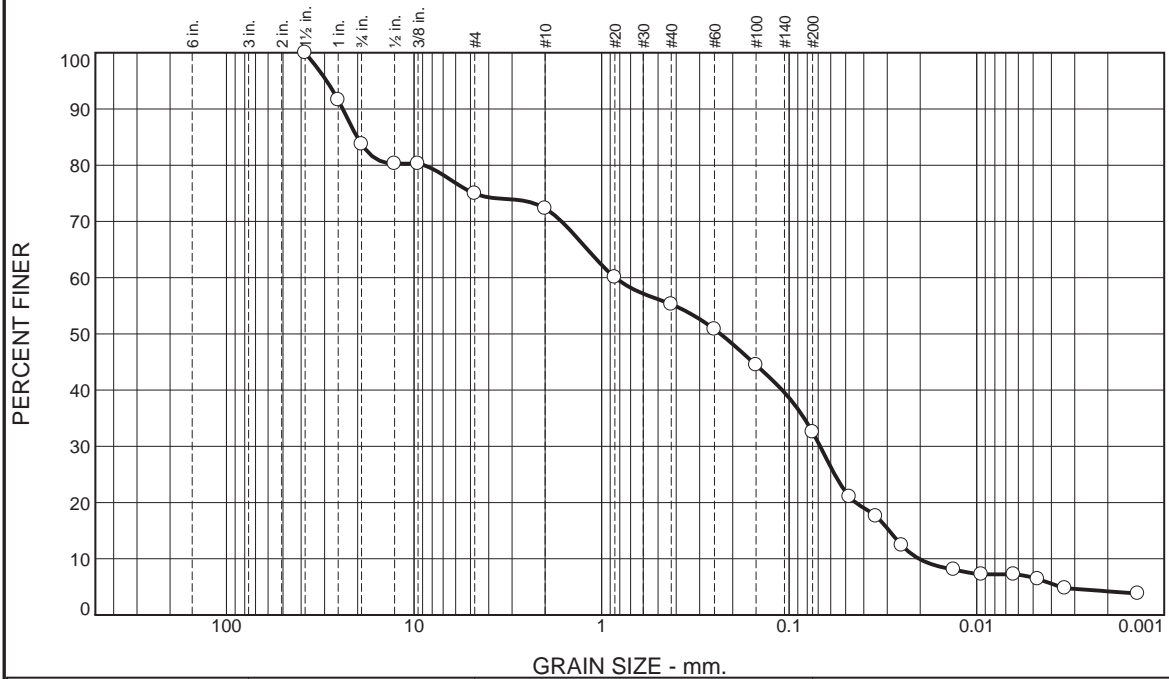
Figure S-3

Particle Size Distribution Report

% +3"	% Gravel		% Sand			% Fines	
	Coarse	Fine	Coarse	Medium	Fine	Silt	Clay
0.0	16.3	8.7	2.7	17.0	22.8	28.3	4.2

Test Results (D7928 & ASTM D 1140)			
Opening Size	Percent Finer	Spec.* (Percent)	Pass? (X=Fail)
1-1/2"	100.0		
1"	91.6		
3/4"	83.7		
1/2"	80.3		
3/8"	80.3		
#4	75.0		
#10	72.3		
#20	60.1		
#40	55.3		
#60	50.8		
#100	44.5		
#200	32.5		
0.0478 mm.	21.0		
0.0345 mm.	17.6		
0.0251 mm.	12.4		
0.0133 mm.	8.1		
0.0094 mm.	7.2		
0.0064 mm.	7.2		
0.0047 mm.	6.4		
0.0034 mm.	4.8		
0.0014 mm.	3.8

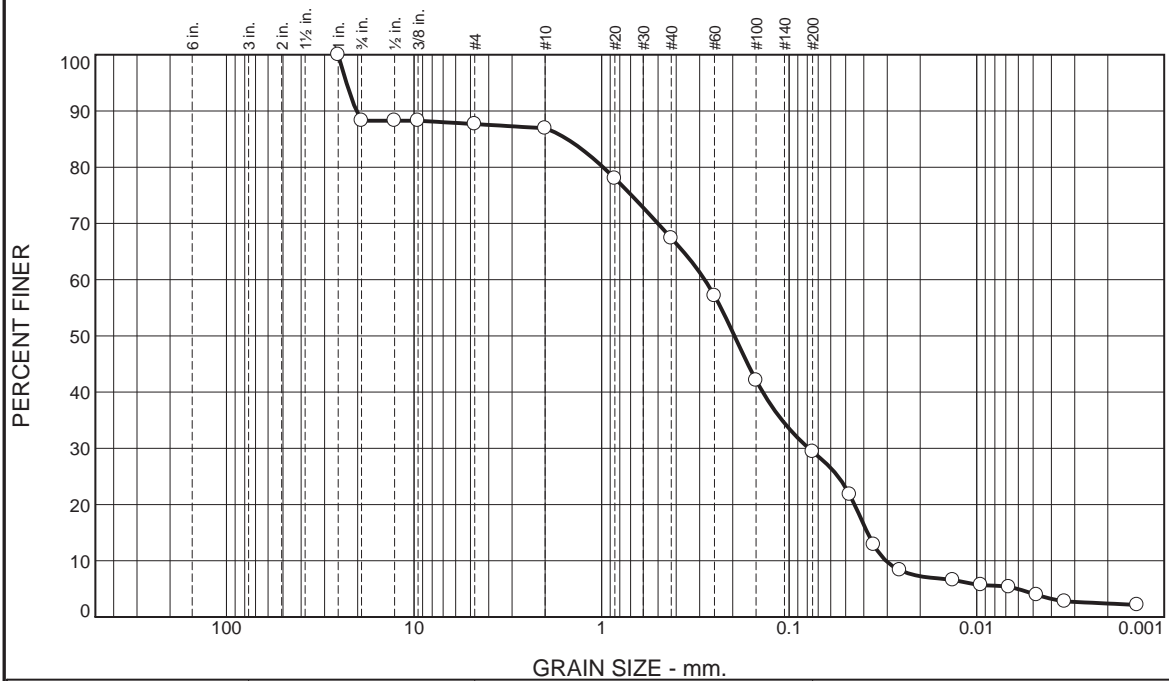
Thielsch Engineering Inc.	<p>Client: GZA GeoEnvironmental</p> <p>Project: Bulloughs Pond Dam Phase II Newton, Massachusetts</p>
Cranston, RI	<p>Project No: 01.0174021.00</p> <p style="text-align: right;">Figure S-4</p>

Particle Size Distribution Report

% +3"	% Gravel		% Sand			% Fines	
	Coarse	Fine	Coarse	Medium	Fine	Silt	Clay
0.0	11.7	0.6	0.8	19.5	38.0	27.0	2.4

Test Results (D7928 & ASTM D 1140)			
Opening Size	Percent Finer	Spec.* (Percent)	Pass? (X=Fail)
1"	100.0		
0.75"	88.3		
0.5"	88.3		
0.375"	88.3		
#4	87.7		
#10	86.9		
#20	78.0		
#40	67.4		
#60	57.1		
#100	42.1		
#200	29.4		
0.0476 mm.	21.8		
0.0354 mm.	12.9		
0.0257 mm.	8.4		
0.0134 mm.	6.6		
0.0095 mm.	5.7		
0.0067 mm.	5.3		
0.0048 mm.	3.9		
0.0034 mm.	2.8		
0.0014 mm.	2.2

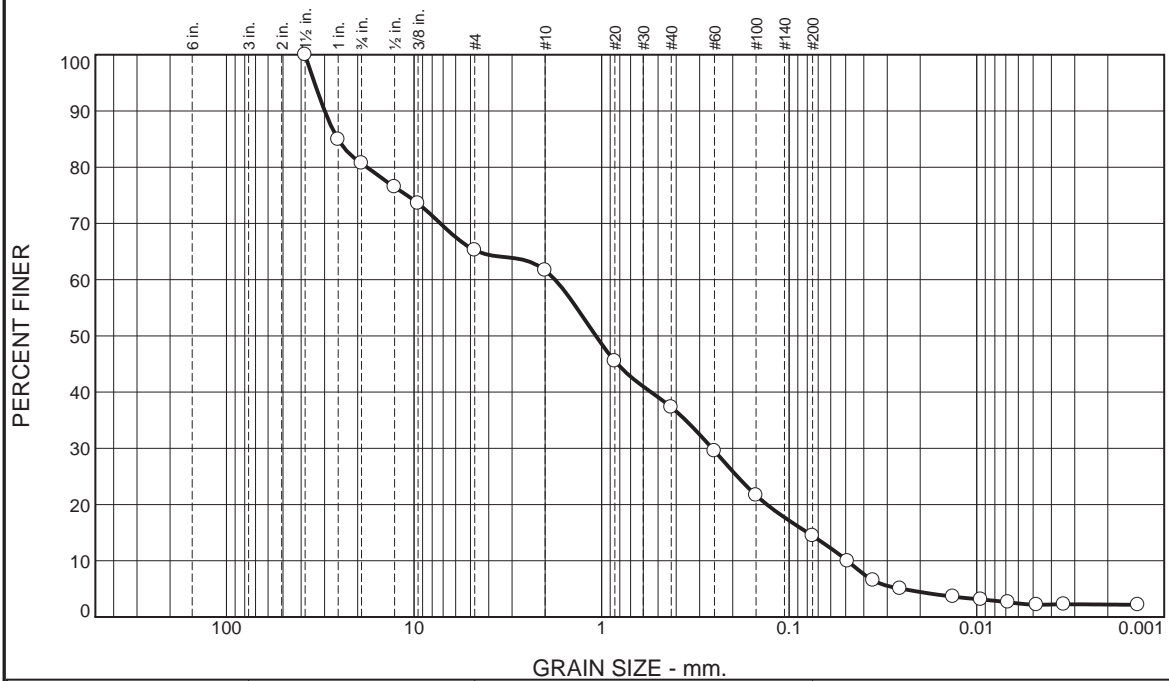
Particle Size Distribution Report

% +3"	% Gravel		% Sand			% Fines	
	Coarse	Fine	Coarse	Medium	Fine	Silt	Clay
0.0	19.3	15.5	3.5	24.4	22.9	12.2	2.2

Test Results (D7928 & ASTM D 1140)			
Opening Size	Percent Finer	Spec.* (Percent)	Pass? (X=Fail)
1-1/2"	100.0		
1"	84.9		
3/4"	80.7		
1/2"	76.5		
3/8"	73.6		
#4	65.2		
#10	61.7		
#20	45.5		
#40	37.3		
#60	29.5		
#100	21.6		
#200	14.4		
0.0488 mm.	9.9		
0.0357 mm.	6.5		
0.0256 mm.	5.1		
0.0134 mm.	3.6		
0.0095 mm.	3.1		
0.0068 mm.	2.6		
0.0048 mm.	2.2		
0.0034 mm.	2.3		
0.0014 mm.	2.2

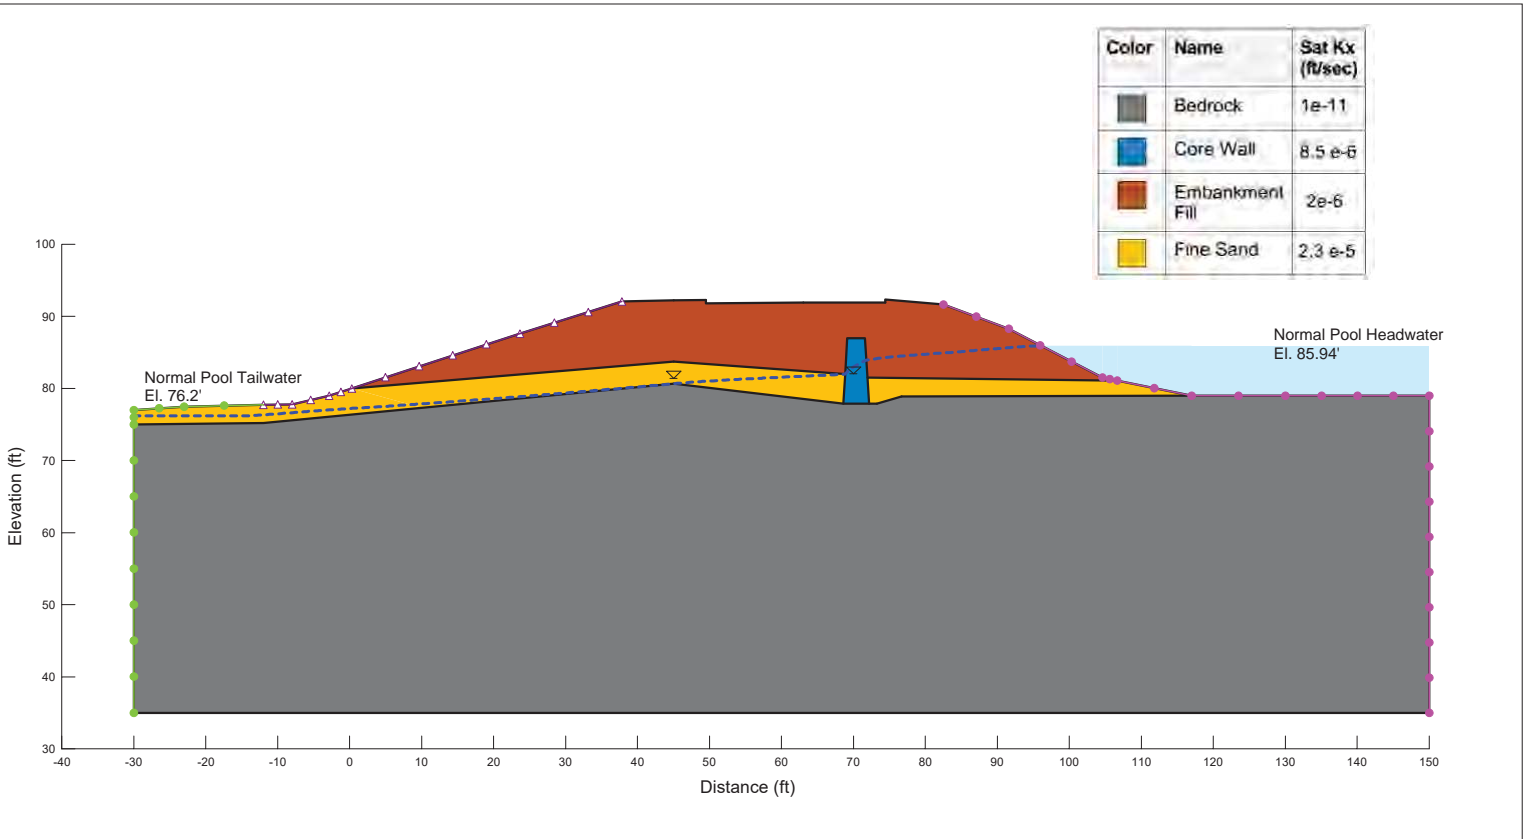
Seepage Analysis - Normal Pool

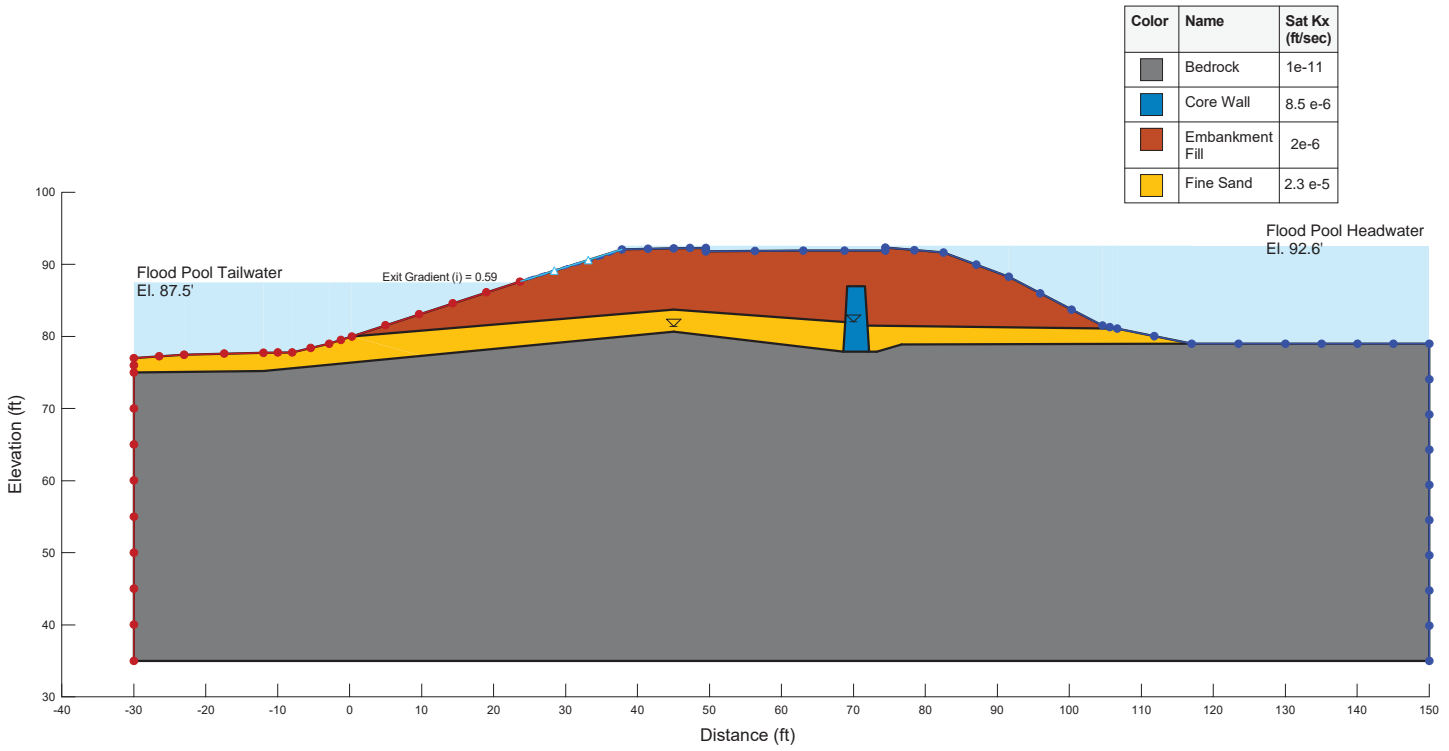
Seepage Analysis - Flood Pool

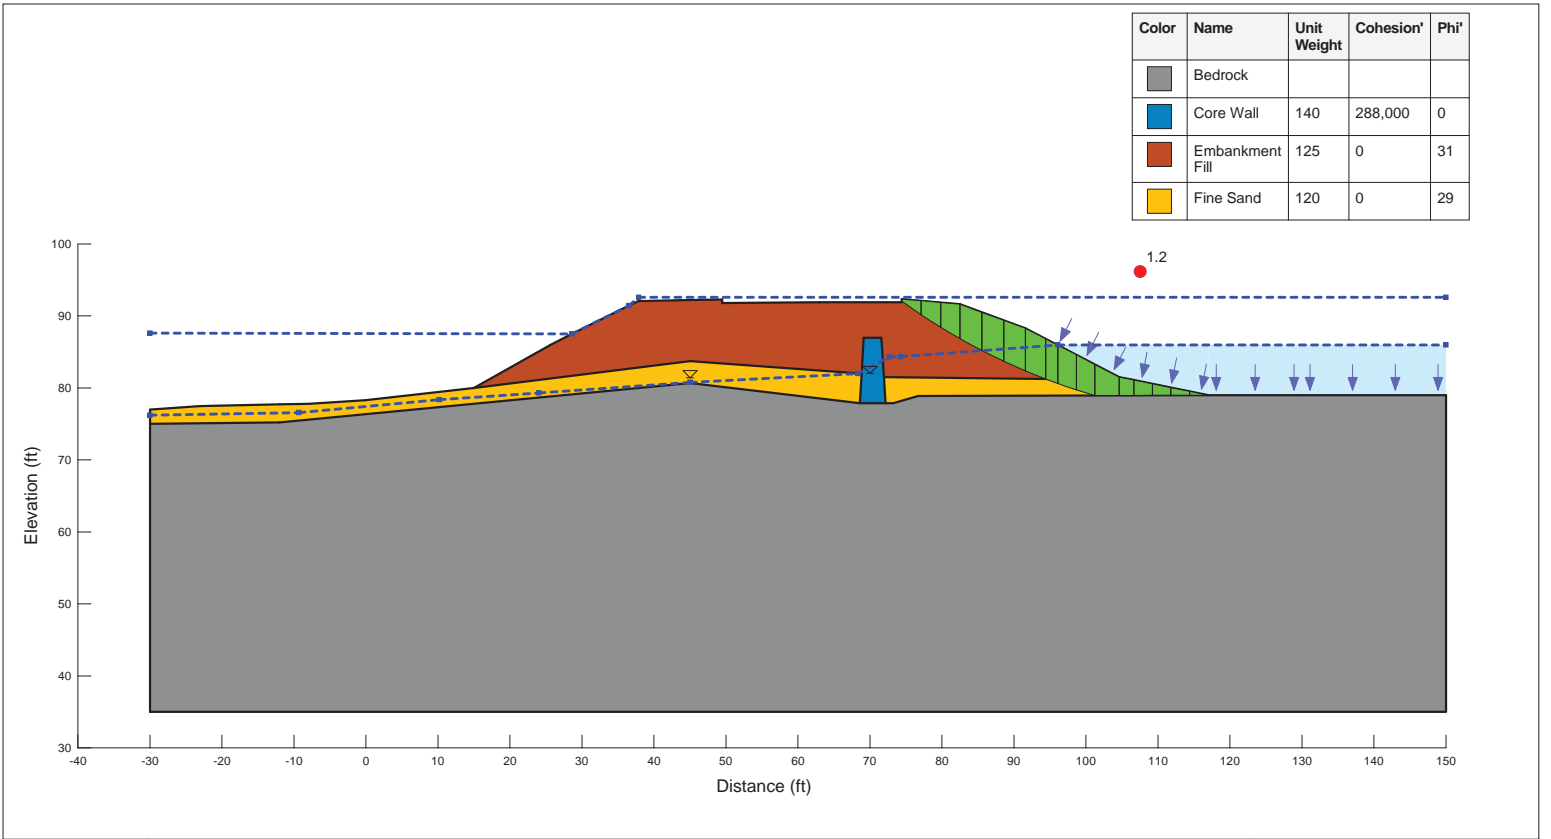
FIGURE G-1

Upstream Stability - Rapid Drawdown from Flood Pool

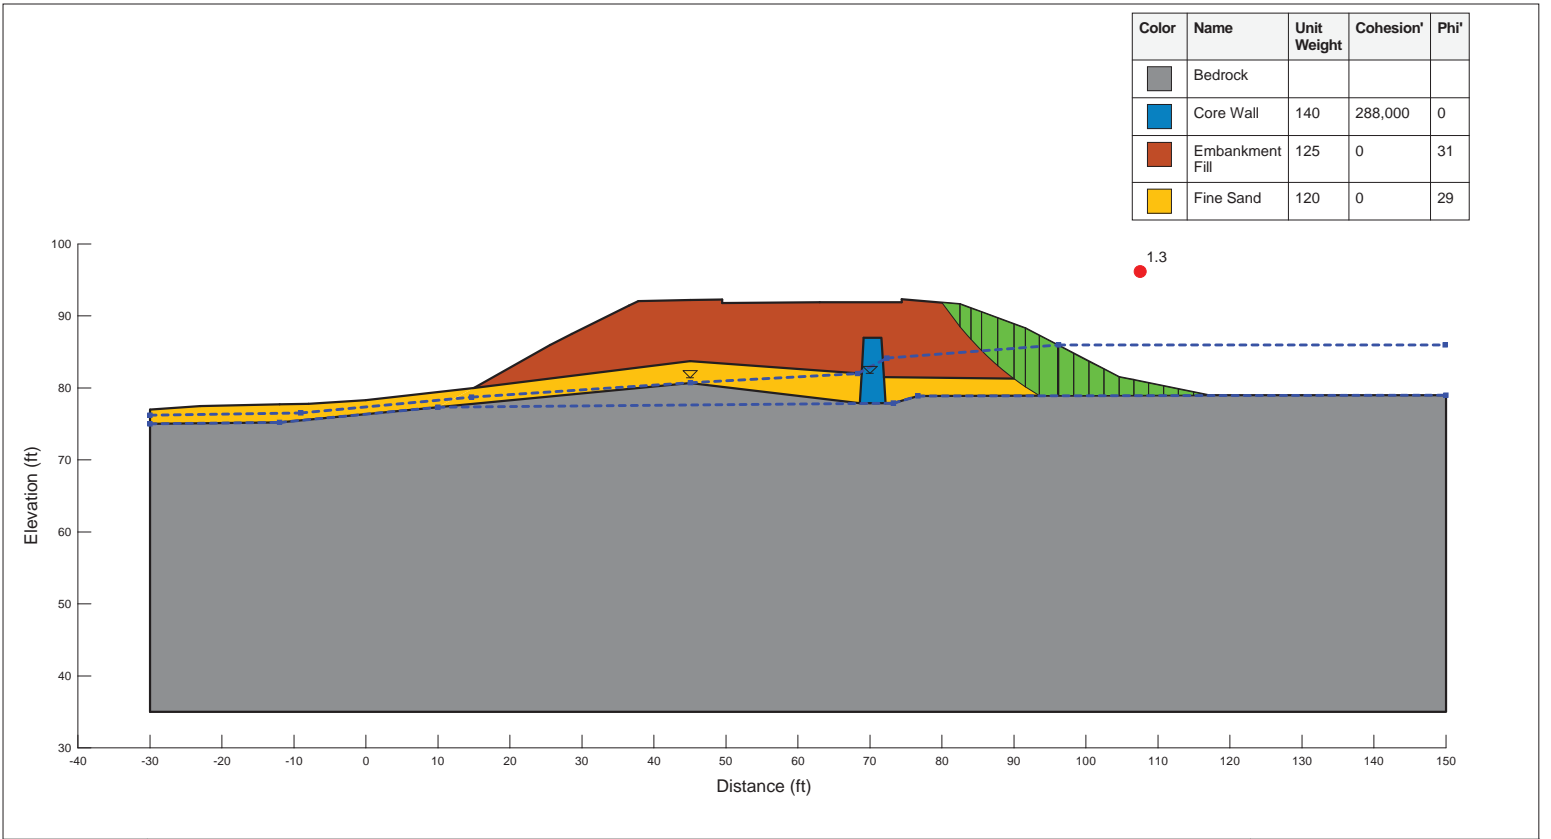
FIGURE G-2

Upstream Stability - Rapid Drawdown from Normal Pool

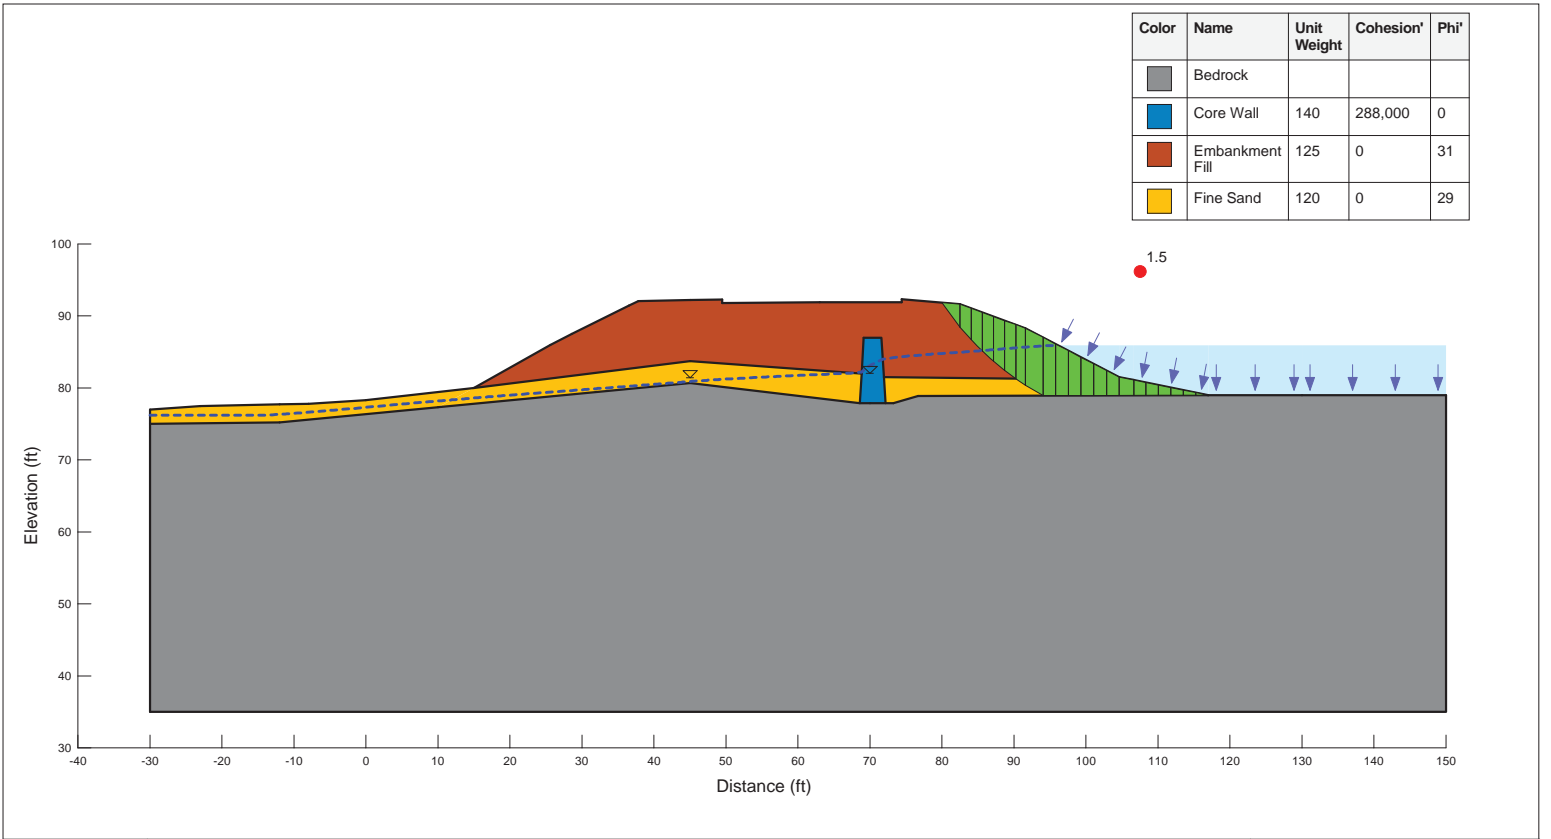
FIGURE G-3

Upstream Stability - Normal Pool

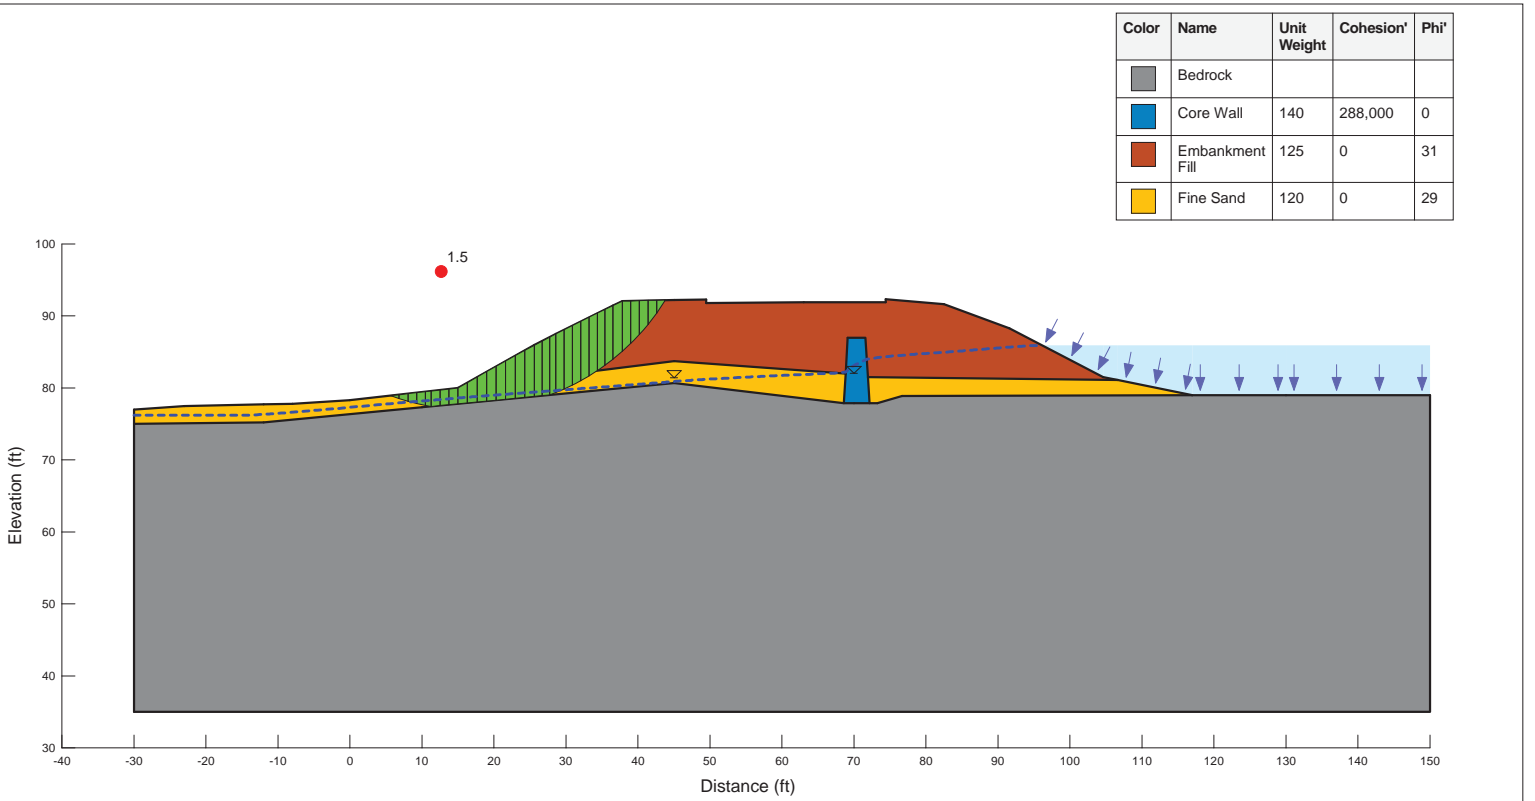
FIGURE G-4

Downstream Stability - Normal Pool

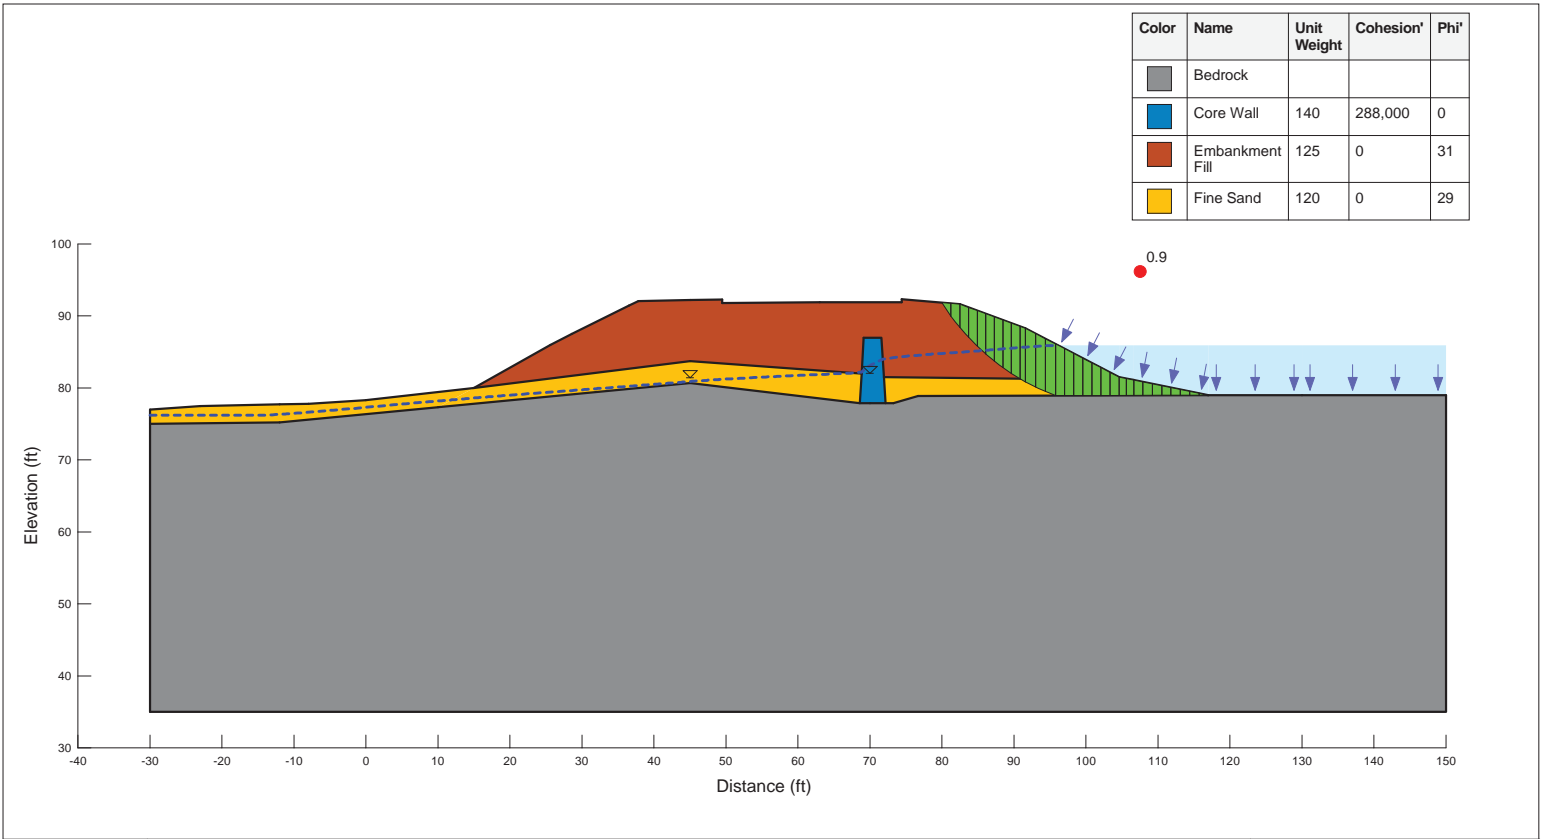
FIGURE G-7

Upstream Stability - Flood Pool (Pseudo-static $A_g = 0.216$)

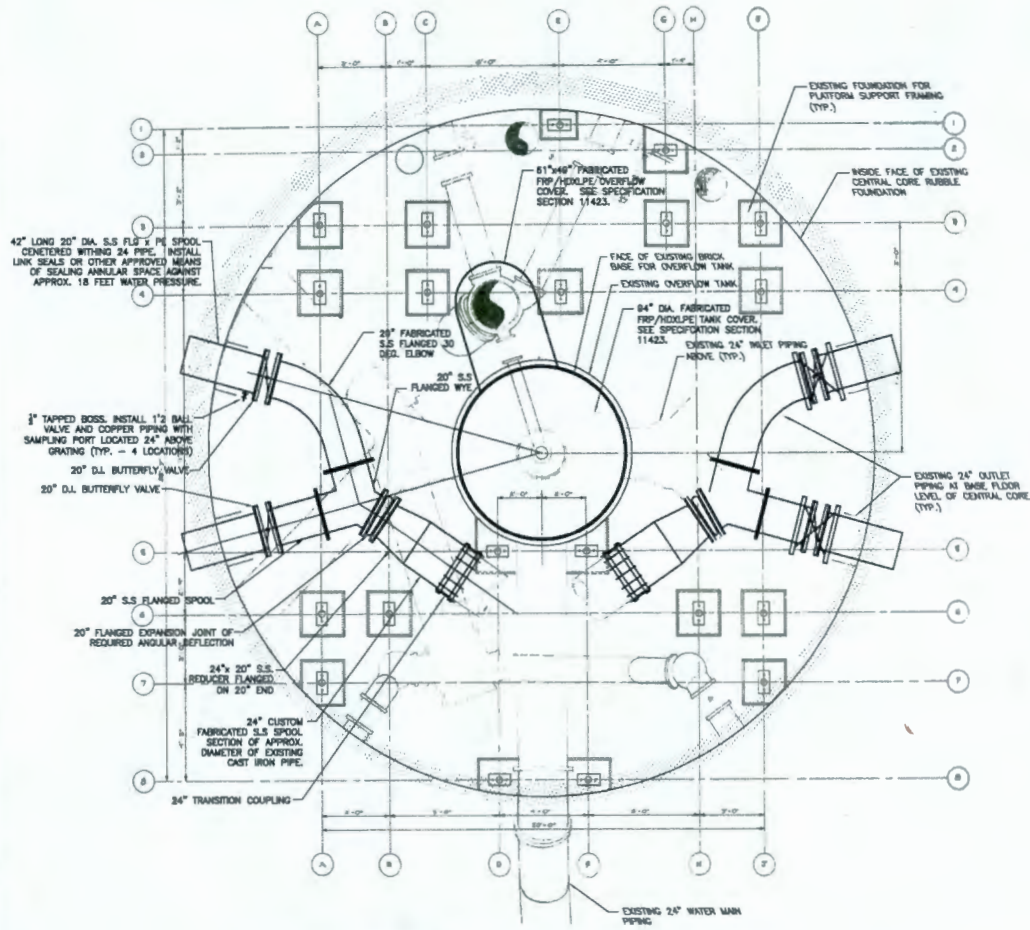
- EXISTING CAST IRON PIPING DATES BACK TO APPROXIMATELY 1900. PIPE DIAMETERS AND FITTINGS DO NOT CORRELATE WITH CURRENT CAST/DUCTILE IRON STANDARDS.
- THE EXISTING PIPING BASE PLAN WAS COPIED FROM EARLY DESIGN DRAWINGS AND MAY NOT REFLECT AS-BUILT CONDITIONS. THEREFORE, THE NEW PIPING CONFIGURATION AS PORTRAYED MAY NOT BE INDICATIVE OF WHAT IS REQUIRED. THE CONTRACTOR IS RESPONSIBLE FOR VERIFYING ALL FIELD DIMENSIONS PRIOR TO PIPE FABRICATION. BUTTERFLY VALVES SHALL BE INSTALLED IN THE APPROXIMATE SAME LOCATION AS THE EXISTING GATE VALVES TO ALLOW VALVE OPERATION FROM THE ELEVATED PLATFORMS.
- THE EXISTING 24" WALL PIPES SHALL BE USED AS SLEEVES FOR THE INSTALLATION OF THE 20" S.S. PIPING, AND THE ANGULAR SPACE SEALED WATER-TIGHT. THE FLANGE SHALL BE CUT AWAY AND THE PIPE EDGES GRIND SMOOTH.
- CONTRACTOR SHALL PROVIDE CONCRETE PIPE SUPPORTS/SADDLES AS PER DRAWINGS AND AS MAY BE REQUIRED.

PROCESS PIPING PLAN
SCALE: 3/8" = 1'-0"

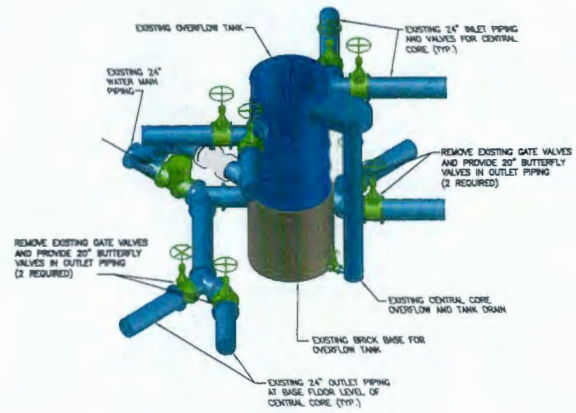
CENTRAL CORE PIPING ISOMETRIC
NOT TO SCALE

- REHABILITATION NOTES:**
- ALL INTERIOR PIPING SHALL BE SAND BLASTED AND PAINTED. COLORS TO BE CHOSEN BY OWNER. SEE SPECIFICATIONS SECTIONS 0980 AND 0900.
 - SAND BLASTING, PIT FILLER, PIT WELDING, AND PLATE WELDING SHALL BE PERFORMED ALONG INTERIOR AND EXTERIOR OF CENTRAL CORE STANDPIPE. PAINT INTERIOR AND EXTERIOR OF CENTRAL CORE STANDPIPE. COLORS TO BE CHOSEN BY OWNER. SEE SPECIFICATIONS SECTIONS 0980 AND 0900.
 - FRP/HUDOLPE TANK AND OVERFLOW COVERS SHALL HAVE SCREEN VENTS. FRP/HUDOLPE TANK COVER SHALL HAVE 24" DIA. MANWAY WITH BOLTED COVER FOR INSPECTION OF CENTRAL CORE STANDPIPE. SEE SPECIFICATION SECTION 11423.
 - INSPECT, TIGHTEN, AND/OR REPLACE LIGHT FIXTURE BRACKETS/SUPPORTS AS REQUIRED. PROVIDE TEN (10) NEW LED LAMPS AT ALL EXISTING LIGHTING LOCATIONS. SEE SPECIFICATION SECTION 18000. SEE LIGHTING SCHEDULE THIS SHEET.
