Newton Schools
Long-Range Facilities Master Plan
Update

Newton, MA
November 2011

VOLUME II

HMFH Architects, Inc.

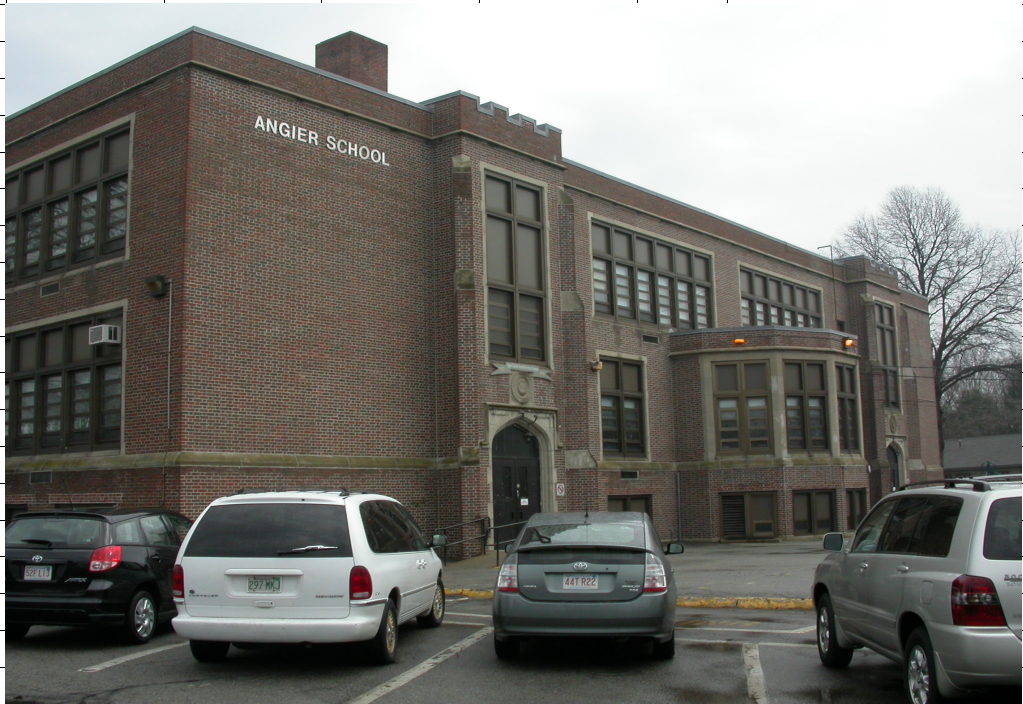
Newton Schools Study - Facility Assessment							
ANGIER SCHOOL							
1697 Beacon Steet							
BUILDING DATA:							
	site area:	1.98 Acres					
	zoning district:	PUB					
	building area:	51,300 gross square feet					
	number of floors:	3					
	historical status:	unknown					
	year built:	1919					
	additions/renovations/upgrades:	1936					
	assessment value:	n/a					
Key to Rating:							
1 = New or in good condition with ordinary maintenance required							
2 = Good condition with minor repairs required							
3 = Fair condition with repairs or replacement required							
4 = Poor condition with replacement required

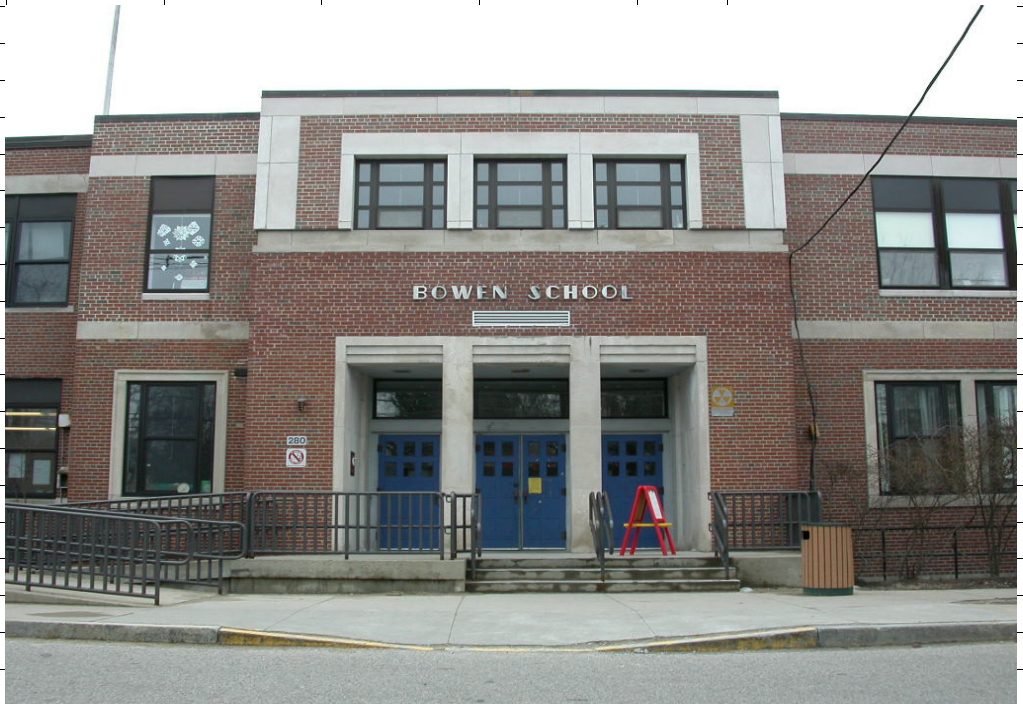
Newton Schools Study - Facility Assessment									
BOWEN SCHOOL									
280 CYPRESS STREET									
BUILDING DATA:									
	site area:	11.54 acres							
	zoning district:	PUB							
	building area:	64,953 gross square feet							
	number of floors:	3							
	historical status:	None							
	year built:	1952							
	additions/renovations/upgrades:	1989, 2000, 2007 - modular							
	assessment value:	n/a							
Key to Rating:									
1 = New or in good condition with ordinary maintenance required									
2 = Good condition with minor repairs required									
3 = Fair condition with repairs or replacement required									
4 = Poor condition with replacement required

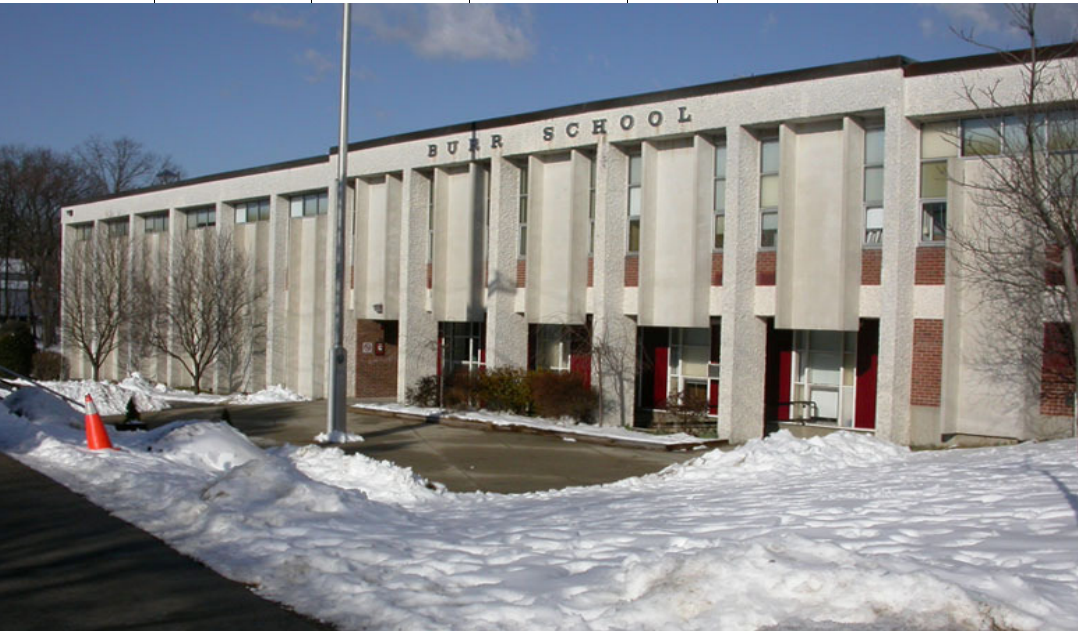
Newton Schools Study - Facility Assessment										
Burr School										
171 Pine Street										
BUILDING DATA:										
	site area:	8.65 acres								
	zoning district:	PUB								
	building area:	54,232 gross square feet								
	number of floors:	2								
	historical status:	None								
	year built:	1967								
	additions/renovations/upgrades:	1998 (walls at 2nd floor classrooms)								
	assessment value:	n/a								
Key to Rating:										
1 = New or in good condition with ordinary maintenance required										
2 = Good condition with minor repairs required										
3 = Fair condition with repairs or replacement required										
4 = Poor condition with replacement required

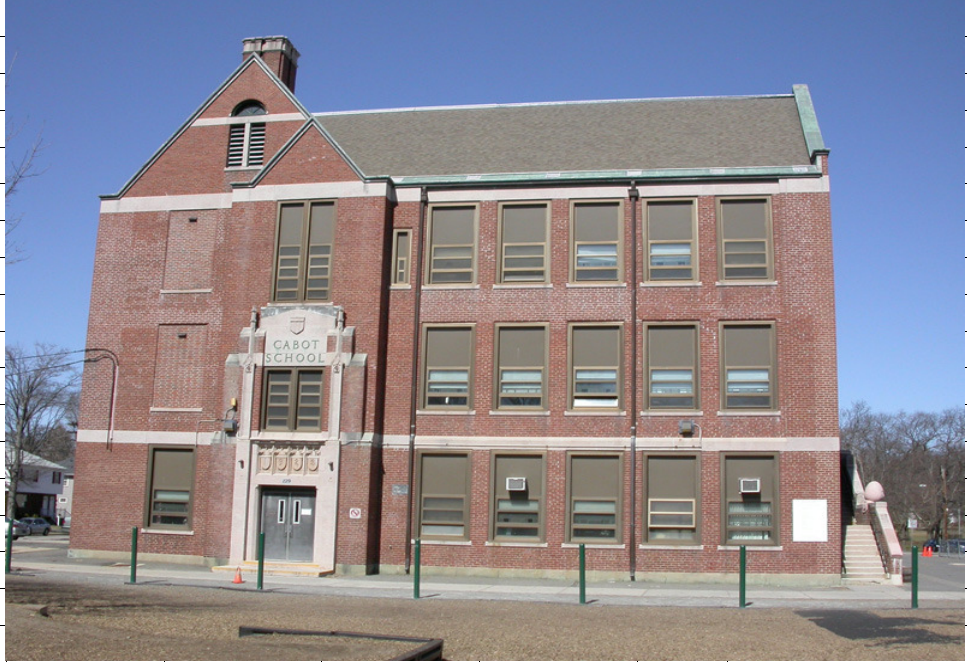
Newton Schools Study - Facility Assessment							
CABOT SCHOOL							
229 CABOT STREET							
BUILDING DATA:							
	site area:	1 acre					
	zoning district:	PUB					
	building area:	45,095 gross square feet					
	number of floors:	3					
	historical status:	None					
	year built:	1929					
	additions/renovations/upgrades:	1957, 2-modular crs-1991, 2-modular crs-2007					
	assessment value:	n/a					
Key to Rating:							
1 = New or in good condition with ordinary maintenance required							
2 = Good condition with minor repairs required							
3 = Fair condition with repairs or replacement required							
4 = Poor condition with replacement required

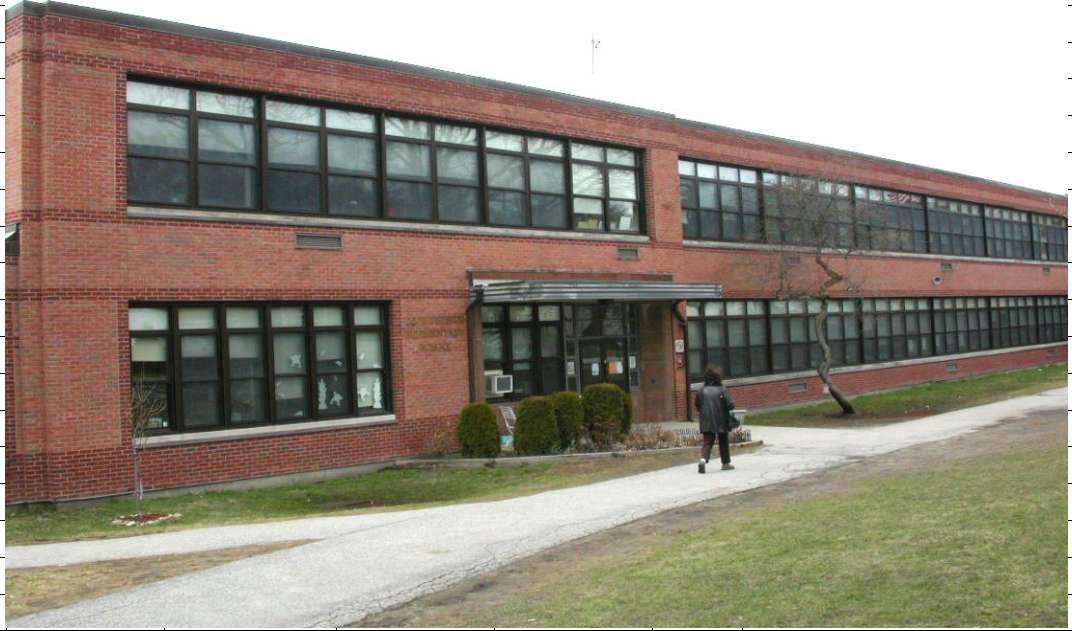
Newton Schools Study - Facility Assessment							
COUNTRYSIDE SCHOOL							
191 DEDHAM STREET							
BUILDING DATA:							
	site area:	7.39 acres					
	zoning district:	PUB					
	building area:	69,600 gross sq. ft.					
	number of floors:	3					
	historical status:	None					
	year built:	1953					
	additions/renovations/upgrades:	1958, 1988, (1991-M, 1999-M)					
	assessment value:	n/a					
Key to Rating:							
1 = New or in good condition with ordinary maintenance required							
2 = Good condition with minor repairs required							
3 = Fair condition with repairs or replacement required							
4 = Poor condition with replacement required

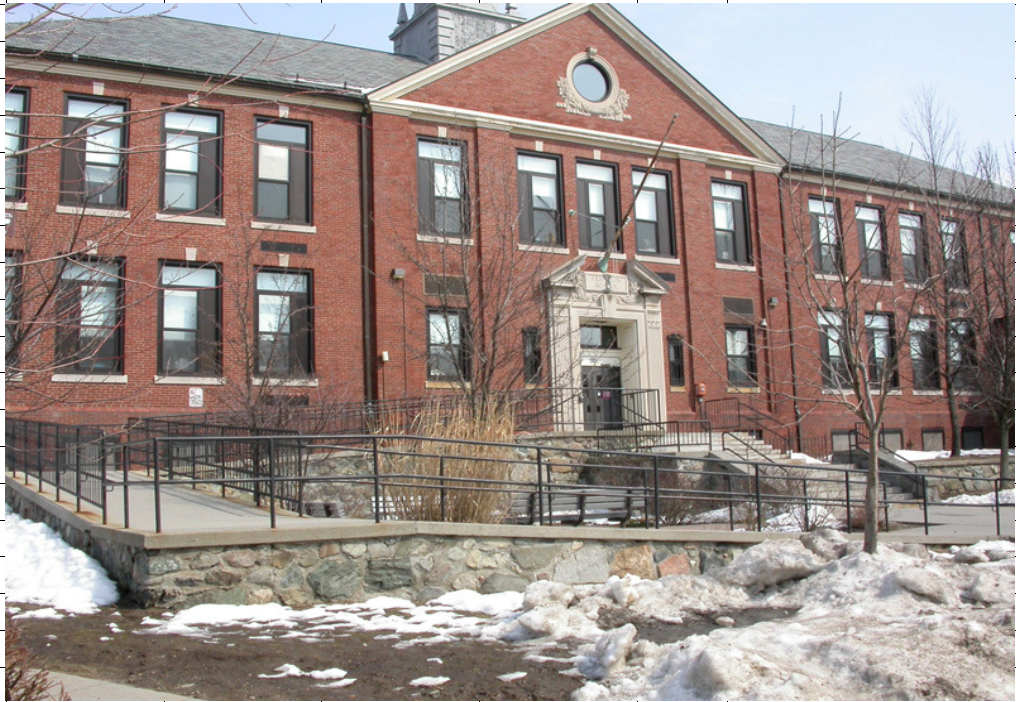
Newton Schools Study - Facility Assessment							
FRANKLIN SCHOOL							
125 DERBY STREET							
BUILDING DATA:							
	site area:	5.45 Acres					
	zoning district:	PUB					
	building area:	56,764 gross square feet					
	number of floors:	3					
	historical status:	None					
	year built:	1939					
	additions/renovations/upgrades:	1950, 1953					
	assessment value:	n/a					
Key to Rating:							
1 = New or in good condition with ordinary maintenance required							
2 = Good condition with minor repairs required							
3 = Fair condition with repairs or replacement required							
4 = Poor condition with replacement required

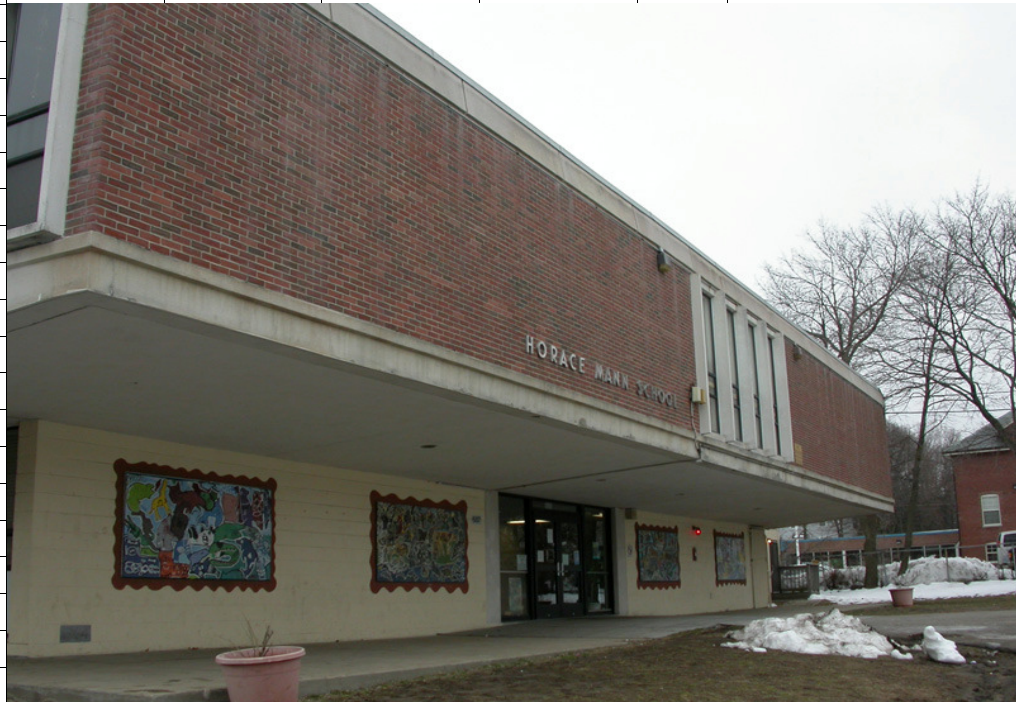
Newton Schools Study - Facility Assessment							
HORACE MANN SCHOOL							
687 WATERTOWN ST							
BUILDING DATA:							
	site area:	1.59 Acres					
	zoning district:	PUB					
	building area:	54,701 gross square feet					
	number of floors:	3					
	historical status:	None					
	year built:	1965					
	additions/renovations/upgrades:	2001-enclosed operable w/ walls 2-modulars 2002; 1-modular 2007					
	assessment value:	n/a					
Key to Rating:							
1 = New or in good condition with ordinary maintenance required							
2 = Good condition with minor repairs required							
3 = Fair condition with repairs or replacement required							
4 = Poor condition with replacement required

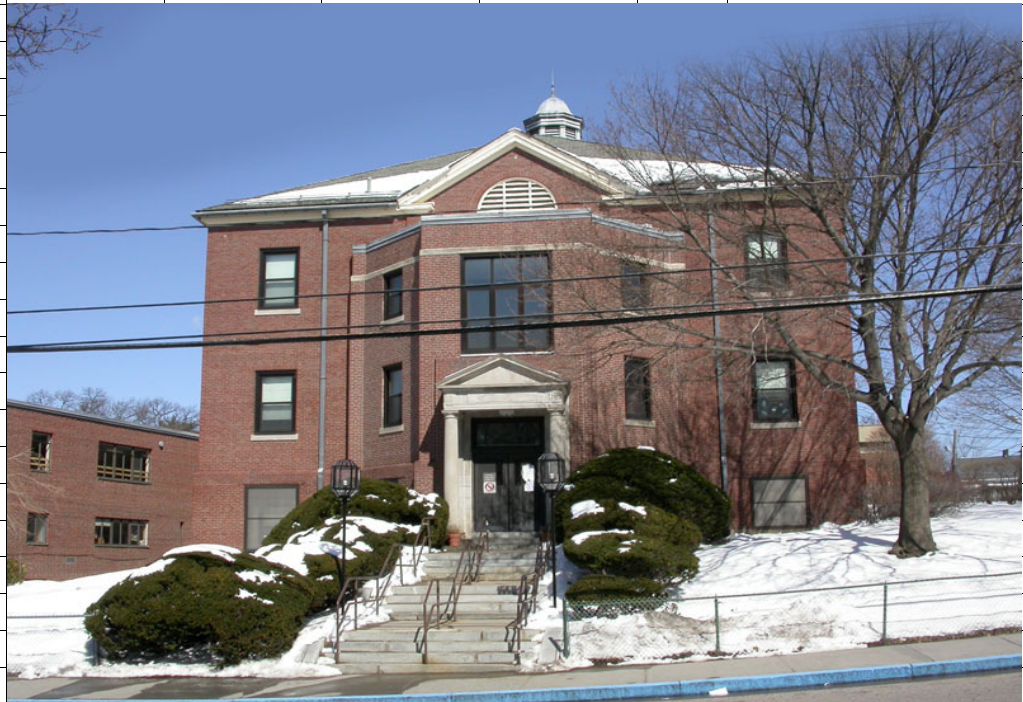
Newton Schools Study - Facility Assessment							
LINCOLN-ELIOT SCHOOL							
191 PEARL STREET							
BUILDING DATA:							
	site area:	4 acres					
	zoning district:	PUB					
	building area:	51,074 Gross Square Feet					
	number of floors:	2/3					
	historical status:	None					
	year built:	1939					
	additions/renovations/upgrades:	1965, 1974					
	assessment value:	n/a					
Key to Rating:							
1 = New or in good condition with ordinary maintenance required							
2 = Good condition with minor repairs required							
3 = Fair condition with repairs or replacement required							
4 = Poor condition with replacement required

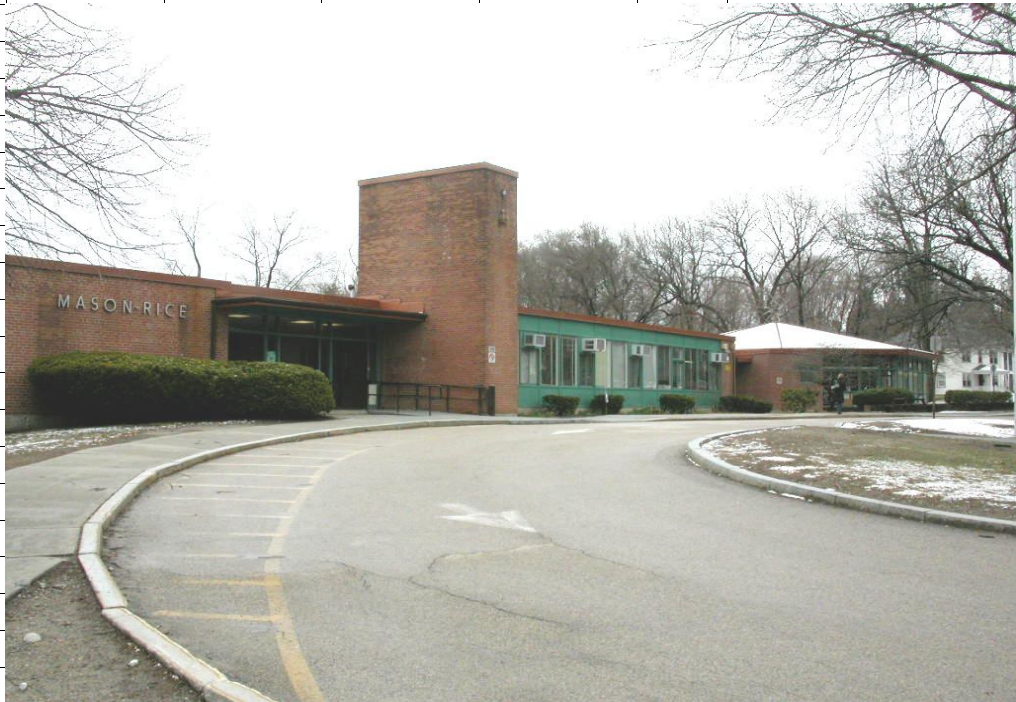
Newton Schools Study - Facility Assessment							
MASON-RICE SCHOOL							
149 PLEASANT STREET							
BUILDING DATA:							
	site area:	3.99 acres					
	zoning district:	PUB					
	building area:	39,000 gross square feet					
	number of floors:	2					
	historical status:	None					
	year built:	1959					
	additions/renovations/upgrades:						
	assessment value:	n/a					
Key to Rating:							
1 = New or in good condition with ordinary maintenance required							
2 = Good condition with minor repairs required							
3 = Fair condition with repairs or replacement required							
4 = Poor condition with replacement required

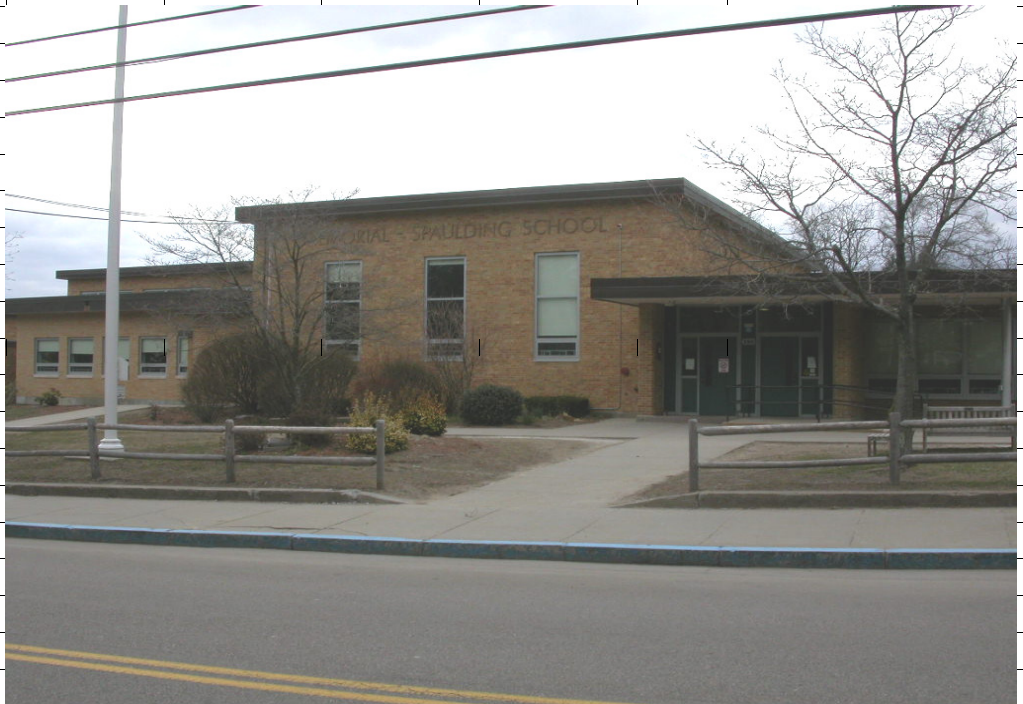
Newton Schools Study - Facility Assessment							
MEMORIAL-SPAULDING SCHOOL							
250 BROOKLINE STREET							
BUILDING DATA:							
	site area:	5.59 acres					
	zoning district:	PUB					
	building area:	68,775 gross square feet					
	number of floors:	2					
	historical status:	None					
	year built:	1954					
	additions/renovations/upgrades:	1959, 2002					
	assessment value:	n/a					
Key to Rating:							
1 = New or in good condition with ordinary maintenance required							
2 = Good condition with minor repairs required							
3 = Fair condition with repairs or replacement required							
4 = Poor condition with replacement required

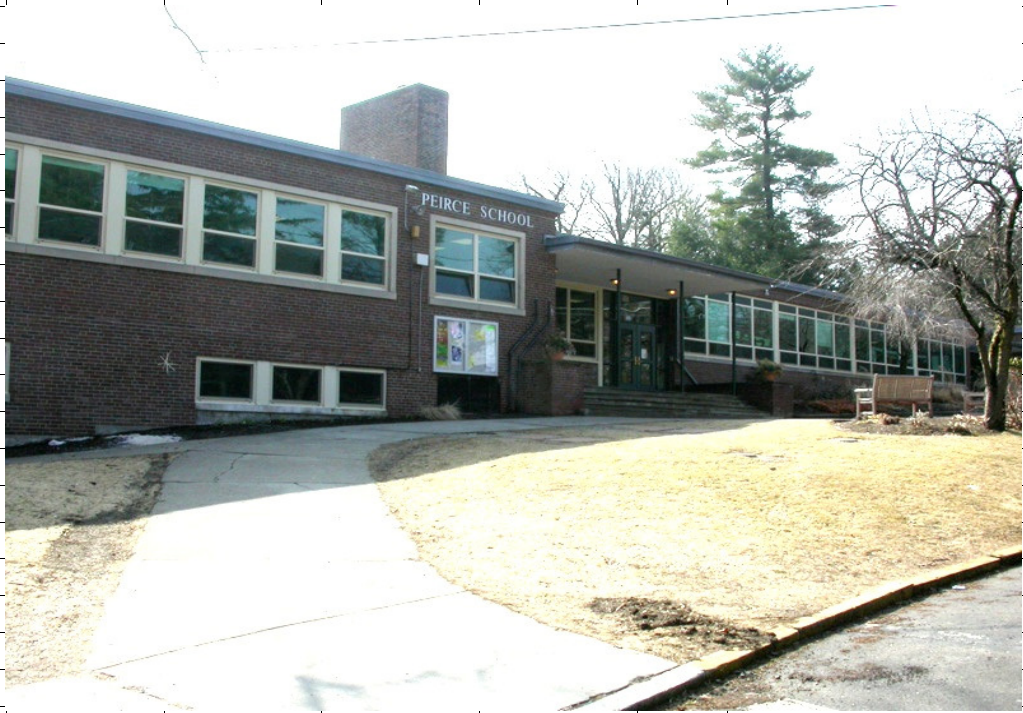
Newton Schools Study - Facility Assessment									
PEIRCE SCHOOL									
170 TEMPLE STREET									
BUILDING DATA:									
	site area:	3.68 acres							
	zoning district:	PUB							
	building area:	36,110 gross square feet							
	number of floors:	2							
	historical status:	None							
	year built:	1951							
	additions/renovations/upgrades:	1955, 2007-modulars							
	assessment value:	n/a							
Key to Rating:									
1 = New or in good condition with ordinary maintenance required									
2 = Good condition with minor repairs required									
3 = Fair condition with repairs or replacement required									
4 = Poor condition with replacement required

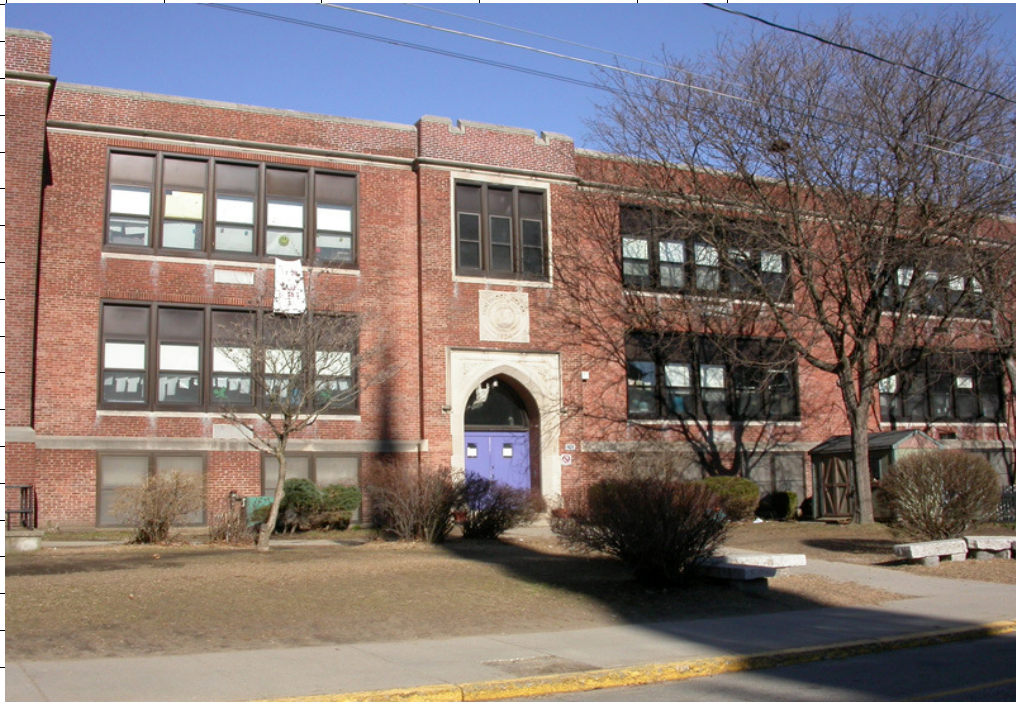
Newton Schools Study - Facility Assessment							
UNDERWOOD SCHOOL							
101 VERNON STREET							
BUILDING DATA:							
	site area:	1 acre					
	zoning district:	PUB					
	building area:	43,300 gross square feet					
	number of floors:	3					
	historical status:	None					
	year built:	1924					
	additions/renovations/upgrades:	1978 (elevator, entry, small rooms)					
	assessment value:	n/a					
Key to Rating:							
1 = New or in good condition with ordinary maintenance required							
2 = Good condition with minor repairs required							
3 = Fair condition with repairs or replacement required							
4 = Poor condition with replacement required

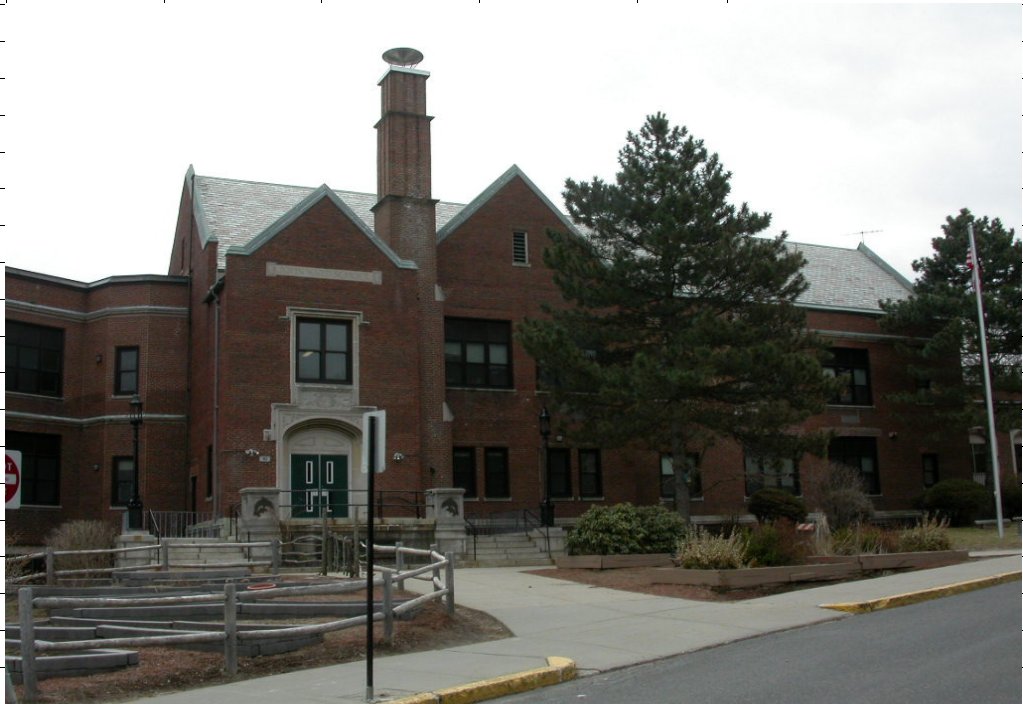
Newton Schools Study - Facility Assessment							
WARD ELEMENTARY SCHOOL							
10 DOLPHIN ROAD							
BUILDING DATA:							
	site area:	3.16 acres					
	zoning district:	PUB					
	building area:	38,000 gross square feet					
	number of floors:	3					
	historical status:	None					
	year built:	1928					
	additions/renovations/upgrades:	1950, 1954					
	assessment value:	n/a					
Key to Rating:							
1 = New or in good condition with ordinary maintenance required							
2 = Good condition with minor repairs required							
3 = Fair condition with repairs or replacement required							
4 = Poor condition with replacement required

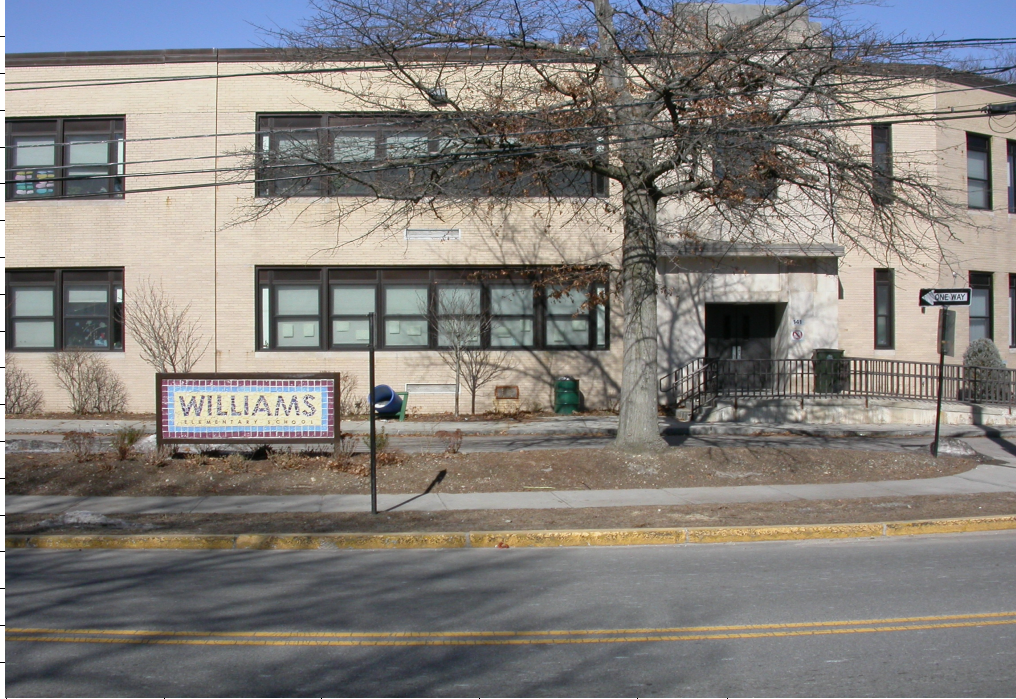
Newton Schools Study - Facility Assessment								
WILLIAMS SCHOOL								
141 GROVE STREET								
BUILDING DATA:								
	site area:	2 acres						
	zoning district:	PUB						
	building area:	41,700 gross square feet						
	number of floors:	2						
	historical status:	None						
	year built:	1950						
	additions/renovations/upgrades:	2001						
	assessment value:	n/a						
Key to Rating:								
1 = New or in good condition with ordinary maintenance required								
2 = Good condition with minor repairs required								
3 = Fair condition with repairs or replacement required								
4 = Poor condition with replacement required

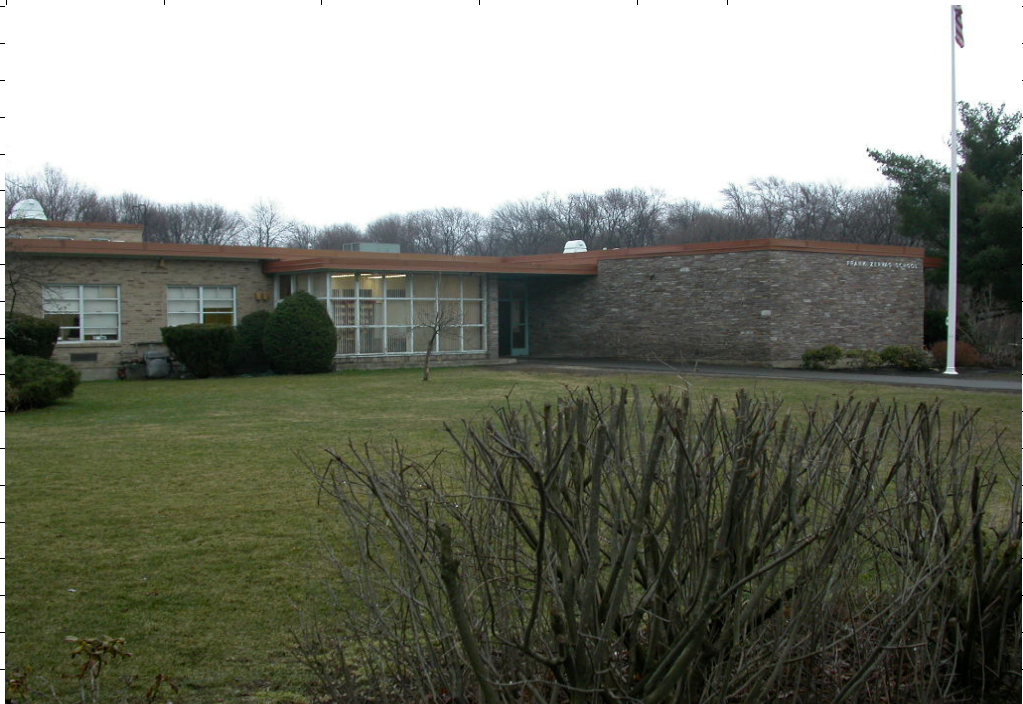
Newton Schools Study - Facility Assessment								
ZERVAS SCHOOL								
30 BEETHOVEN AVENUE								
BUILDING DATA:								
	site area:	5.28 acres						
	zoning district:	PUB						
	building area:	36,006 gross sq. ft.						
	number of floors:	1						
	historical status:	None						
	year built:	1954						
	additions/renovations/upgrades:	1991-modular, 2007-modulars						
	assessment value:	n/a						
Key to Rating:								
1 = New or in good condition with ordinary maintenance required								
2 = Good condition with minor repairs required								
3 = Fair condition with repairs or replacement required								
4 = Poor condition with replacement required

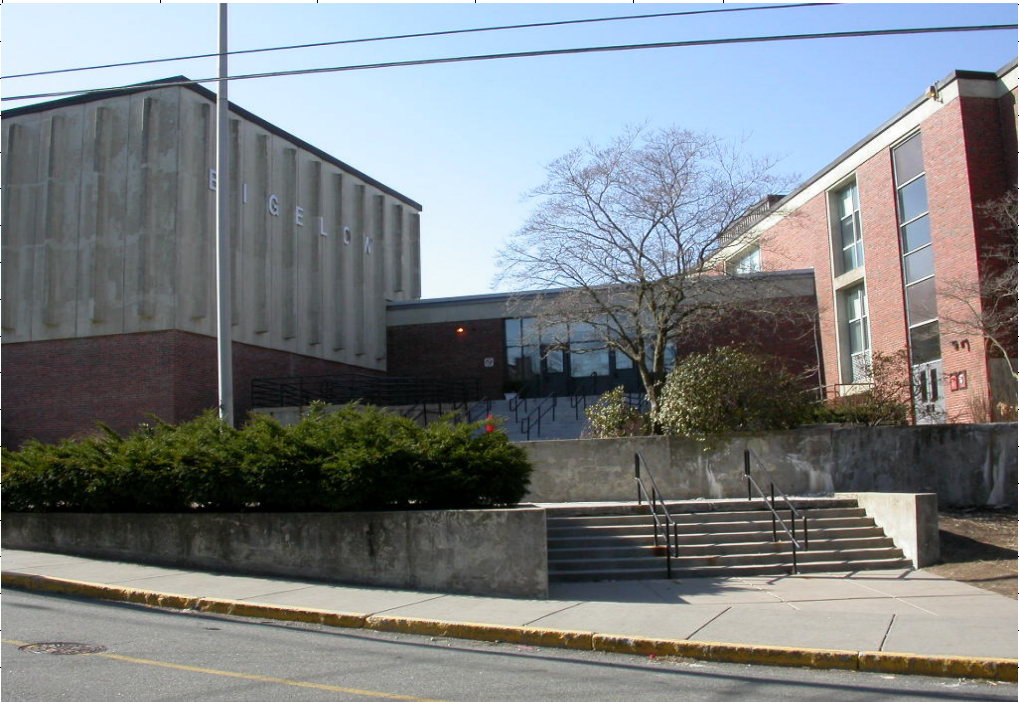
Newton Schools Study - Facility Assessment								
BIGELOW MIDDLE SCHOOL

42 VERNON STREET								
BUILDING DATA:								
	site area:	2.81 Acres						
	zoning district:	PUB						
	building area:	92,500 gross square feet						
	number of floors:	3						
	historical status:	None						
	year built:	1967						
	additions/renovations/upgrades:	1993 (opened as MS)						
	assessment value:	n/a						
Key to Rating:								
1 = New or in good condition with ordinary maintenance required								
2 = Good condition with minor repairs required								
3 = Fair condition with repairs or replacement required								
4 = Poor condition with replacement required

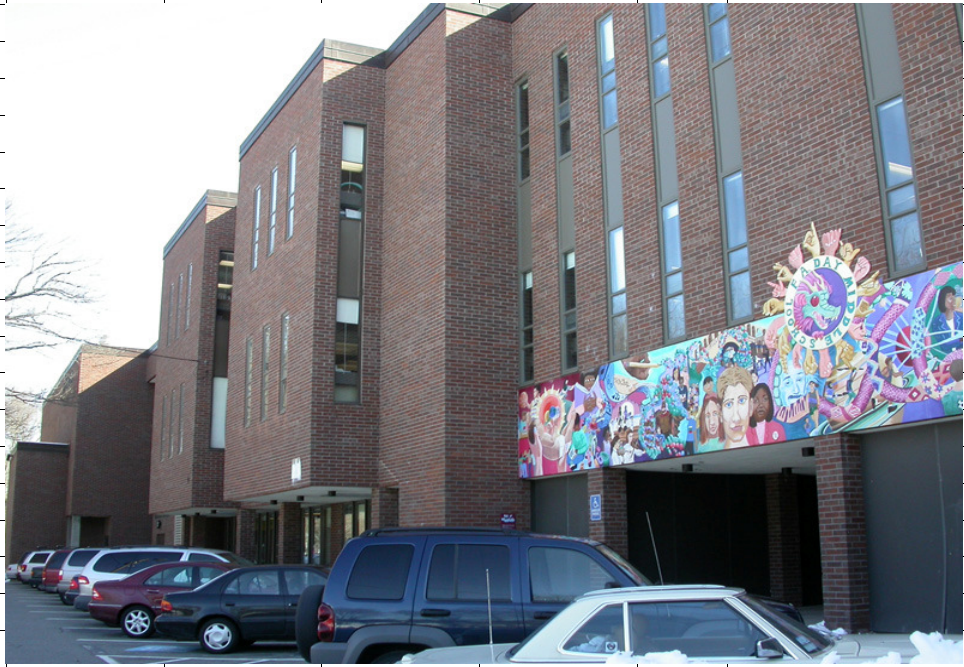
Newton Schools Study - Facility Assessment							
DAY MIDDLE SCHOOL							
21 MINOT PLACE							
BUILDING DATA:							
	site area:	8.57 Acres					
	zoning district:	PUB					
	building area:	145,600 gross square feet					
	number of floors:	3					
	historical status:	None					
	year built:	1971					
	additions/renovations/upgrades:	1997					
	assessment value:	n/a					
Key to Rating:							
1 = New or in good condition with ordinary maintenance required							
2 = Good condition with minor repairs required							
3 = Fair condition with repairs or replacement required							
4 = Poor condition with replacement required

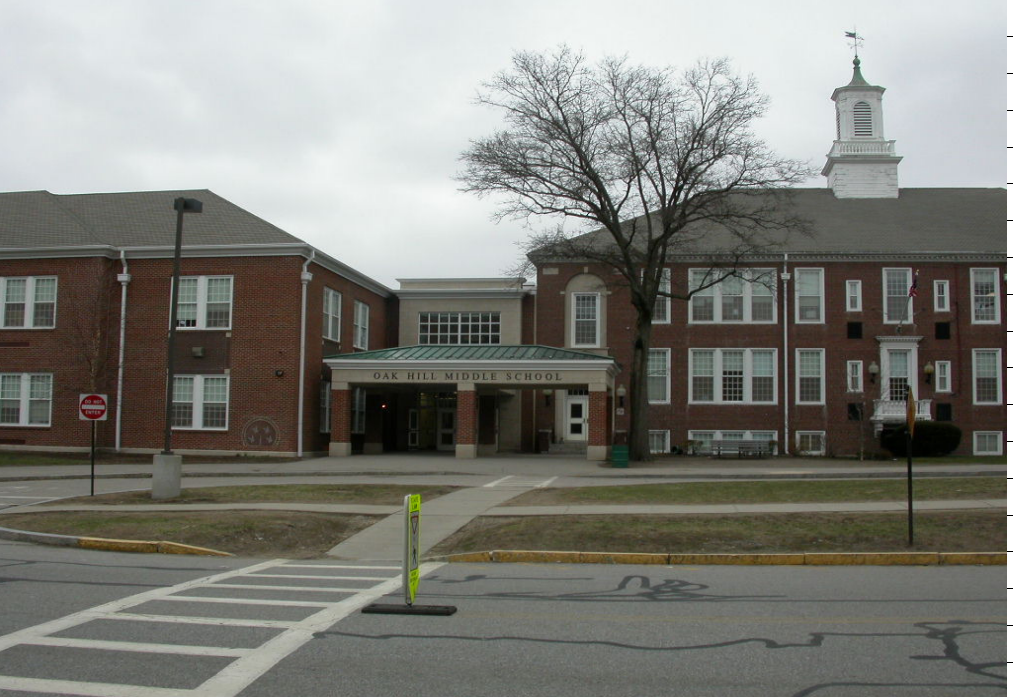
Newton Schools Study - Facility Assessment								
OAK HILL MIDDLE SCHOOL

130 WHEELER ROAD								
BUILDING DATA:								
site area:	8.04 acres							
zoning district:	PUB							
building area:	96,000 gross square feet							
number of floors:	3							
historical status:	None							
year built:	1936							
additions/renovations/upgrades:	1960, 1997 (opened as MS) 2010 - modular addition							
assessment value:	n/a							
Key to Rating:								
1 = New or in good condition with ordinary maintenance required								
2 = Good condition with minor repairs required								
3 = Fair condition with repairs or replacement required								
4 = Poor condition with replacement required

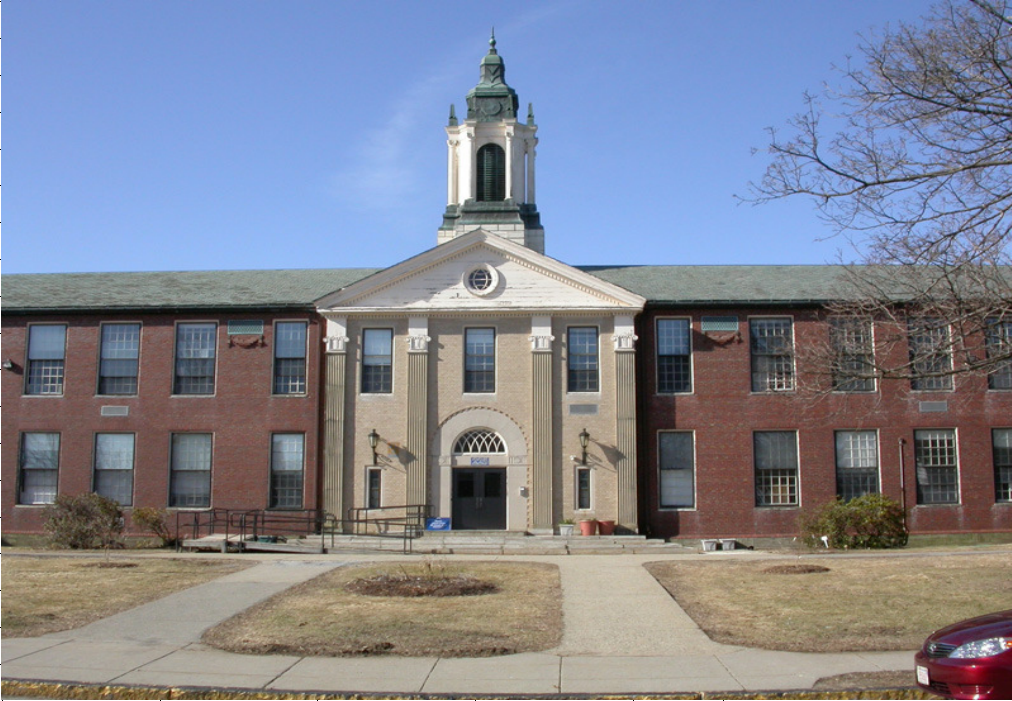
Newton Schools Study - Facility Assessment							
CARR SCHOOL							
225 NEVADA STREET							
BUILDING DATA:							
	site area:	4.85 acres					
	zoning district:	PUB					
	building area:	49,000 gross square feet					
	number of floors:	2					
	historical status:	None					
	year built:	1936					
	additions/renovations/upgrades:	1960					
	assessment value:	n/a					
Key to Rating:							
1 = New or in good condition with ordinary maintenance required							
2 = Good condition with minor repairs required							
3 = Fair condition with repairs or replacement required							
4 = Poor condition with replacement required

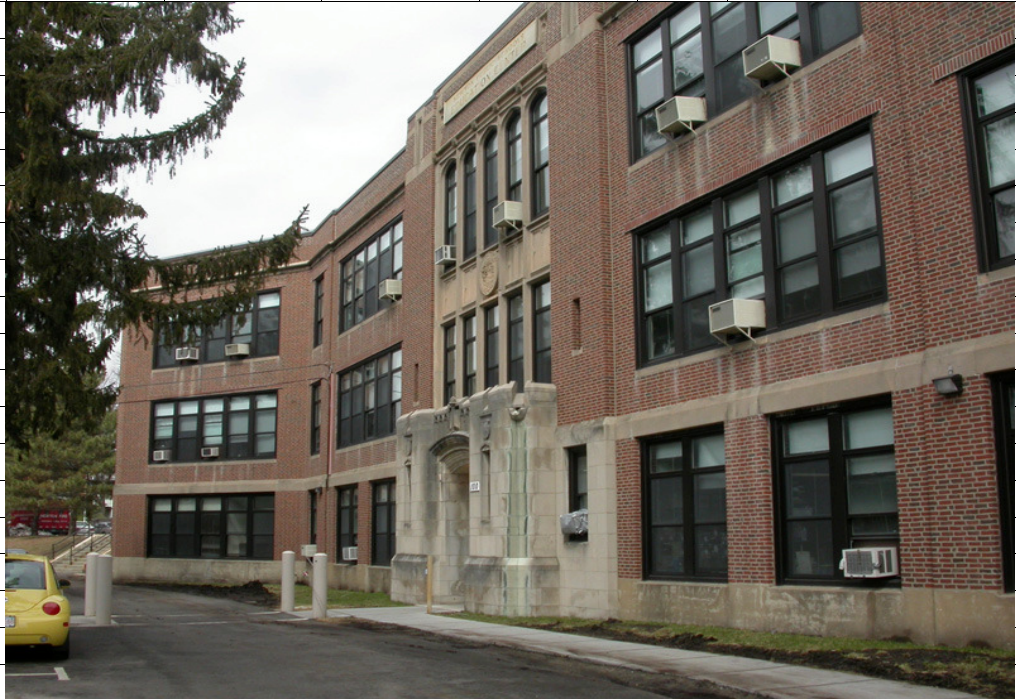
Newton Schools Study - Facility Assessment							
EDUCATION CENTER							
100 WALNUT STREET							
BUILDING DATA:							
	site area:	3.78 acres					
	zoning district:	PUB					
	building area:	70,000 gross square feet					
	number of floors:	3					
	historical status:	None					
	year built:	1928					
	additions/renovations/upgrades:	1934-add, 1966-modulars					
	assessment value:	n/a					
Key to Rating:							
1 = New or in good condition with ordinary maintenance required							
2 = Good condition with minor repairs required							
3 = Fair condition with repairs or replacement required							
4 = Poor condition with replacement required
