NEWTON LOCAL LANDMARK REPORT

***The Kaplan House, TAC #1
12 Drumlin Road***

**Prepared for:
Newton Historical
Commission
March 2003**

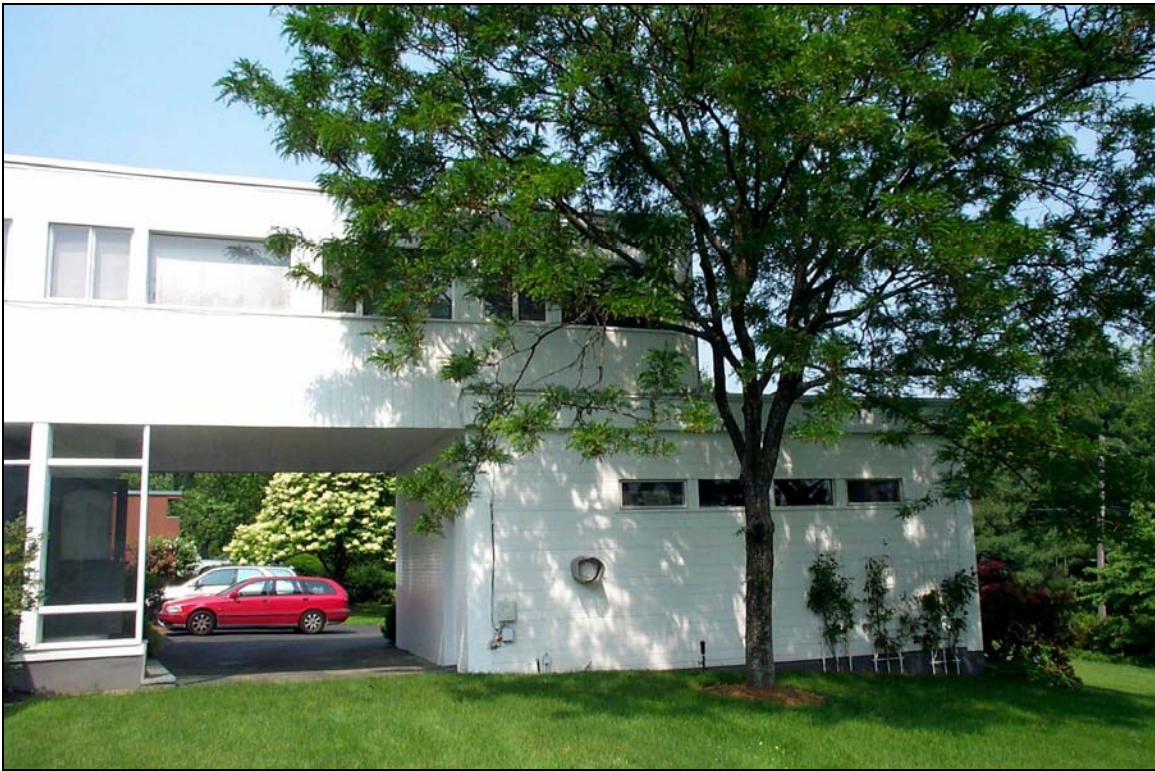
View of Garage Facing Dudley Road

Set apart from the rest of the first floor, the garage forms the last piece of the structure and serves as part of the support system for the second floor. The square, predominantly brick structure is located so that its back wall faces Dudley Road and is accessed by a driveway off Drumlin Road. Due to the slope of the lot, low stone and brick retaining walls were used along the street edge of the driveway, which now blend in with the garage's foundation and plantings. A shallow overhang projects out over the large, rectangular garage door made up of four rows of eight squares panels. Fixed rectangular windows over the garage door and on the rear wall of the garage provide light into the structure and a second entry is located across from the front entrance.

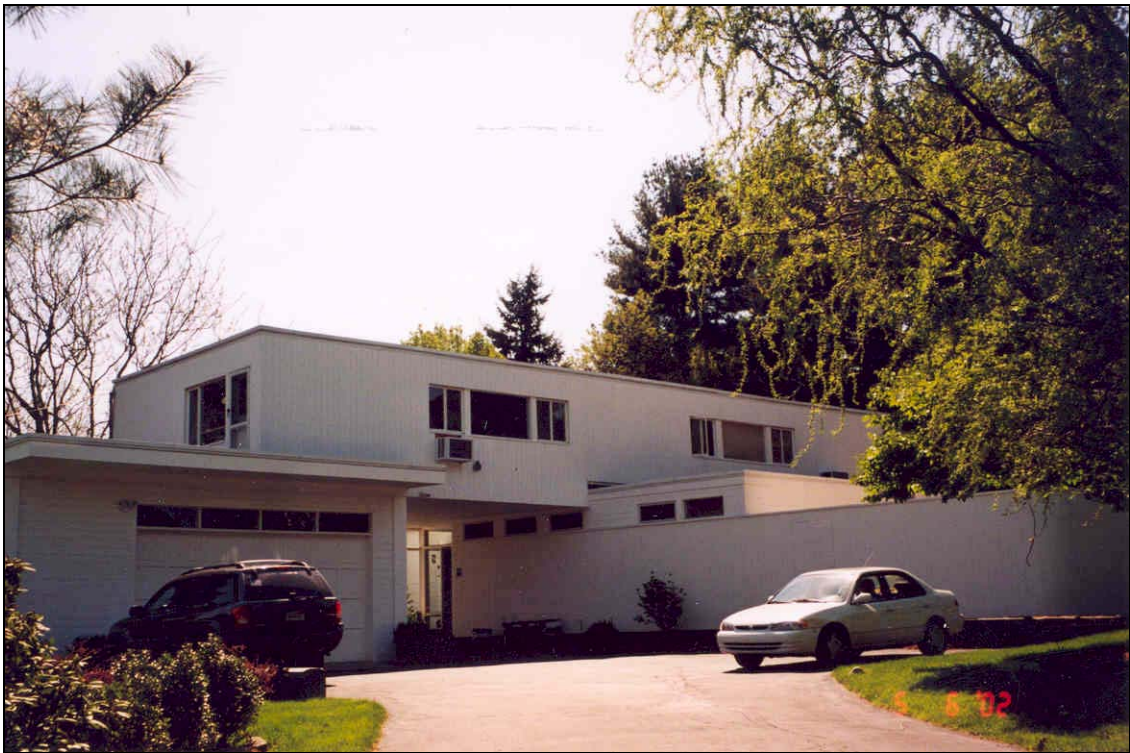
View from Driveway/Drumlin Road

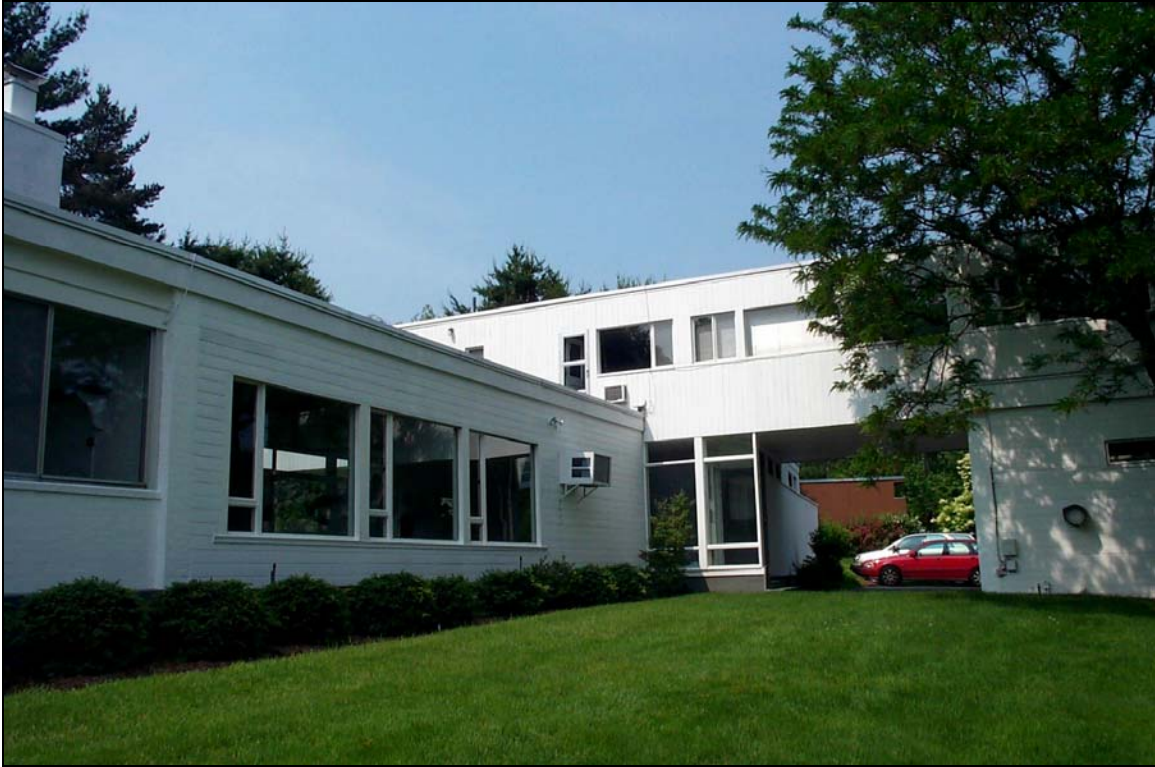
Front View of House from Dudley Road

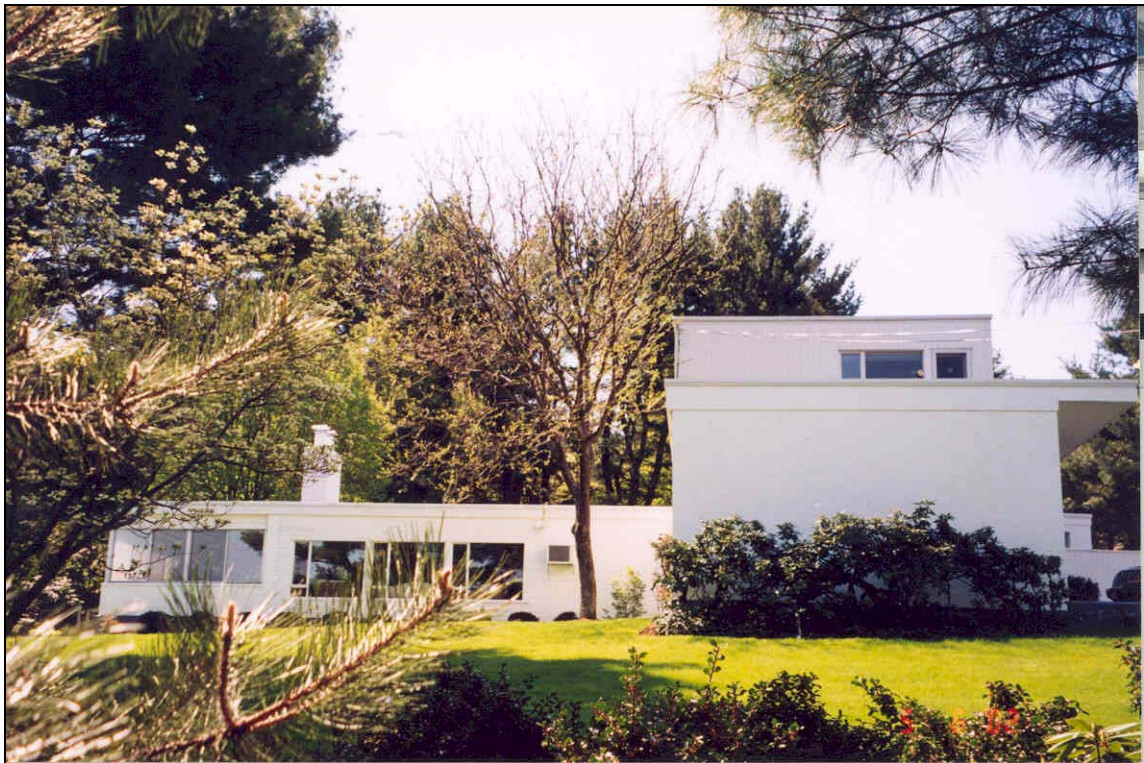
View of House from Drumlin Road

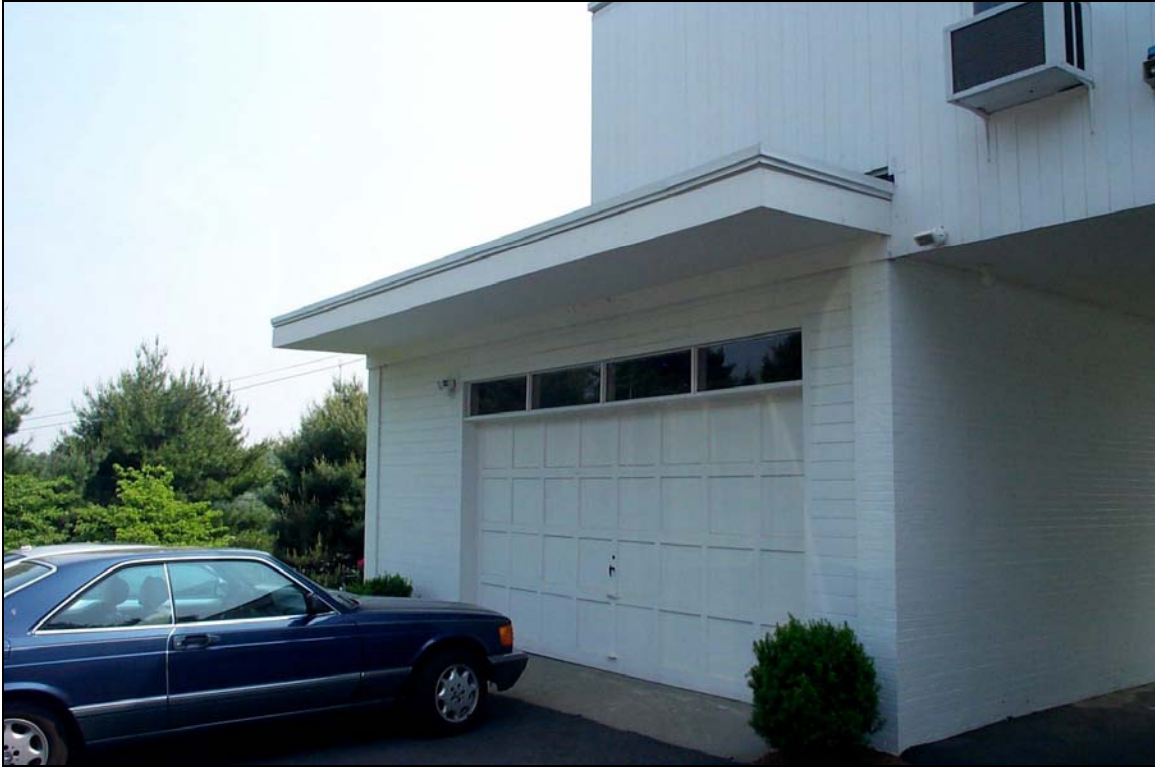
View of Garage from Driveway

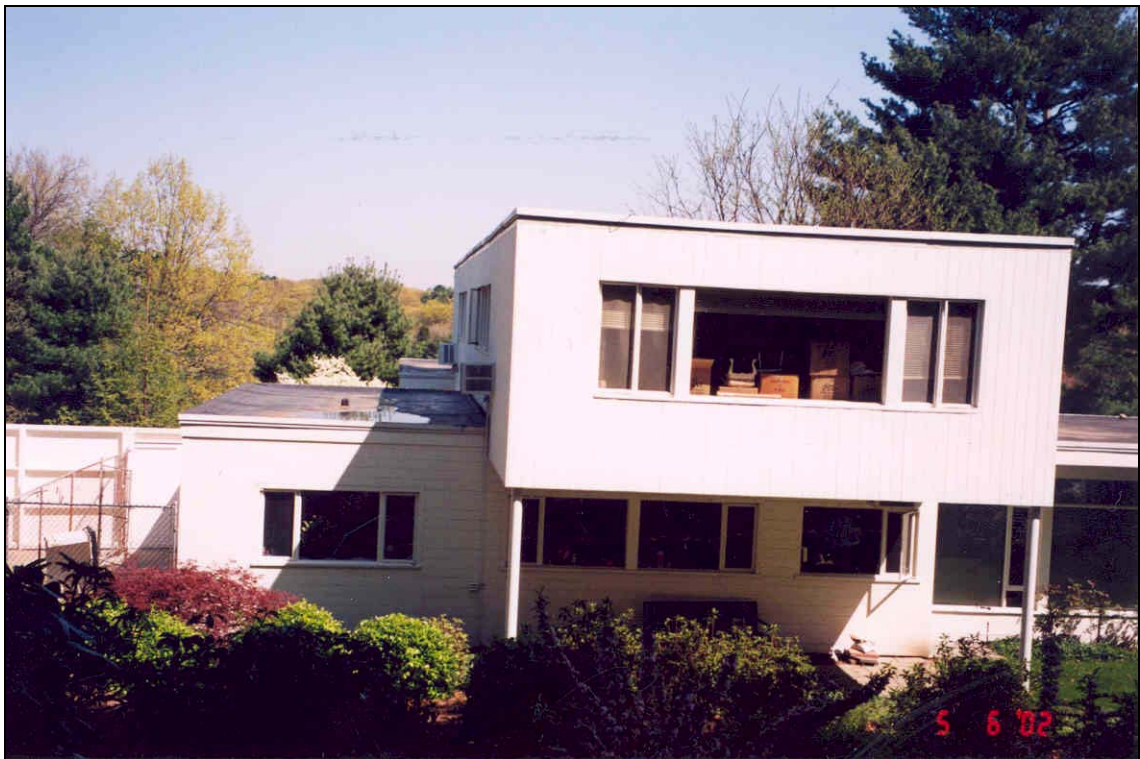
Rear View of House

The rear of the first floor rectangle faces into the back yard which rises steeply up Bald Pate Hill. A small lawn area created by low brick and stone retaining walls exists directly behind the house with a brick patio located under the overhanging second floor. To the right of this patio, the rear façade is indented slightly to create a small overhang along the rear elevation.
