City of Newton Historic Preservation

GUIDELINES FOR EXTERIOR MAINTENANCE

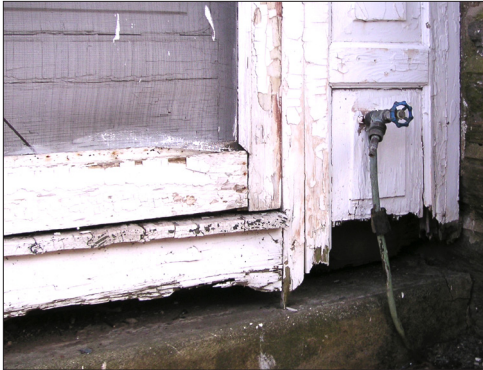
The wood base is in contact with the concrete foundation. Regular wood dampness can eventually lead to rot and deterioration, necessitating future replacement.

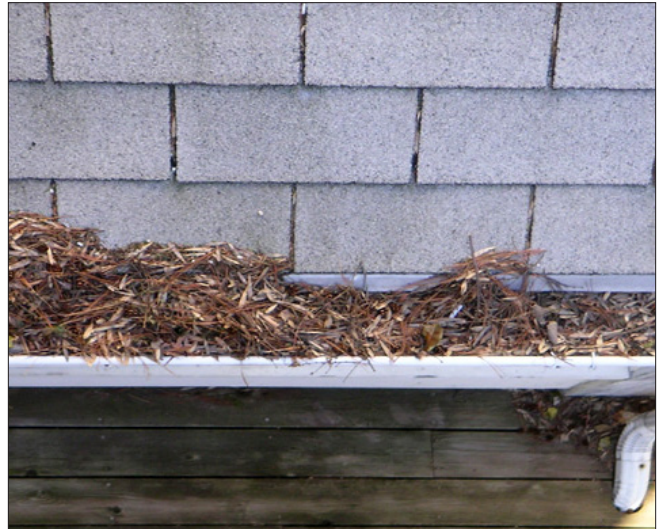
The regular cleaning of gutters and downspouts is one of the most effective preventive maintenance tasks. Clean gutters and downspouts provide a means for moisture that accumulates on the roof to be directed away from the building without causing damage. This gutter is filled with leaves, twigs and debris preventing clear drainage and allowing water to overflow the gutter and damage exterior wall surfaces. Gutters and downspouts should be cleaned at least twice each year to minimize potential problems.

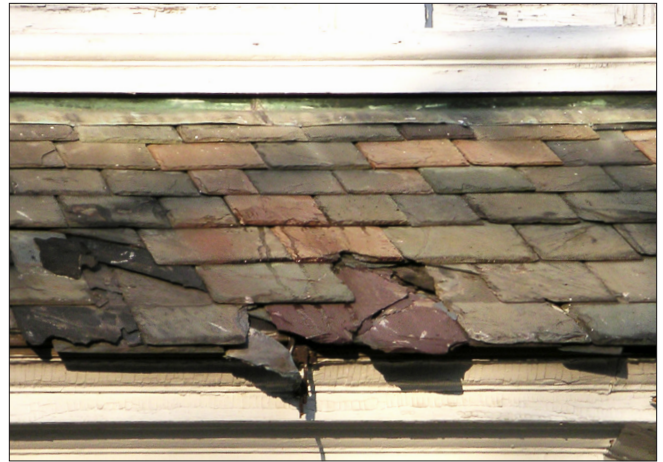
Slates are cracked, dislodged and missing. Some of the surfaces are delaminating. Approximately 25 to 30 percent of the slates on this roof are either missing or damaged. Given the pervasiveness of the problems, considering roof replacement would be appropriate.

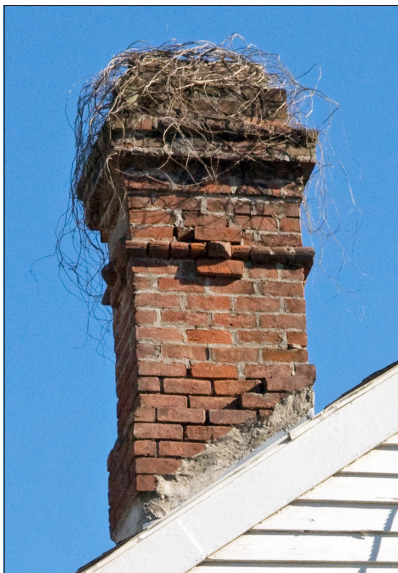
This chimney is leaning and has several visible open joints. Rebuilding to match existing detailing is recommended.

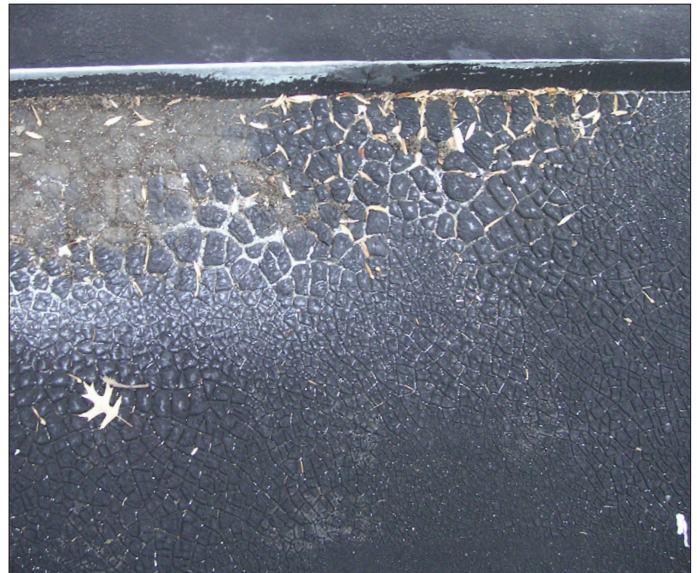
The alligatored roof surface indicates deterioration and possible need for replacement.

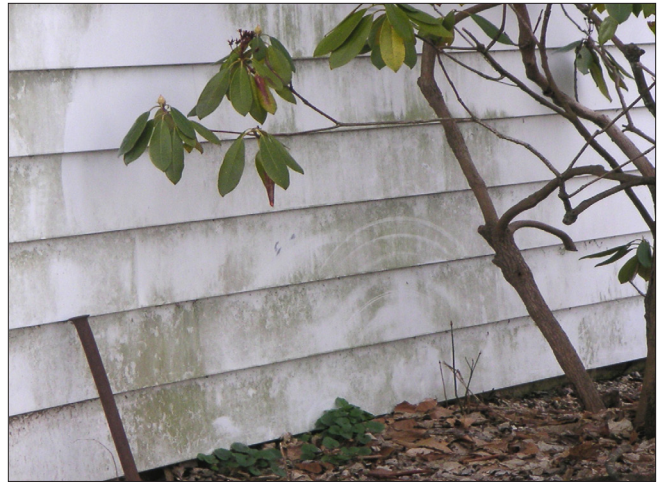
The staining on the siding is an indication of mold or algae growth. The shrubs should be removed or thinned to increase ventilation and allow sunlight to strike the wall. The siding is located only 2-3 inches above grade, making it susceptible to water damage.

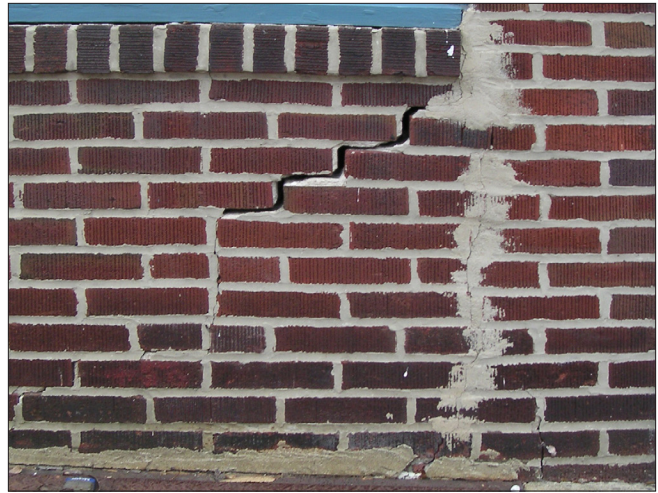
A previous vertical crack has been improperly repaired with hard grout smeared onto the wall surface. The second diagonal crack suggests a settlement or movement problem, that warrants consultation with an architect or engineer.

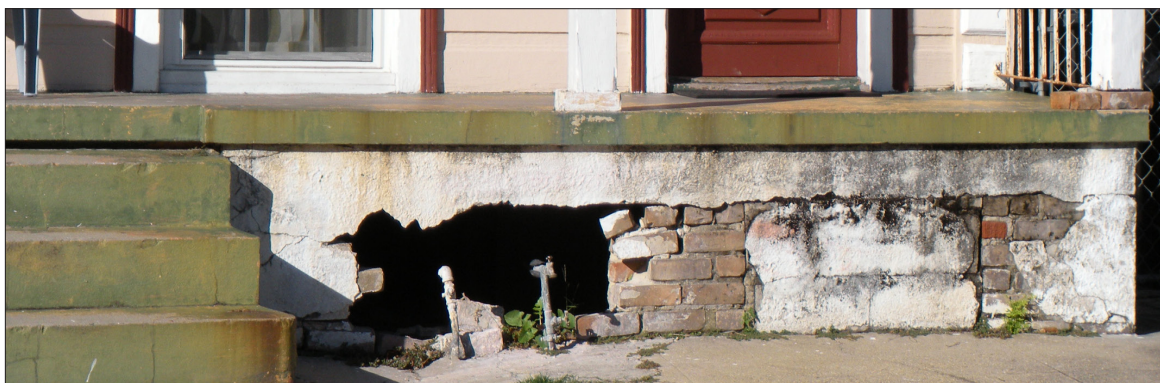
The stucco has not been maintained and the bricks under the porch post are falling out of position. The dislodged bricks can lead to structural problems in the porch if not repaired.

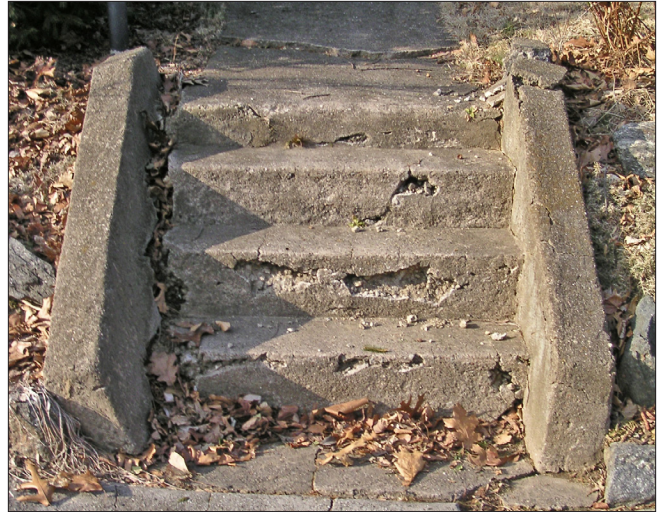
Without proper upkeep, tripping hazards can develop at steps and walkways. There are significant cracks and openings at these steps, exposing the reinforcing bars to stormwater and de-icing salts. This can accelerate the rusting of the reinforcing and deterioration of the concrete.

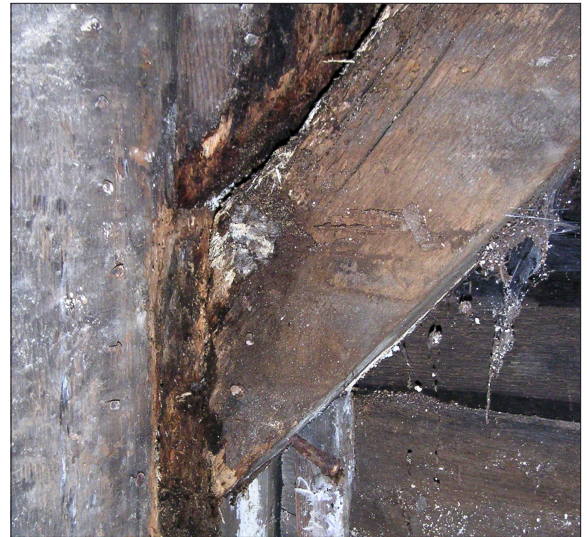
The dark areas at the top and side of the diagonal wood brace indicate moisture. The end of the diagonal wood frame is rotting. The cause of the moisture infiltration should be addressed and the wood framing repaired.

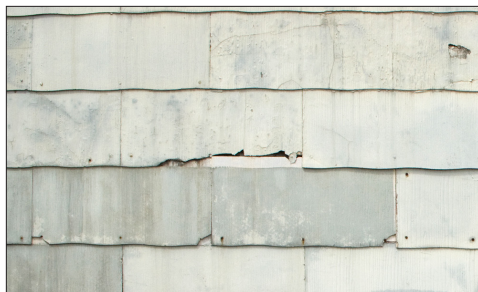
These asbestos shingles are cracked and worn. If replacement is considered, removal should be completed by a trained contractor.

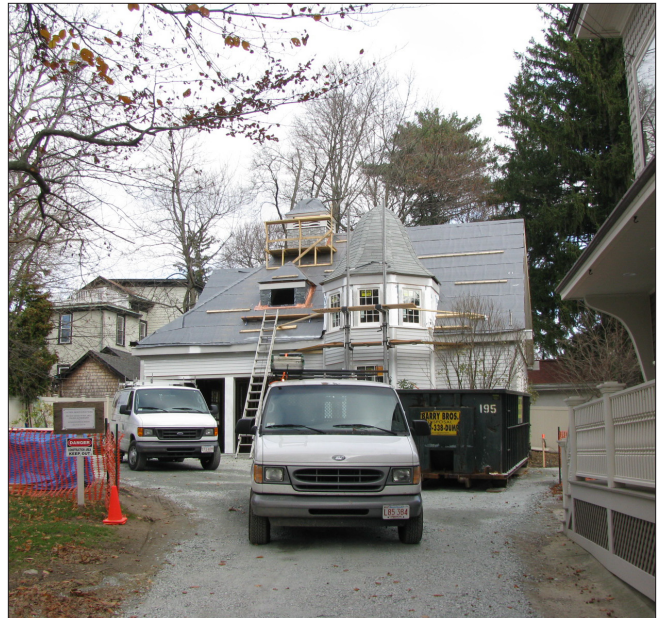
This carriage house at 43 Fairmount Avenue is being adapted for reuse as an office. The work is being funded in part through state and federal tax credits.
