GRACE  
EPISCOPAL  
CHURCH  
NEWTON, MASSACHUSETTS

November 1, 2022

**Re: Grace Church Bell Tower Restoration, Project Status Report No. 12**

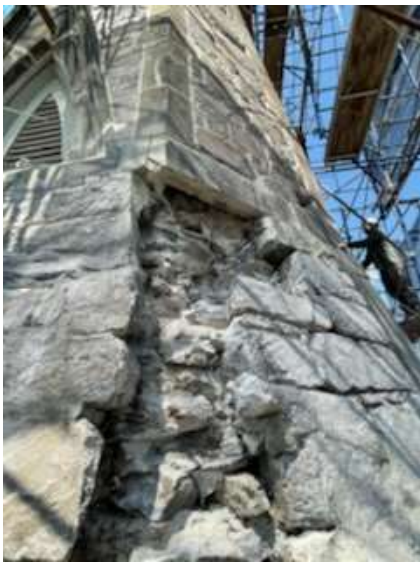
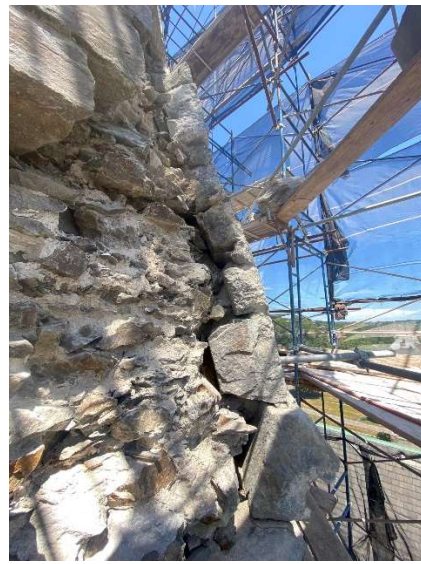
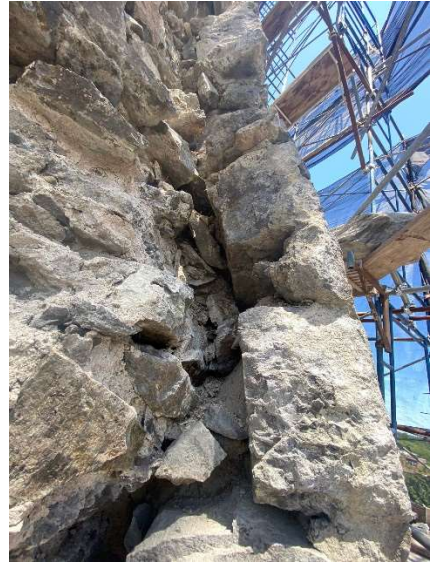
Loose exterior masonry at base of spire was removed to expose the inner masonry wall.

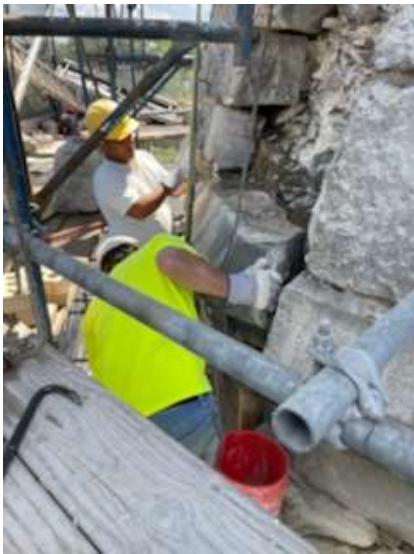
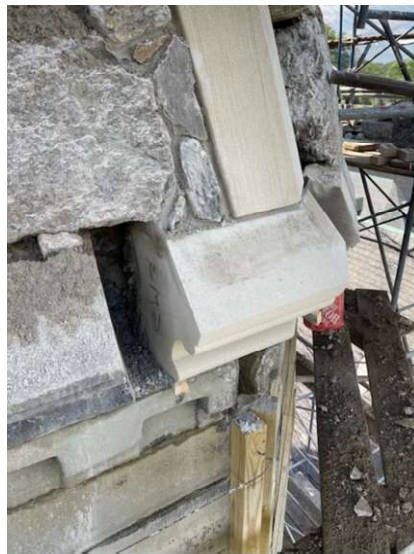
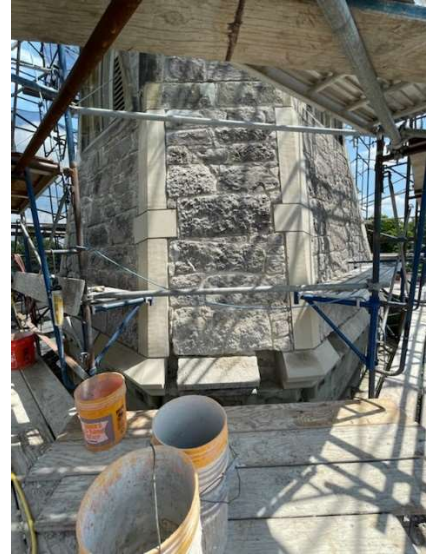
Existing and new masonry at base of spire was set in place and anchored to the inner masonry.

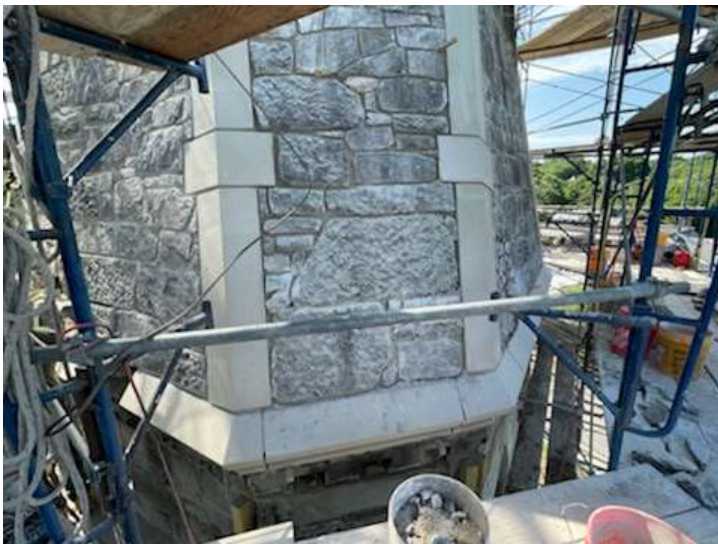
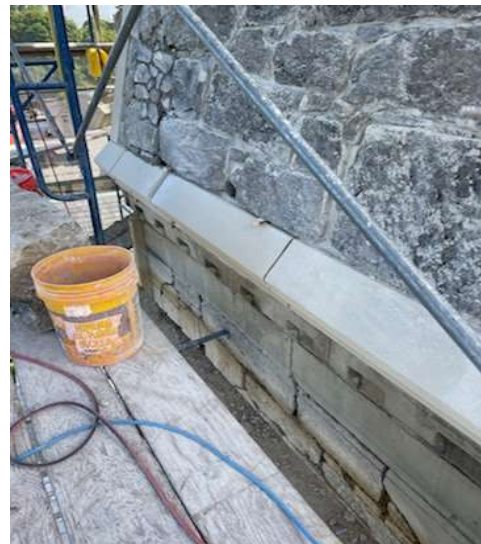
Reconstructed base of spire incorporated extensive areas of new material to replace fragmented stone.

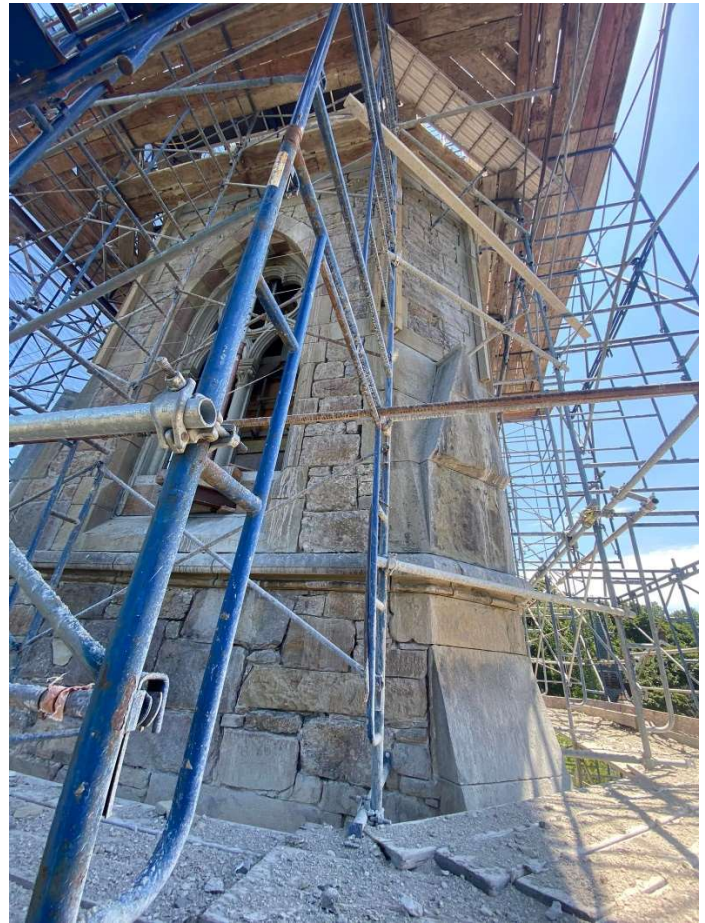
Next phase of work: pointing mid tower at Bell Loft
