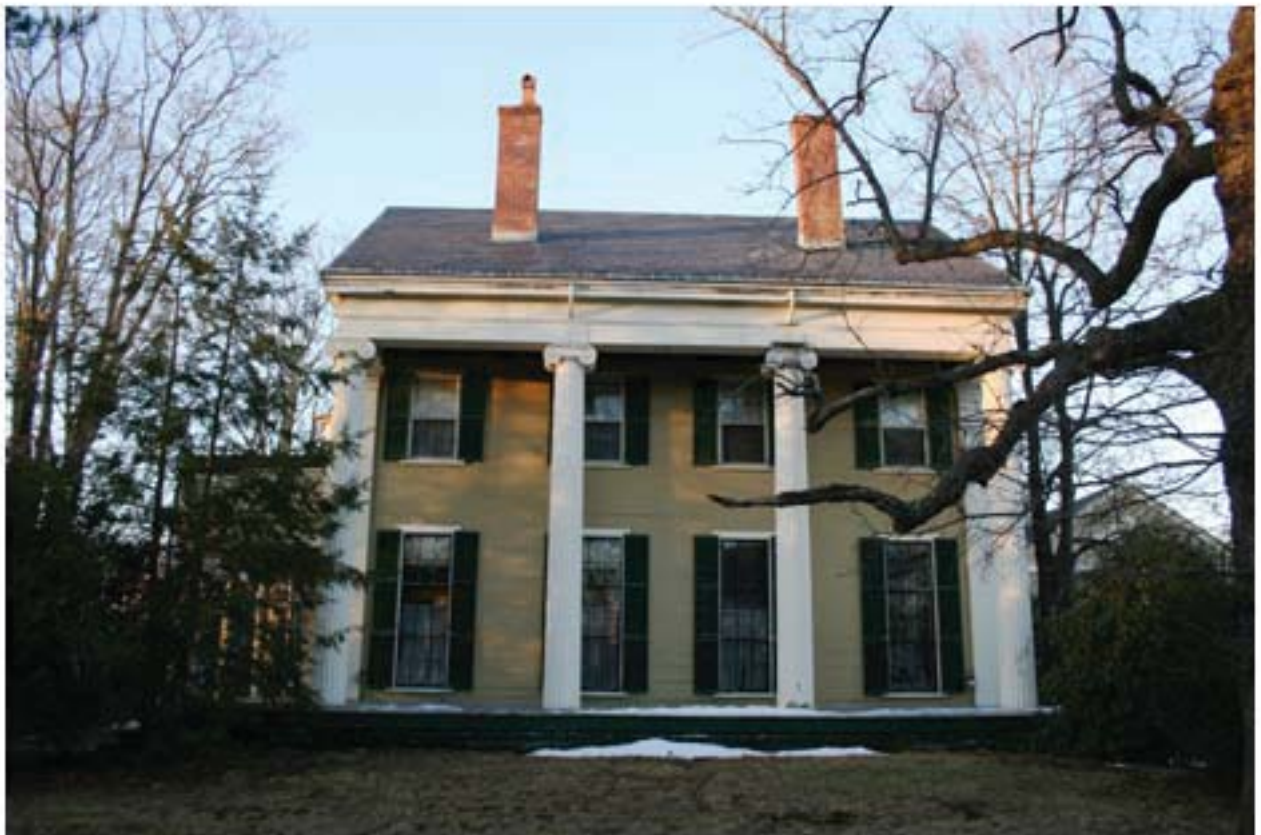
6D- Existing house chimneys on south facade

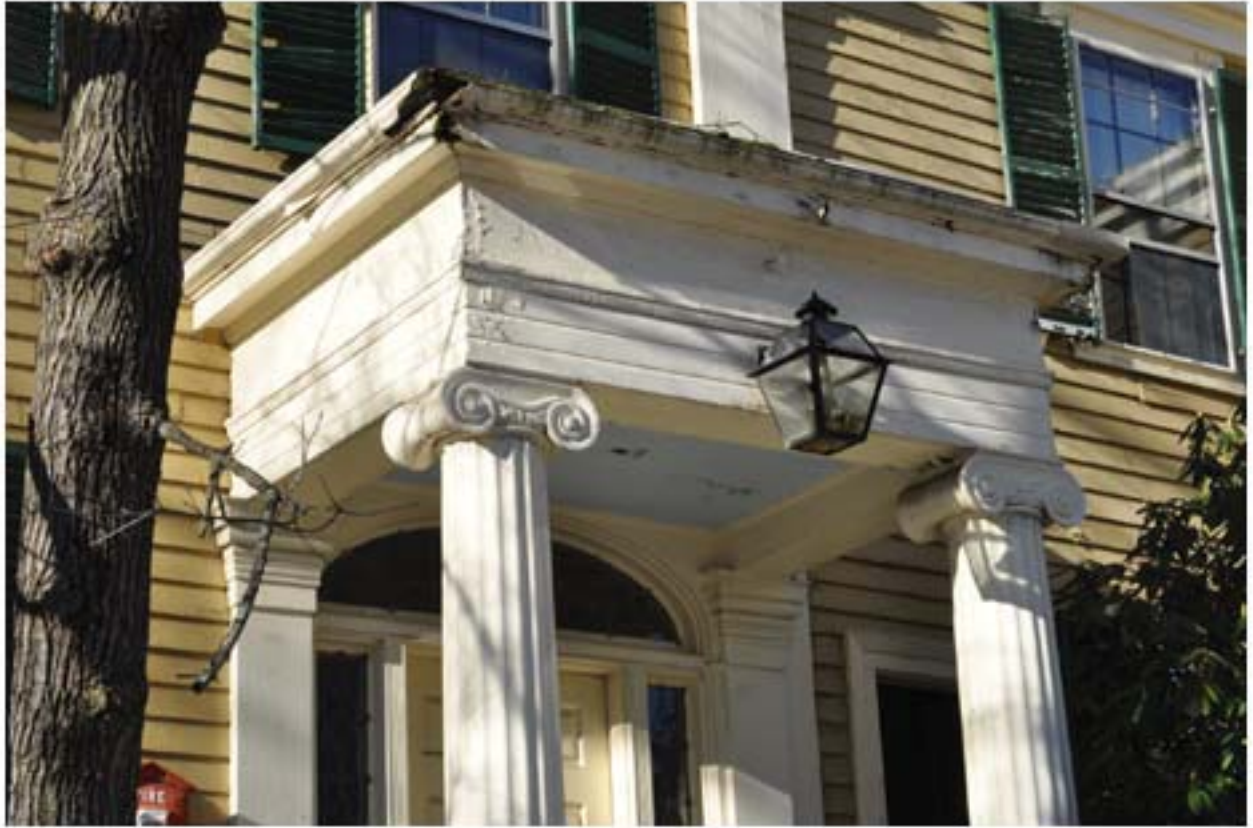
9A- Existing east porch low sloped hot mopped asphalt roof

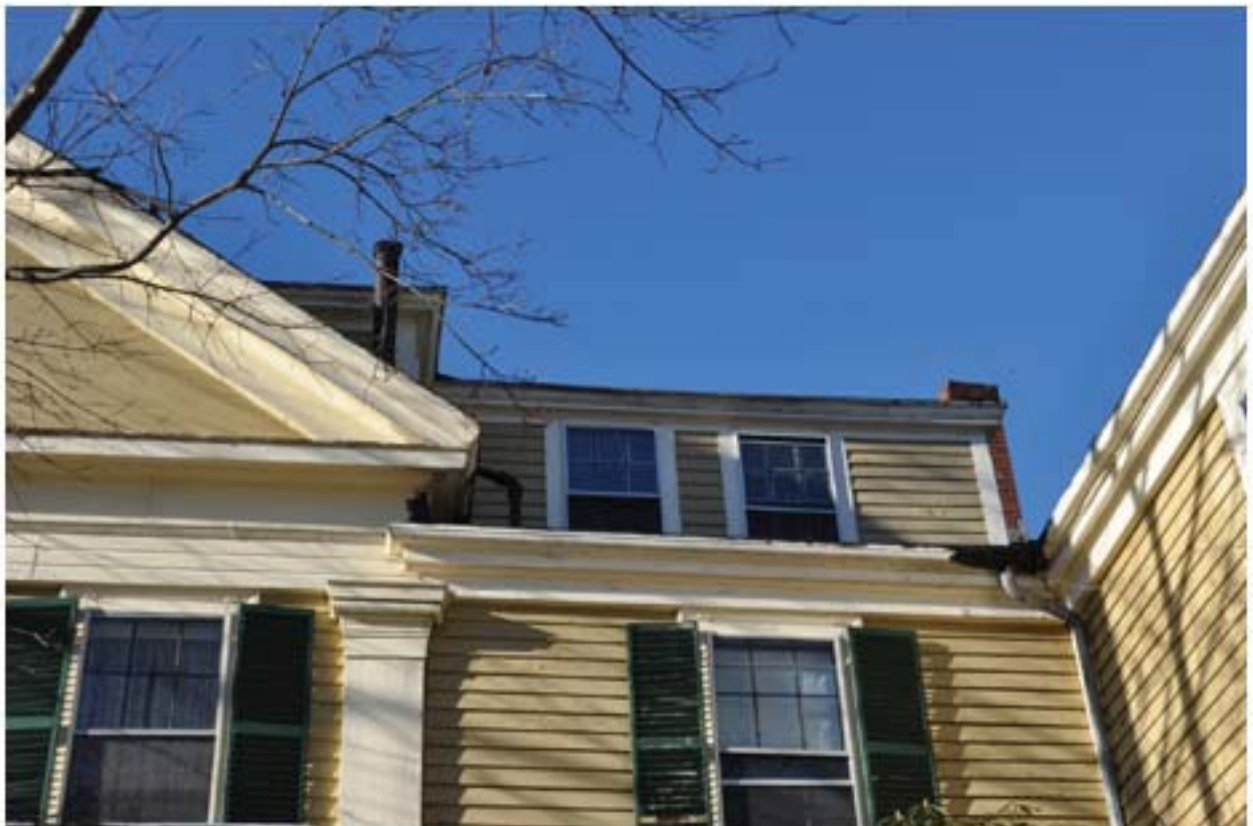
10B- Existing east house cornice, gutters and downspouts

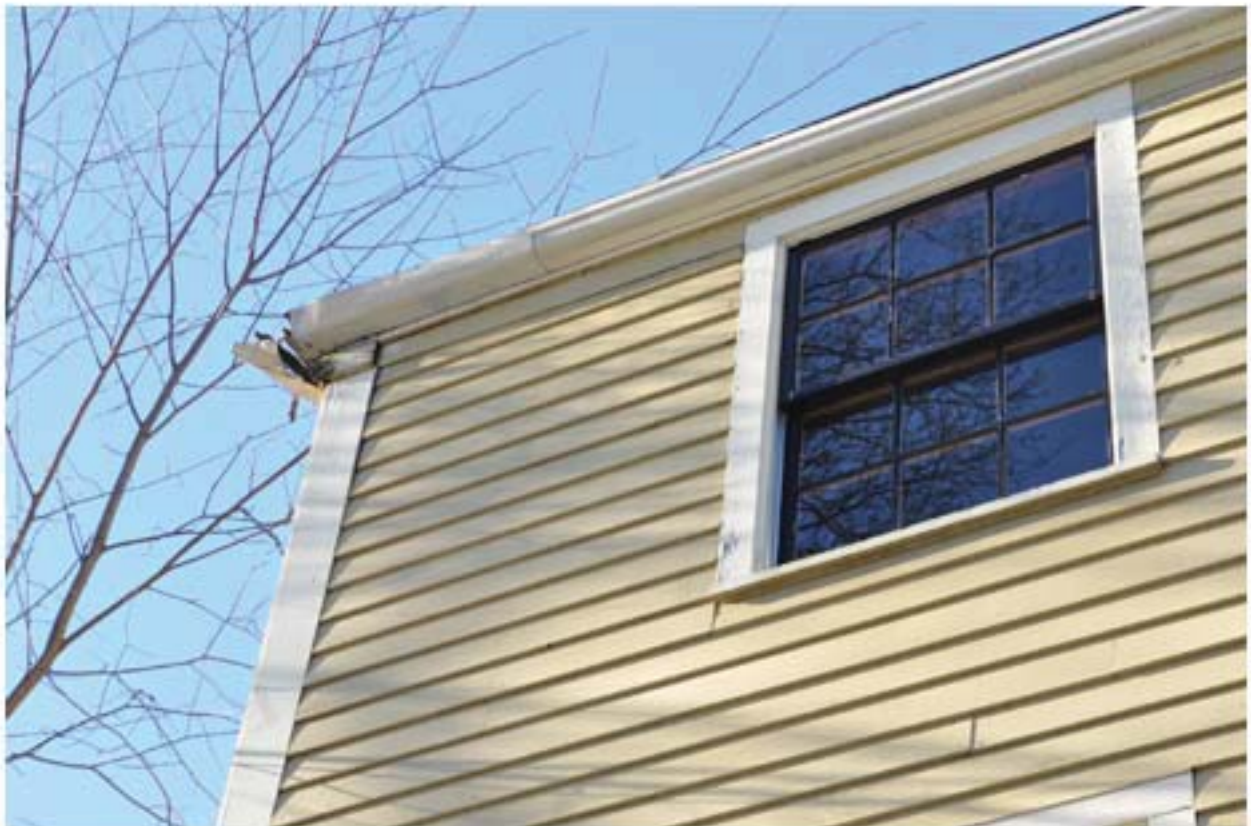
11B- Existing east side barn gutter, fascia and soffit

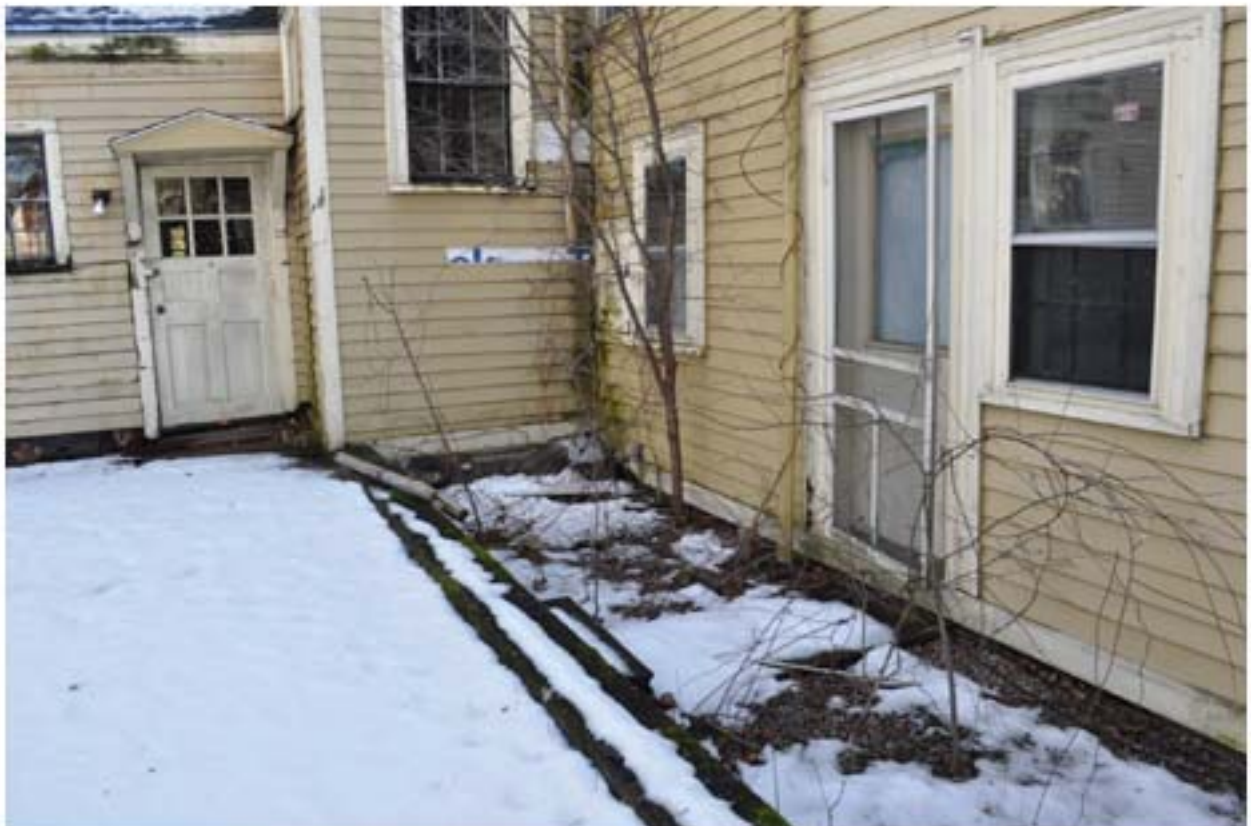
12B- Existing window trim, door trim and frieze boards

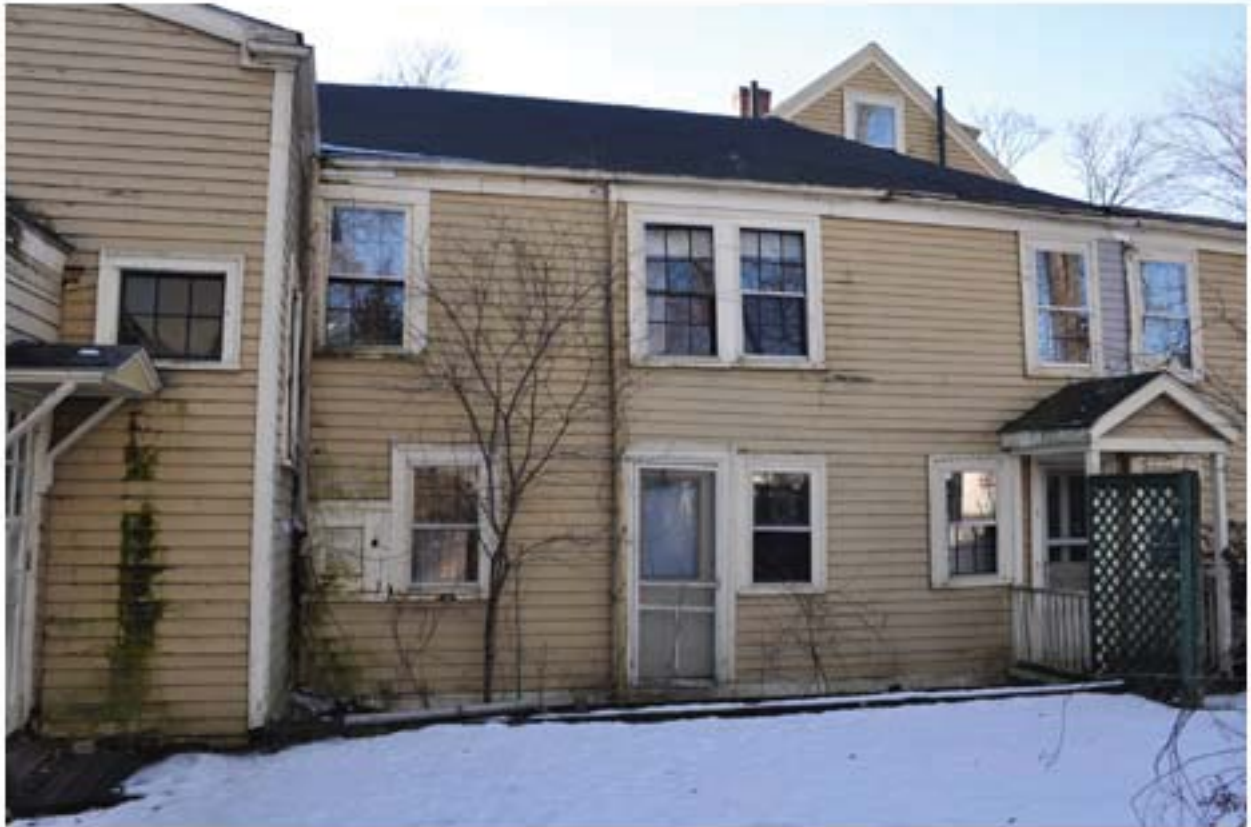
12C- Existing window trim, door trim, gable trim and frieze boards on north side of building

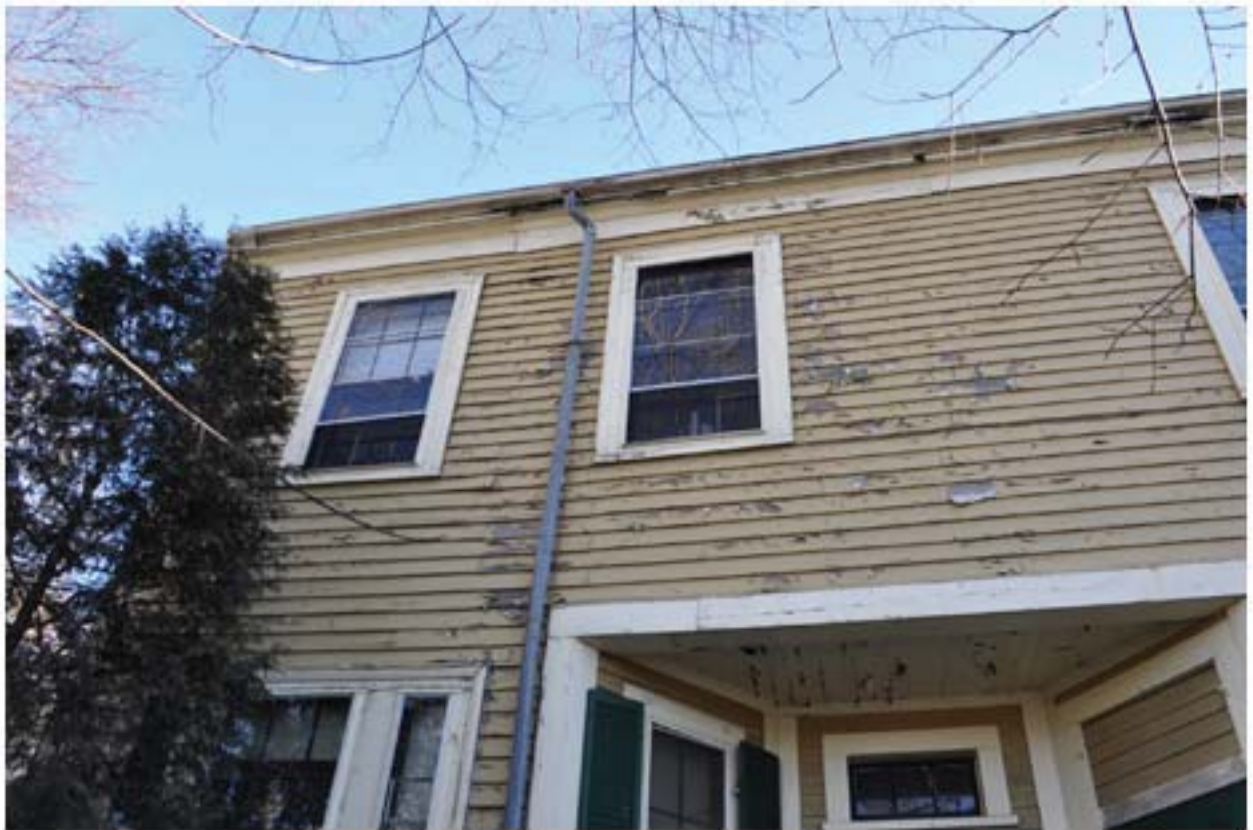
13D- Existing siding on west side of house

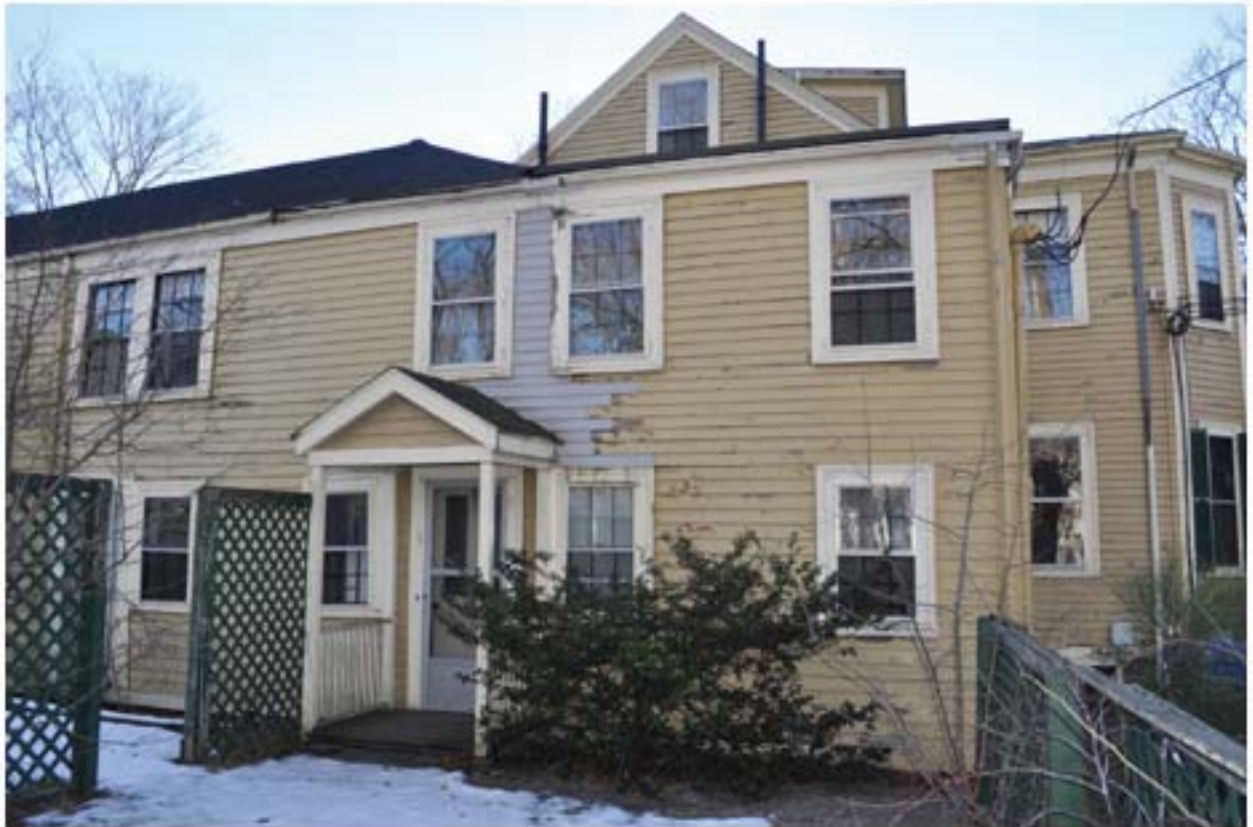
14C- Existing double hung wood windows on north side of house

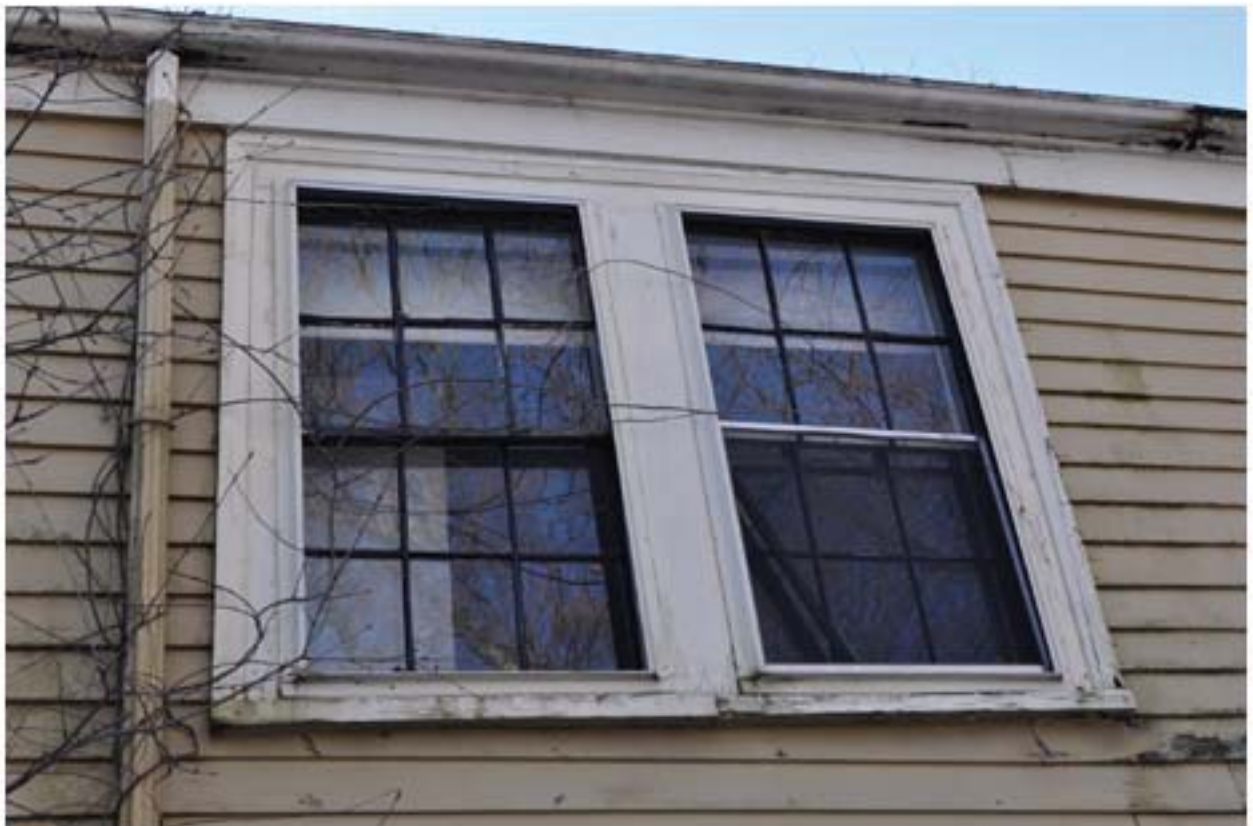
14D- Existing double hung wood window

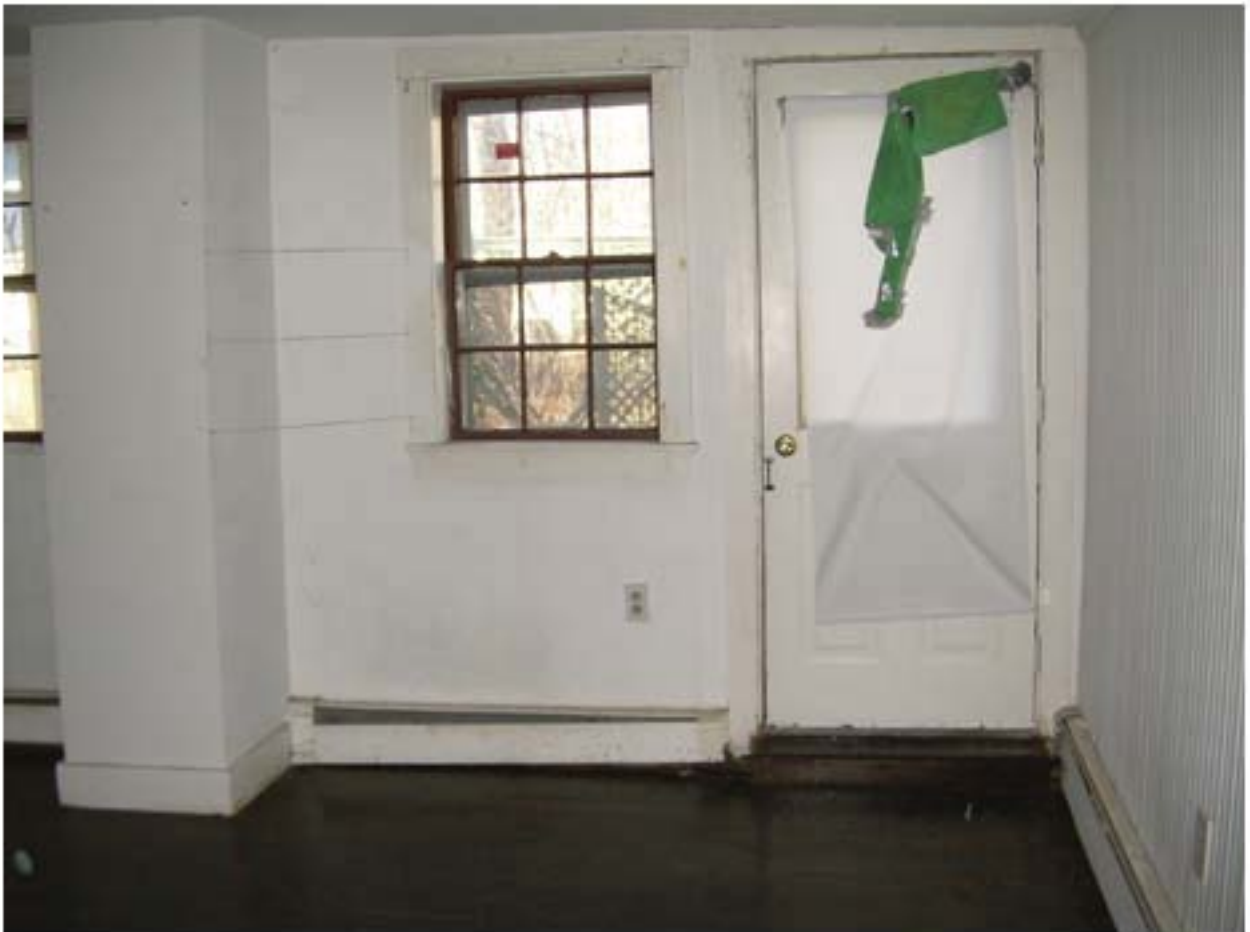
15C (Interior)- Existing north house entrance door

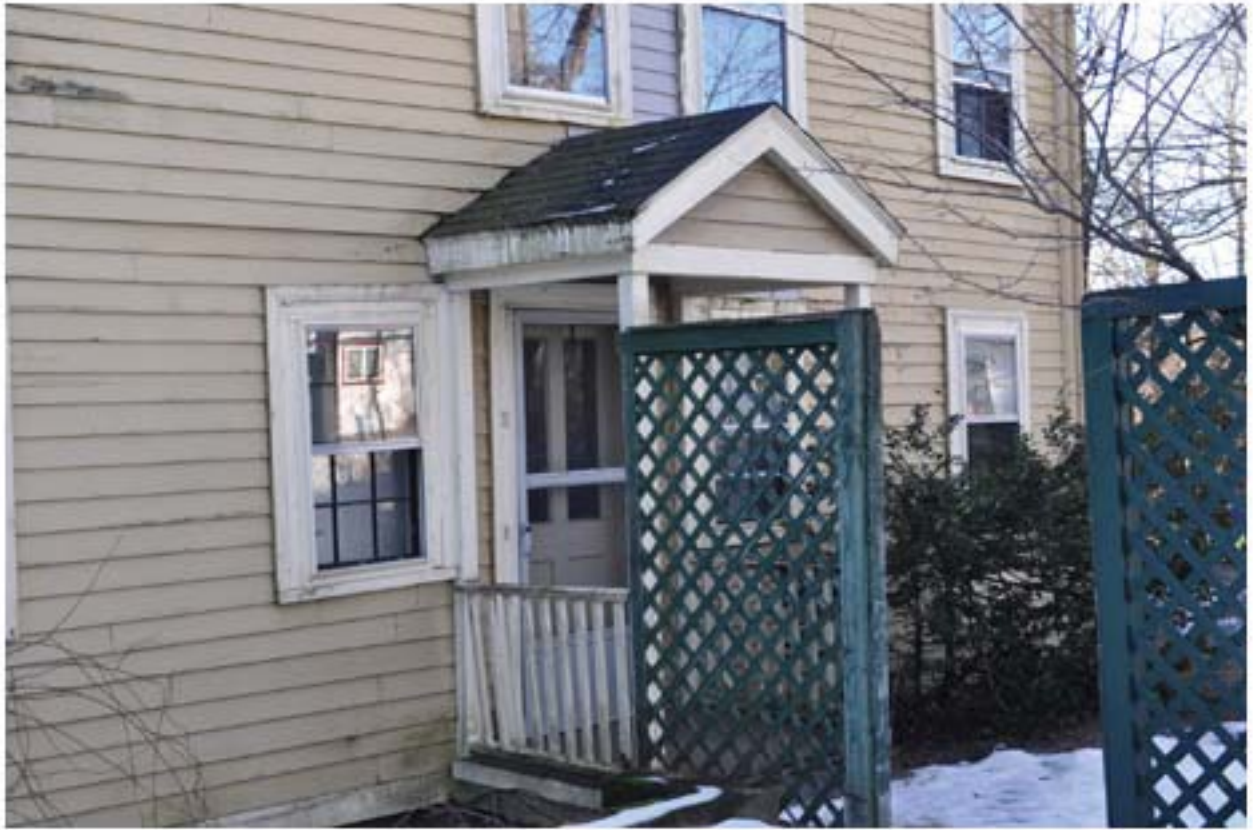
15F- Existing north house entrance door

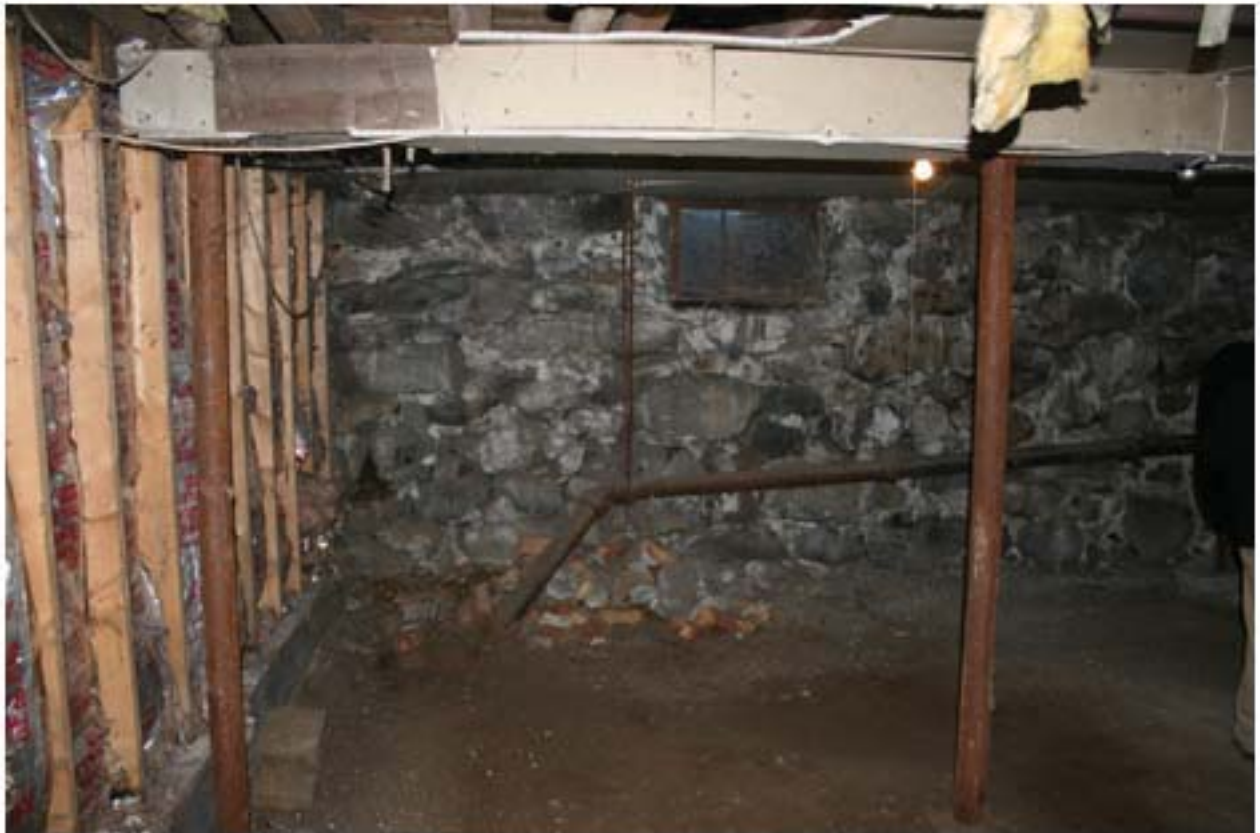
19C (Interior)- Existing basement window at south side of barn

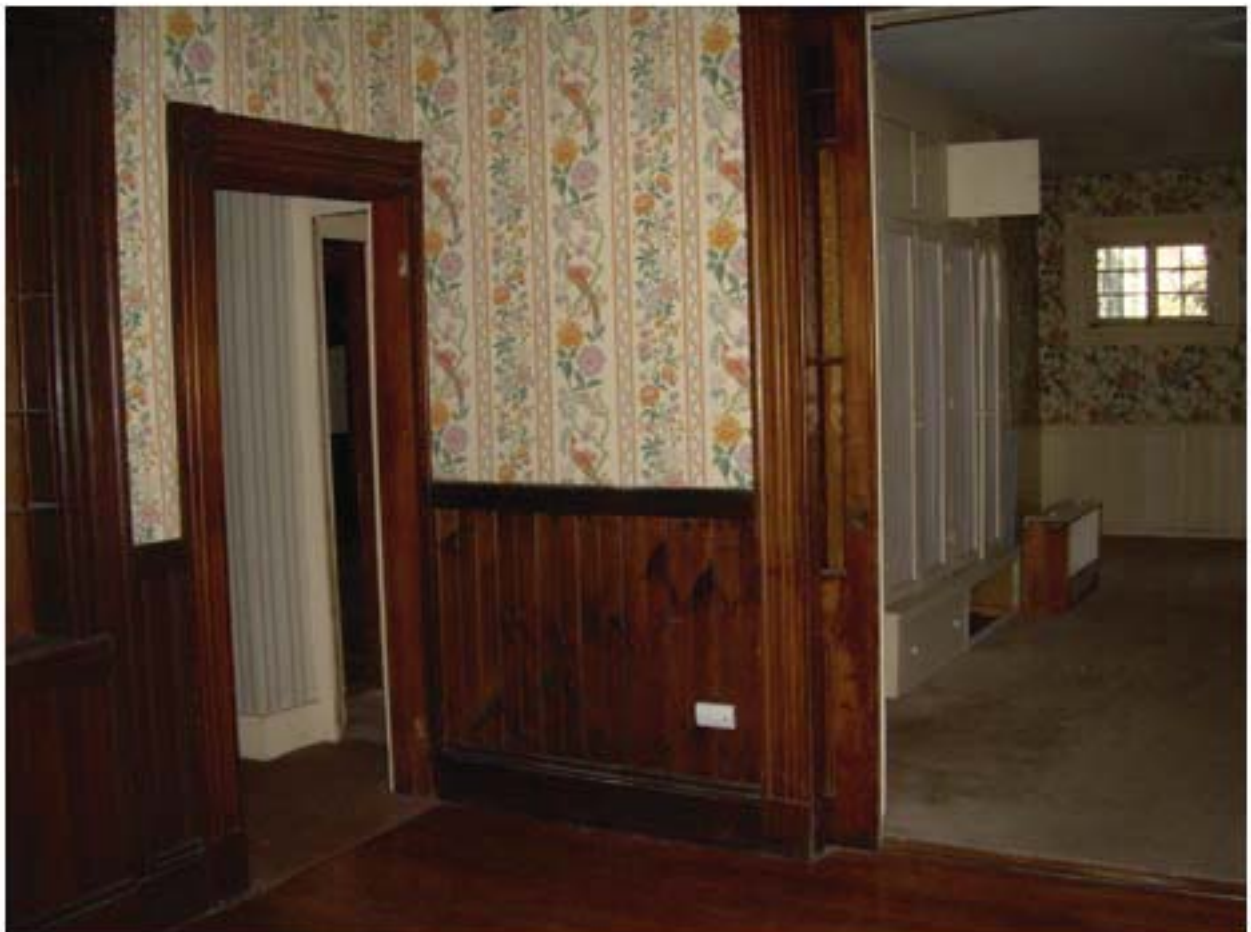
20F- Existing original door, casing, mop boards, wall paneling and wood parquet floors

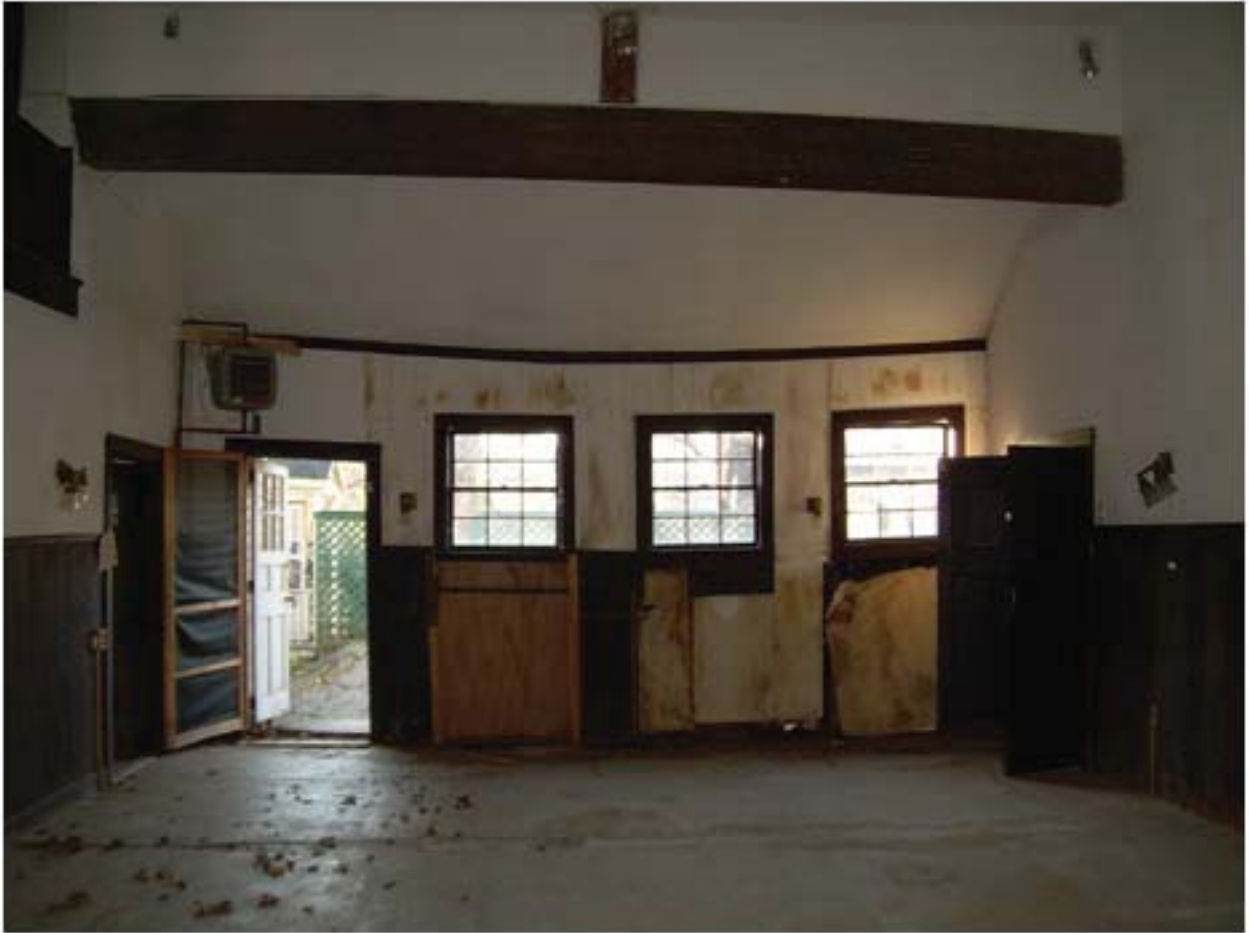
21A (Interior)- Existing west side of barn

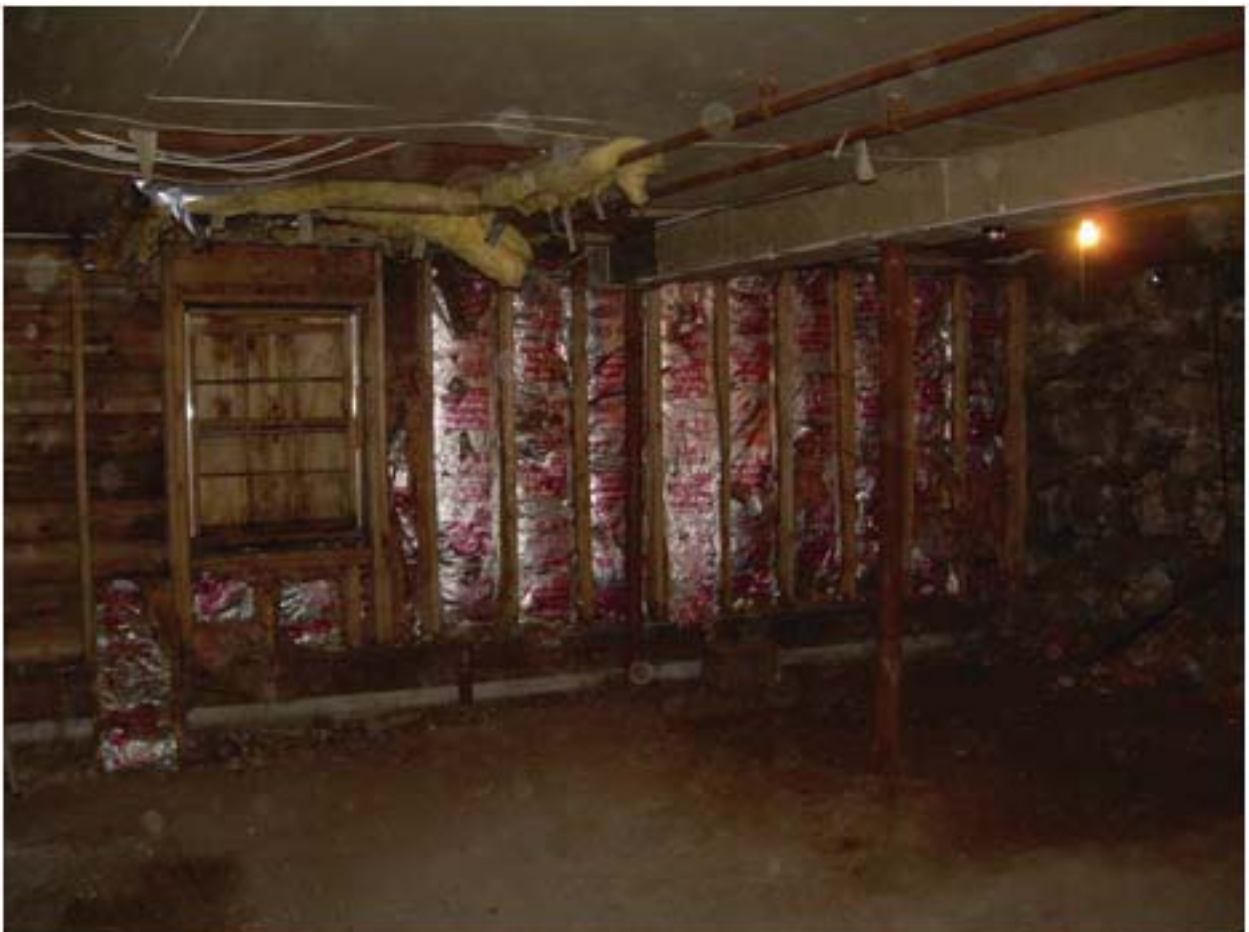
21B (Interior)- Existing east side of barn
