West Newton Armory

1137 Washington St, Newton, Massachusetts 02465

Report of Facility Condition Assessment

Project 100060875

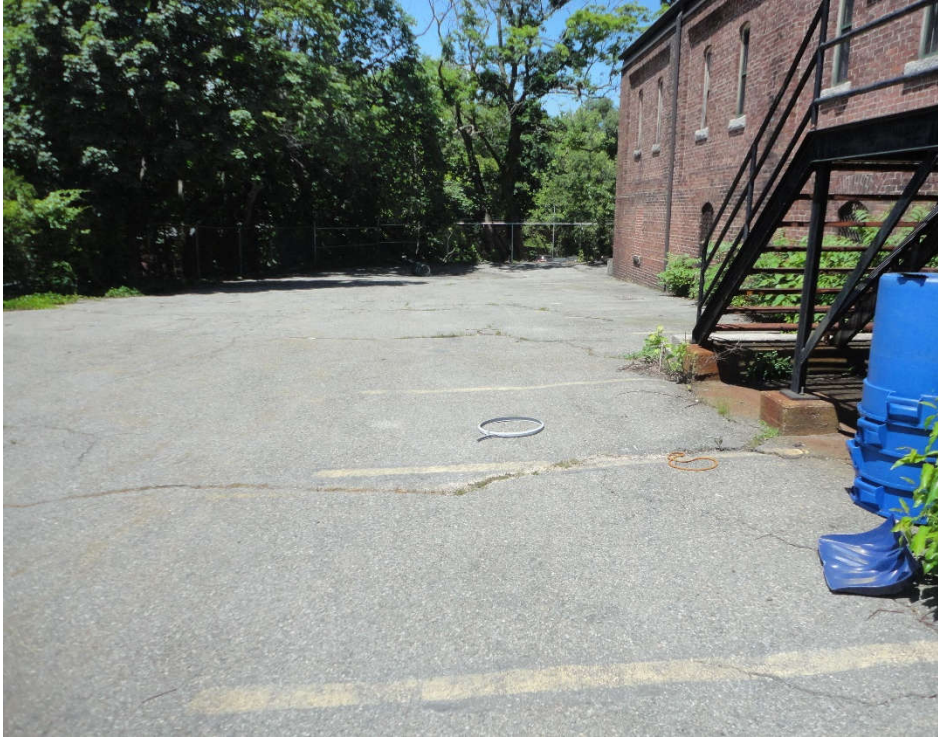
Photograph No. S-01

Parking lot and egress stair
west side of building

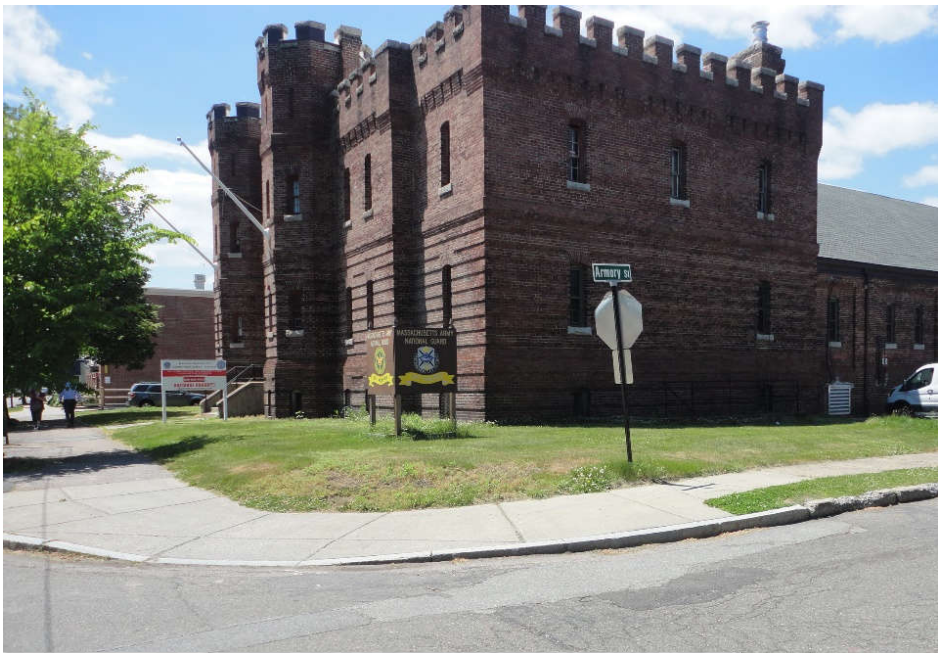
Photograph No. S-02

Landscaping and parking at
southeast corner

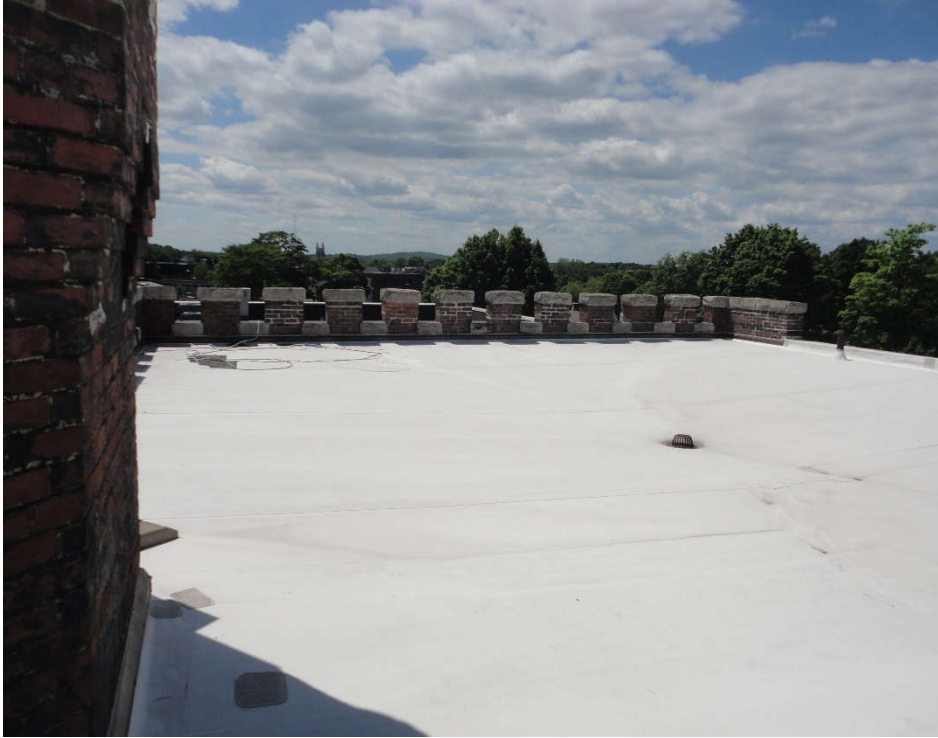
Photograph No. R-02

Southwest view of TPO roof and parapets at main building

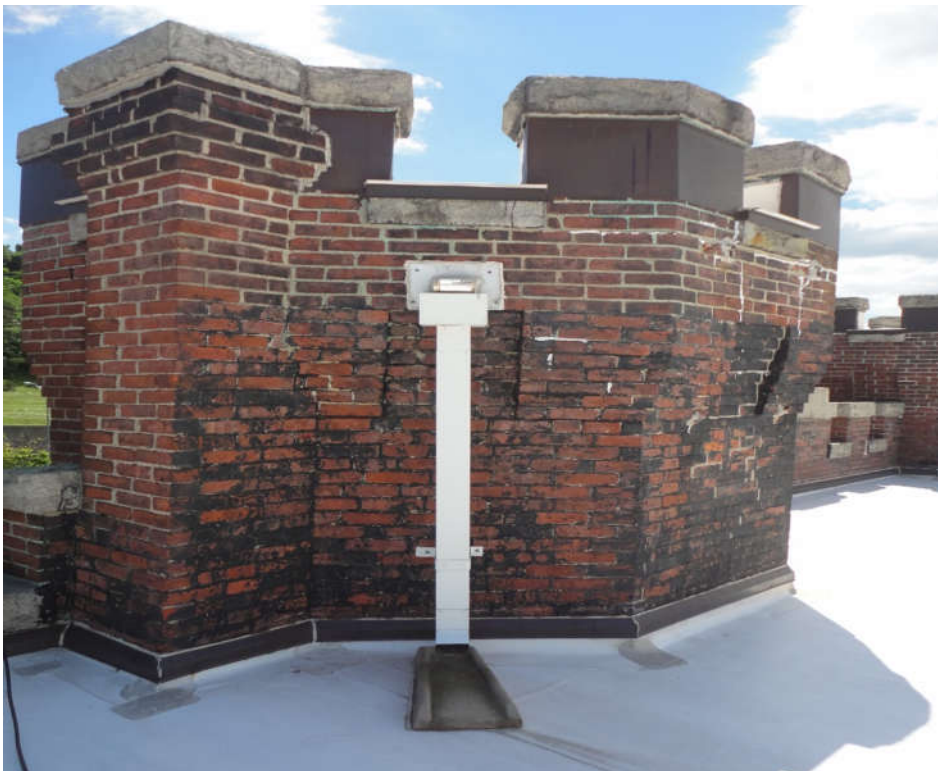
Photograph No. R-03

Masonry at south turret feature with decorative copper cladding

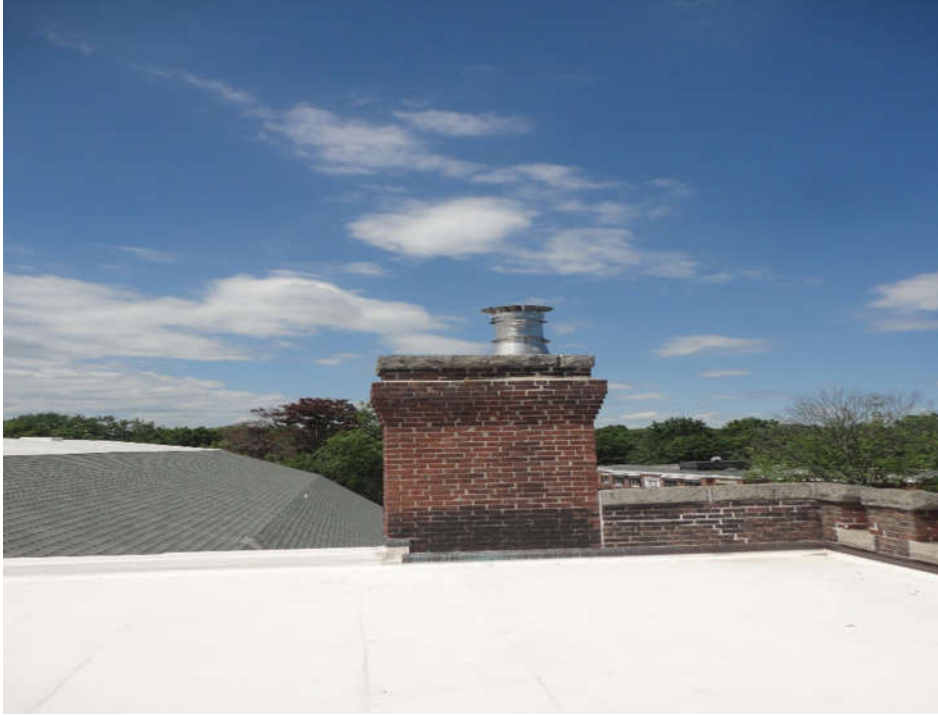
Photograph No. R-04

Existing brick chimney with newer discharge flue for boilers, drill hall shingle and TPO roof beyond

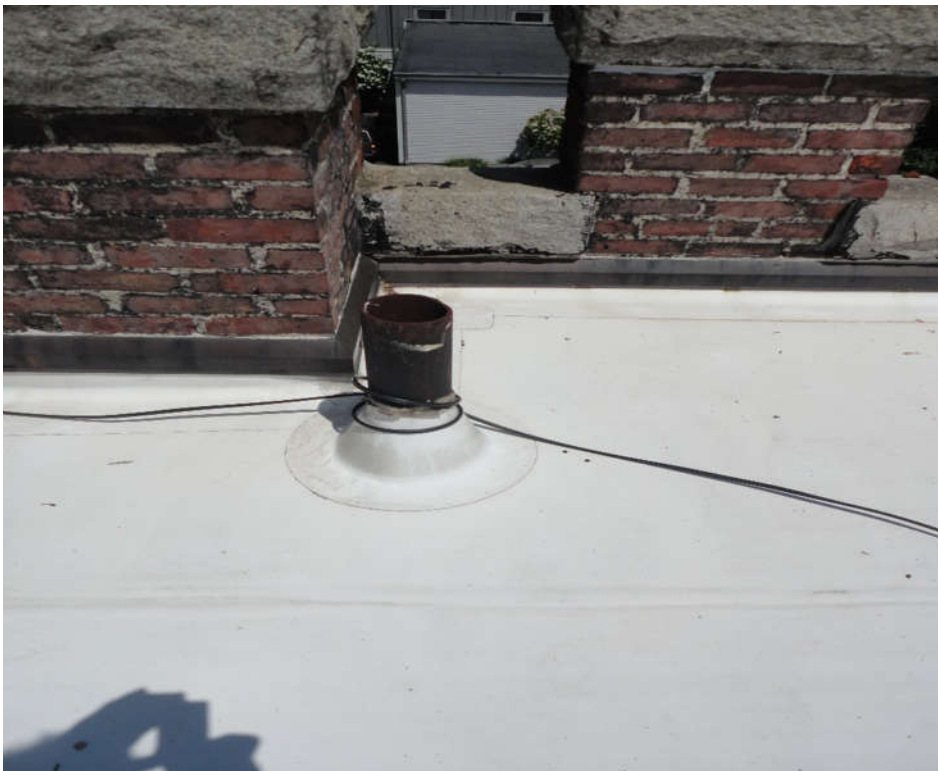
Photograph No. R-05

Typical TPO boot flashing

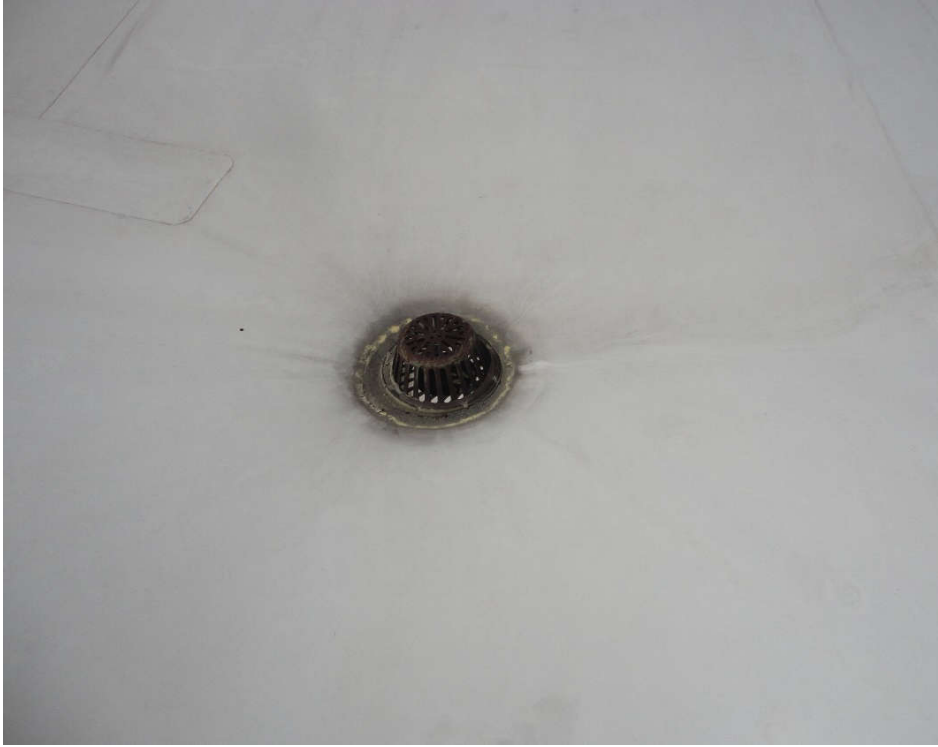
Photograph No. R-06

Typical internal roof drain with cover

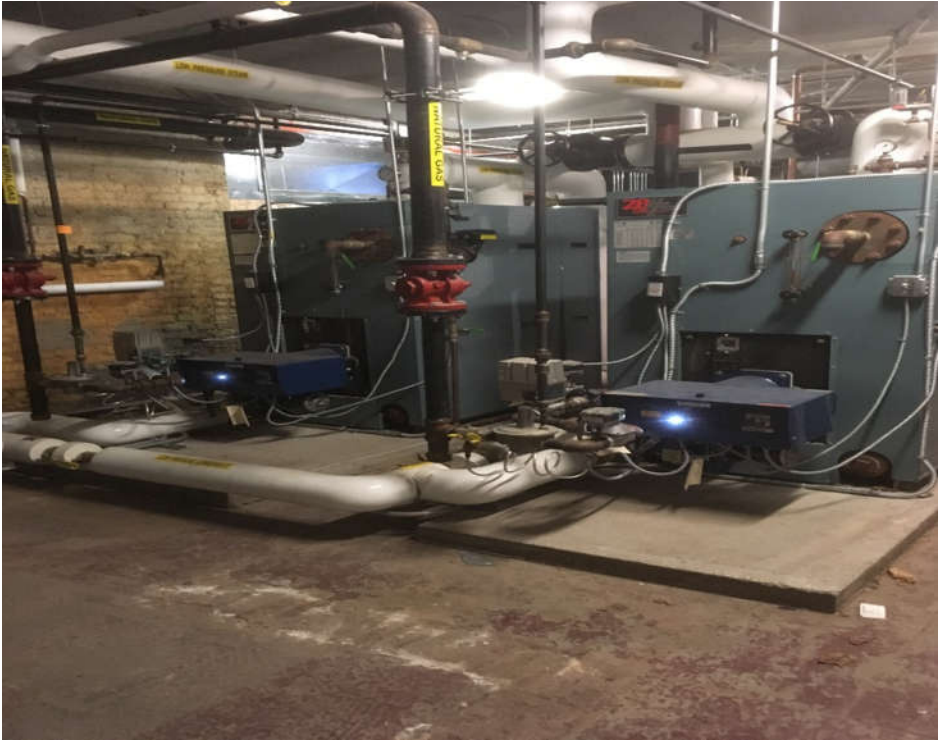
Photograph No. M-02

New Smith Boilers

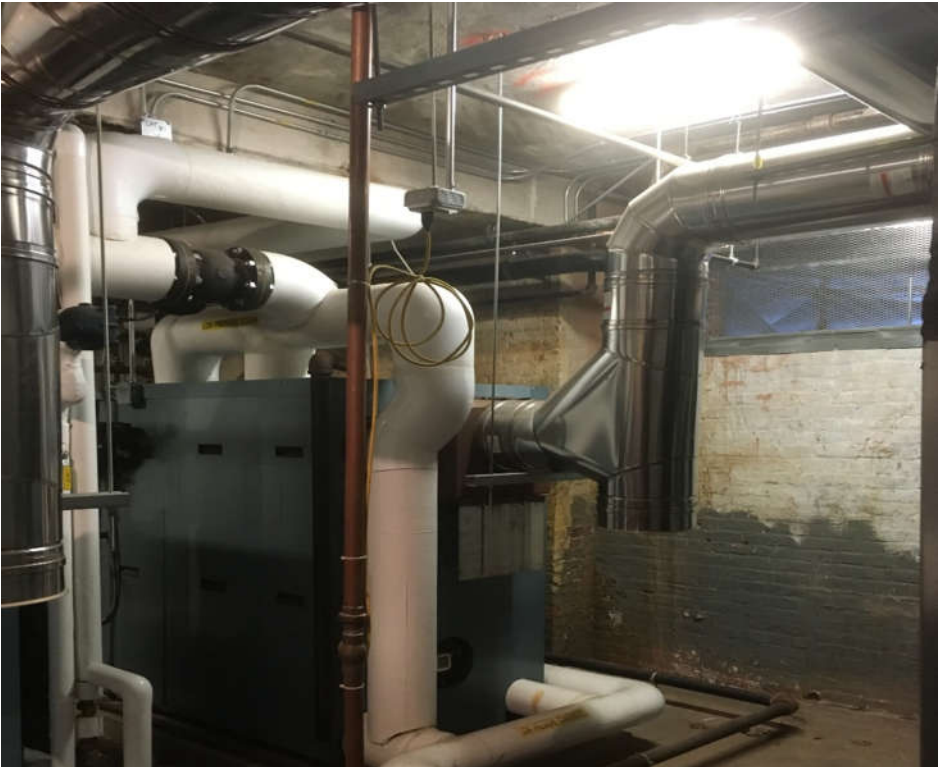
Photograph No. M-03

New insulated steam piping
for space heating system

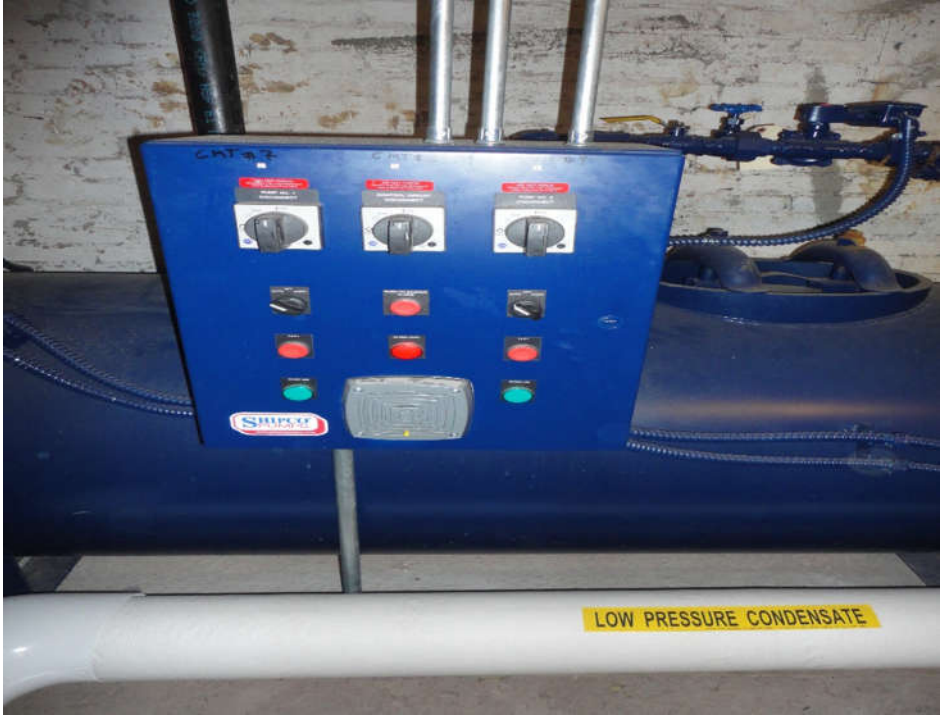
Photograph No. M-04

New condensate pump controller

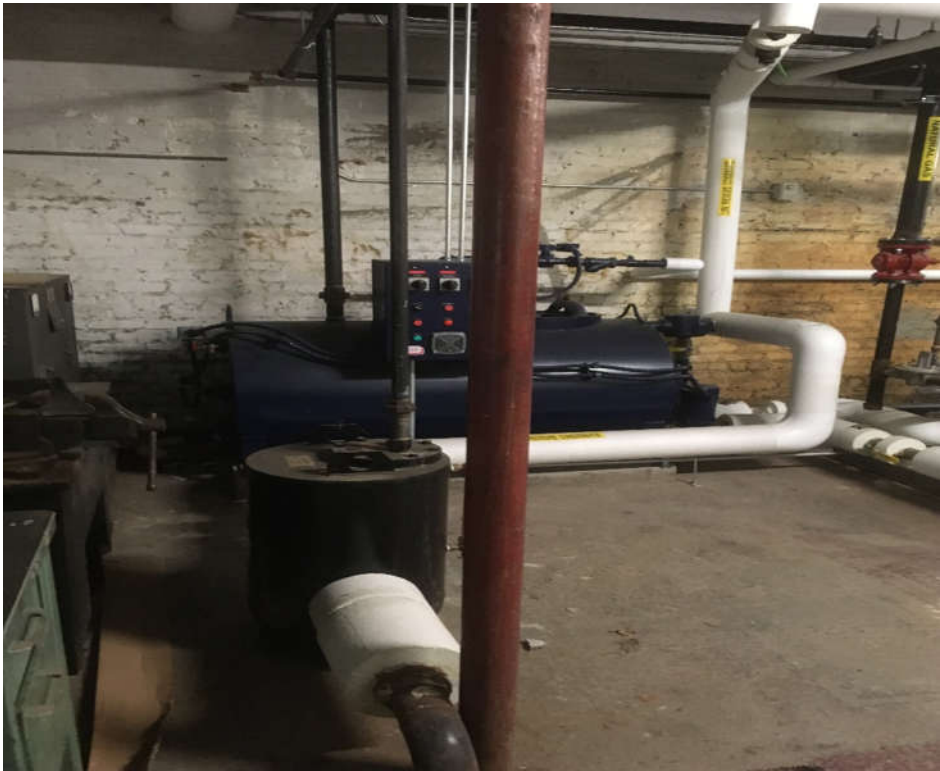
Photograph No. M-05

New condensate receiver for steam heating system

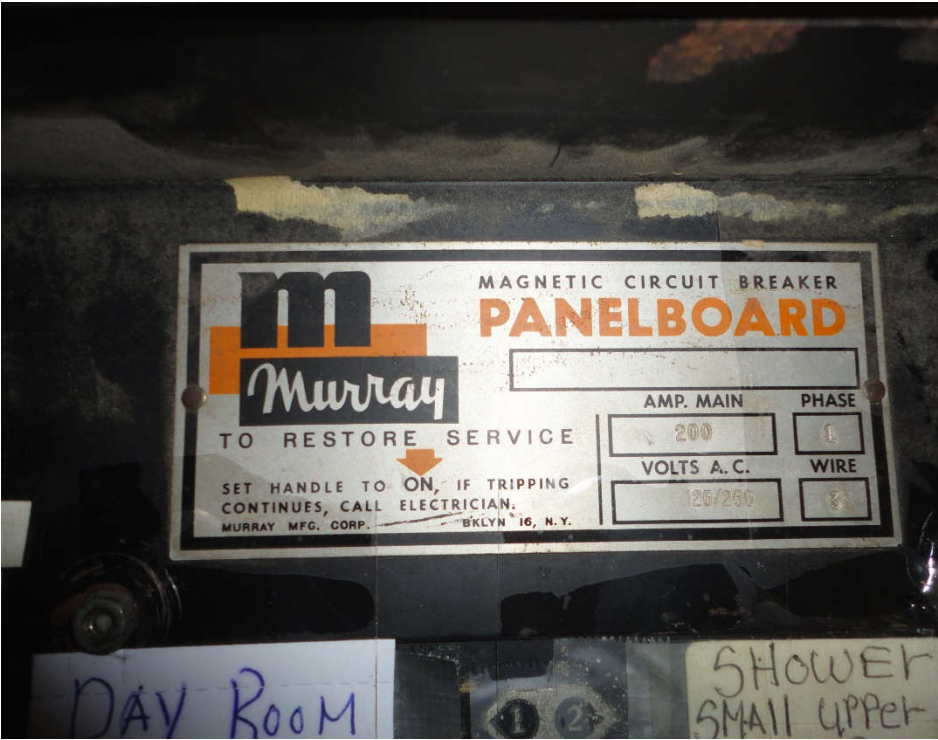
Photograph No. E-02

Main 200 A electrical panelboard

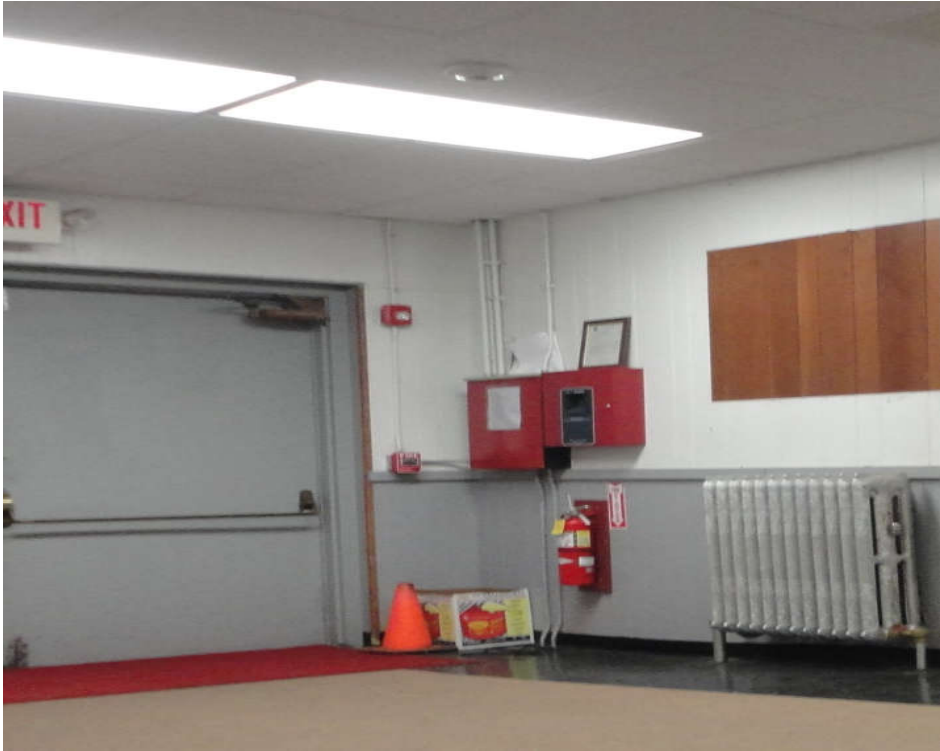
Photograph No. FLS-01

Main fire alarm and annunciator panel, horn/strobe and fire alarm pull station at front door

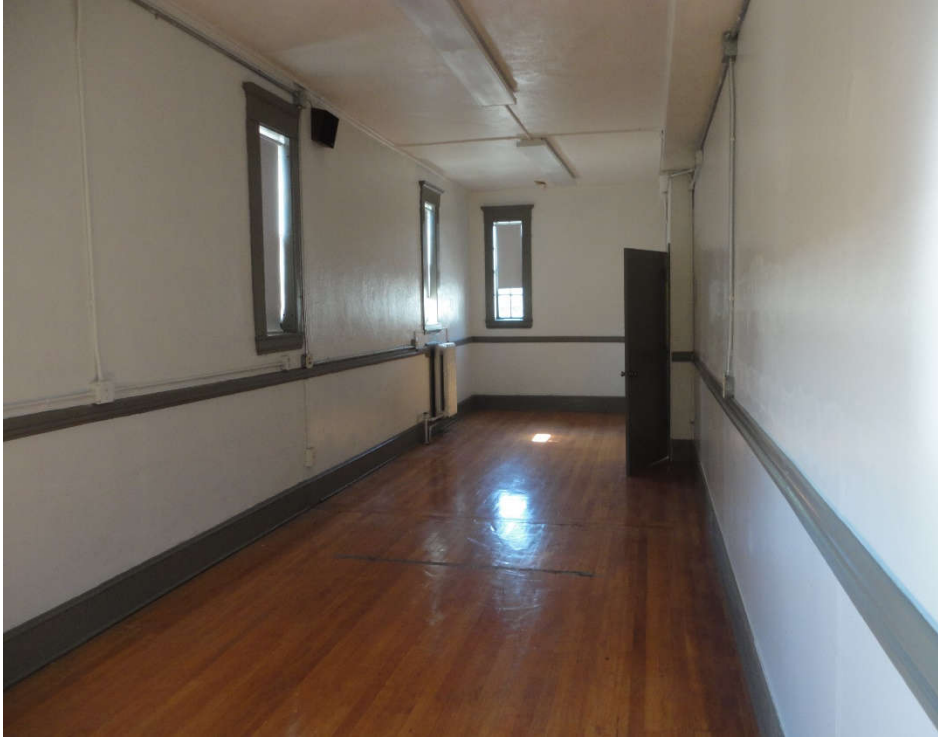
Photograph No. INT-03

Second-floor corridor

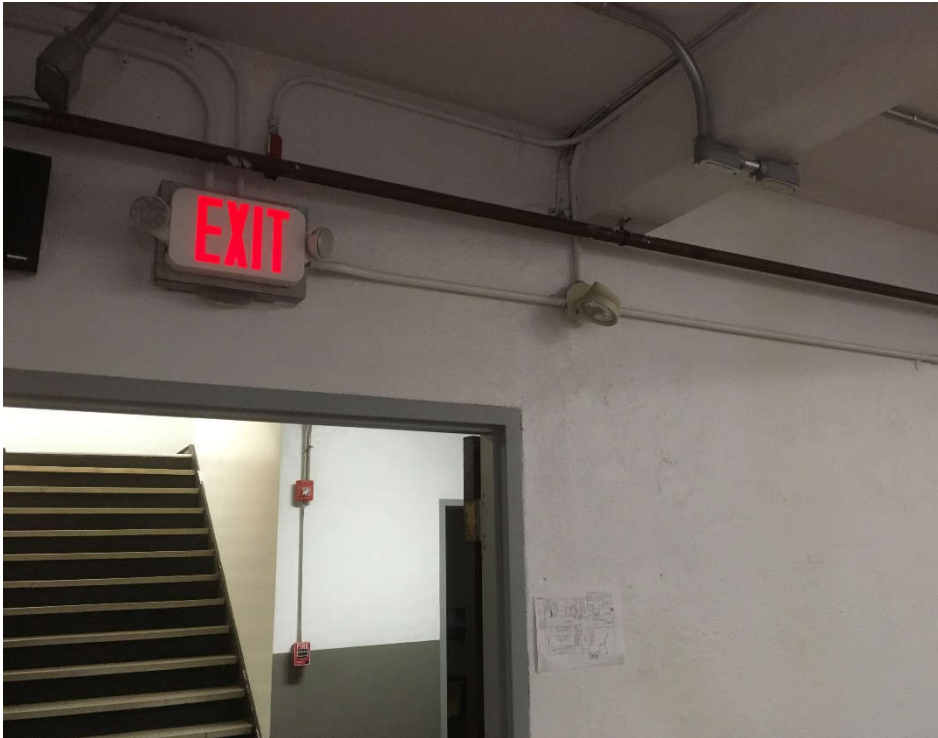
Photograph No. INT-04

Representative illuminated exit signs and emergency lighting heads; horn/strobe and fire alarm pull station beyond

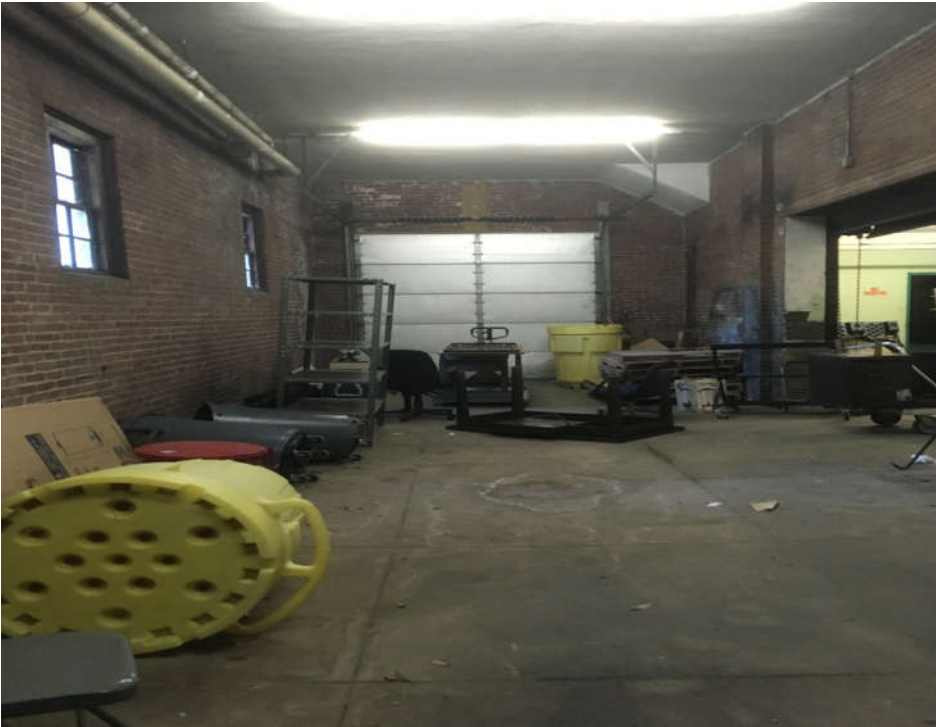
Photograph No. INT-08

Storage bay accessible by overhead door at northeast corner of drill hall building
